**Forensic Engineering – Part C**  
**Case Histories: Metallurgical & Mechanical Failure**  
**Analyses**

Gerald O. Davis, P.E.

**Case 1- Superheater Tube Failures in a Large Steam Boiler**

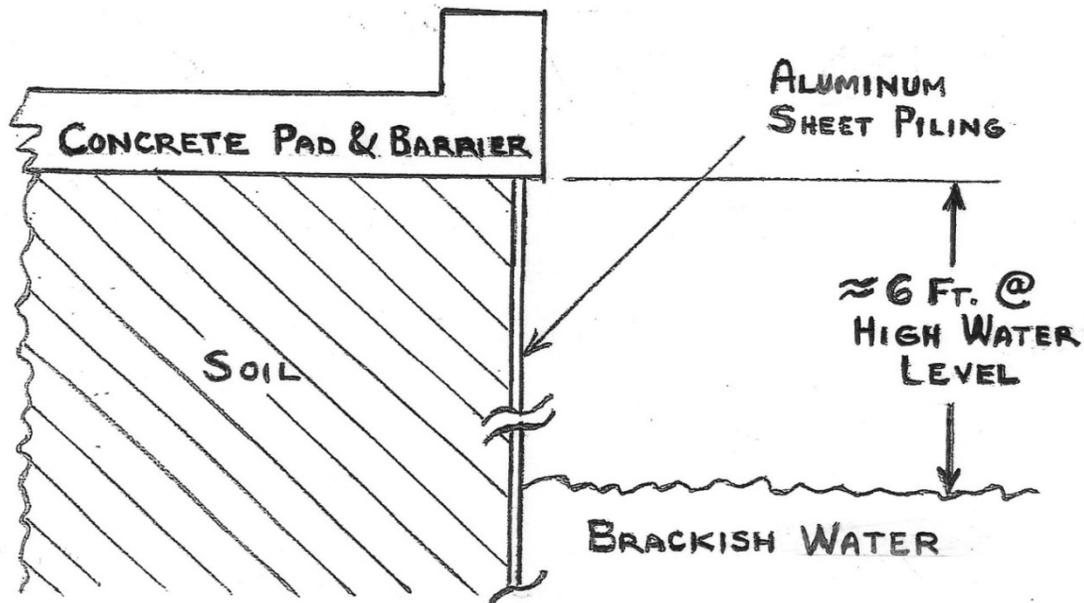
**Figure 2 – Cross-sectional Sketch of Aluminum Sheet Piling Adjacent to the Concrete Pad and Traffic Barrier at the Marina**

In conclusion, it is most probable that the severe pitting corrosion that occurred on this section of aluminum was due to the proximity of the concrete barrier directly above it. Over time, ( several years in this case) rain water leached out lime that contained calcium from the traffic barrier above the piling. The resulting rain water and calcium ran down onto the upper portion of the piling. The water evaporated and left behind random deposits of calcium on the aluminum. Chloride ions necessary to combine with the calcium and form  $\text{CaCl}_2$  were in the atmospheric air around the marina or may have collected on the sheet piling because of the occasional high level splashing of the brackish water during high winds or storms. Like rain water, the brackish water

- Hydro blast and then wash off with fresh water the severely corroded piling over its entire length to remove all possible solid corrosion products in and around the pits.
- Weld small circular patches (using only 6061 –T6 material) over all pits that have any significant depth (to assure structural integrity of the piling).
- For long-term minimization of future severe corrosion, bolt a thin plate formed into a projecting “awning” shape onto the outer vertical surface of the concrete barrier over the piling’s length so as to form a barrier above the Al below. Form this “awning” out of Type 316 stainless steel.

Type 316 will offer better corrosion resistance in this marine atmosphere than Type 304 because of its molybdenum content. The formed “awning” should cause most future leaching of lime (and calcium) from the concrete barrier by rain water to run onto its downward slope and fall into the brackish water and not onto the aluminum piling. To prevent galvanic corrosion of the aluminum, the stainless steel should never physically contact the piling.

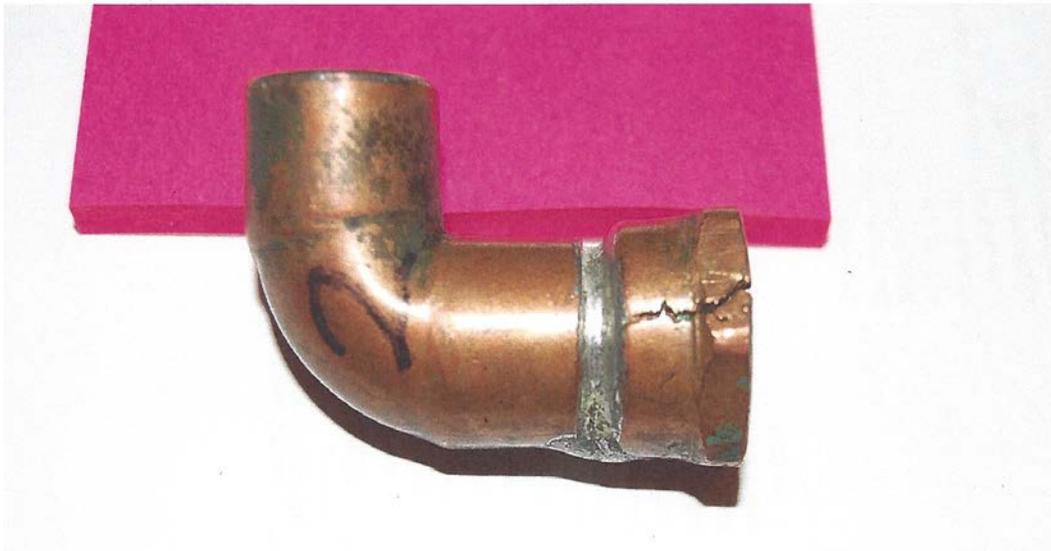
**Figure 3 – Macroscale Photo of a Typical Cracked Copper Fitting Silver-soldered to a 3/8-inch Copper Elbow** (the small colored pad is being used to position the fitting for the photo)

Initially it was believed that the cracking and leaks may have been produced in the newly installed system by lab personnel that applied too much torque to some of the fittings when they screwed in attachments. Those actions might have created small cracks in the affected fittings, which over a period of several weeks could grow and eventually produce the leaks. To test this idea, the contractor obtained three new fittings of the same type, brand and model number as those that failed but before having the cleaning treatment. They were alternately put in a bench-mounted vise. A 1/2-inch threaded copper plug was inserted in each fitting. The plug was torqued to a value at least 50% above the maximum recommended level for the fittings. No cracks were found, but each fitting had significant plastic deformation.

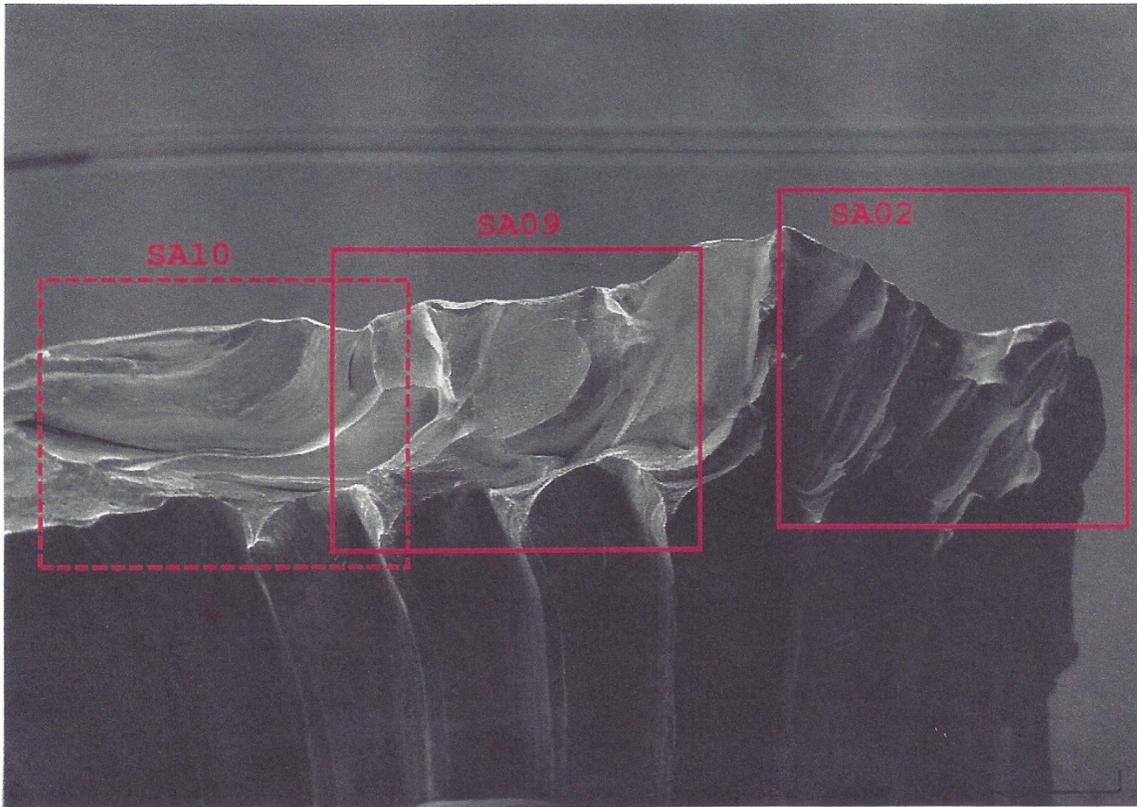
**Figure 4 – SEM View of Brittle Fracture Surface of the Broken-apart Copper Fitting at 10X Magnification. Boxed Areas Were Later Examined at Higher Magnifications.**

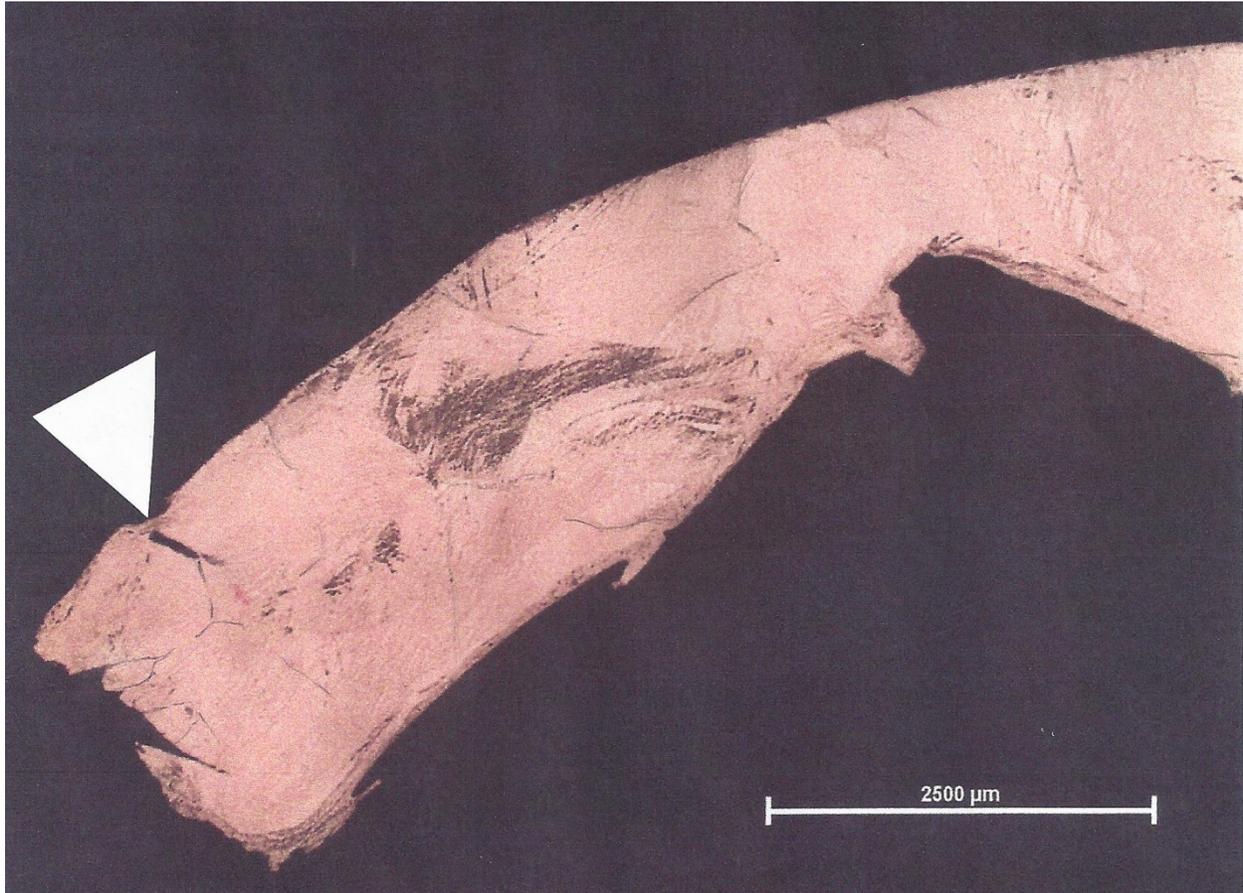
**Figure 6 – Light Microscope Photo of a Polished and Etched Cross-section Through the Copper Fitting’s Fracture Perpendicular to the Crack Path. 12.5X magnification.**

The white triangle attached to the photo points to a dark oblong-shaped feature at the crack opening on the outside diameter of the fitting. This is an open secondary crack, in the examined plane, coming off the main crack. Just below and joining the secondary crack is a grain boundary that has increased width. This grain boundary is wider because it has an intergranular crack that is growing through it towards the intersection of three large grains. Other less clear examples of intergranular cracking were also seen. Intergranular cracking in the fitting was significant because this type of cracking often occurs when large grains are present. Additional examinations were completed with this cross-section at higher magnifications but still using a

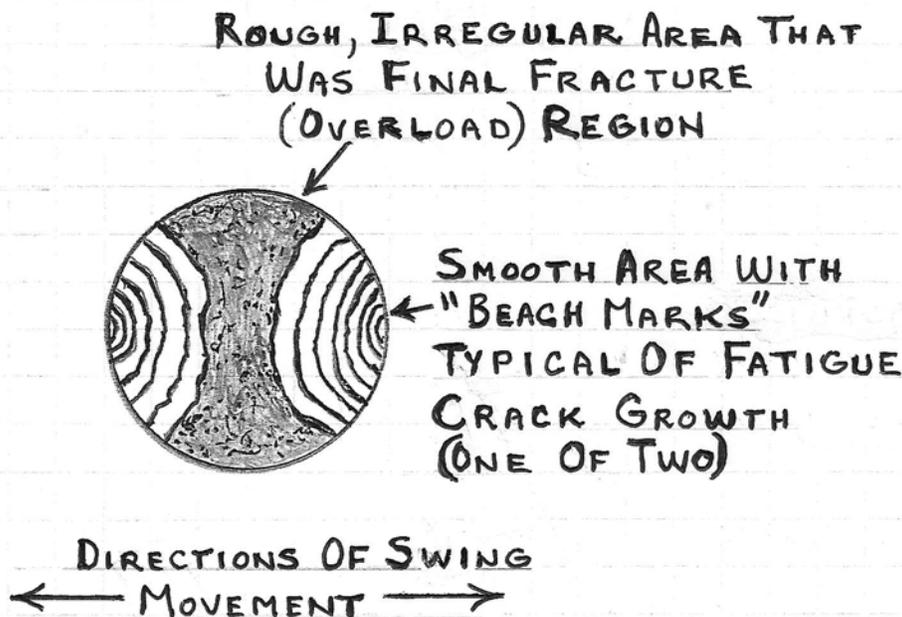
The fracture surfaces on the two portions of the bolt were examined in more detail, first in a light microscope and then in a SEM. Photomicrographs were made of these surfaces while in the SEM, but unfortunately, those were lost before this writing. However, Figure 8 is a sketch which provides the salient features of both fracture surfaces as seen in the SEM at low magnification. Those examinations confirmed that the bolt experienced fatigue loading. Two fatigue cracks initiated and grew, 180 degrees apart, from two areas on the outside surface of the bolt in the threads. Each time the swing moved back and forth, the bolt received a reverse bending fatigue cycle. The two fatigue cracks grew towards the center of the bolt until too little sound metal remained in the bolt to support the applied forces. The final fracture was by stress overload.

**Figure 8 – A Representation of the Cross-section of the Fracture Surface of the Eye Bolt as Seen in a SEM at 50X Magnification.** (Descriptive notes have been added).

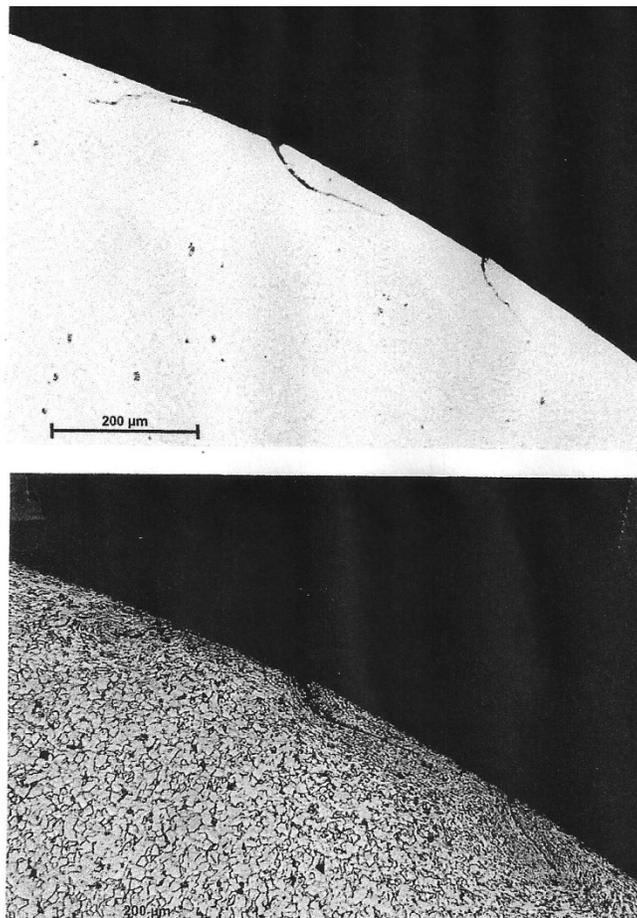
Additional notable features of the failed bolt were seen on the outer edge of another prepared (polished and then etched) metallographic cross-section sample, directly at the outer edge of the fracture surface. These were metallurgical laps. They are seen most clearly in Figure 9 in the top photomicrograph before the sample was etched and less distinctly after etching in the bottom view. The lower view also shows the very small grain sizes of this steel. Both were originally viewed at 100X magnification.

**Figure 9 – Photomicrographs of a Prepared Metallographic Cross-section at the Outer Edge of the Bolt’s Fracture Surface Showing Laps. Top Photo is Before Etching and Bottom Photo is After Etching. Both at 100X Magnification.**

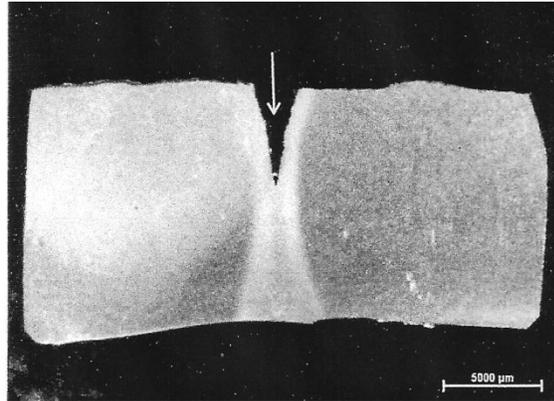
**Figure 11 – Cross Section of the ERW Pipe Wall Showing Severe Grooving Corrosion at the Center of the Weld. Magnification 5X.**

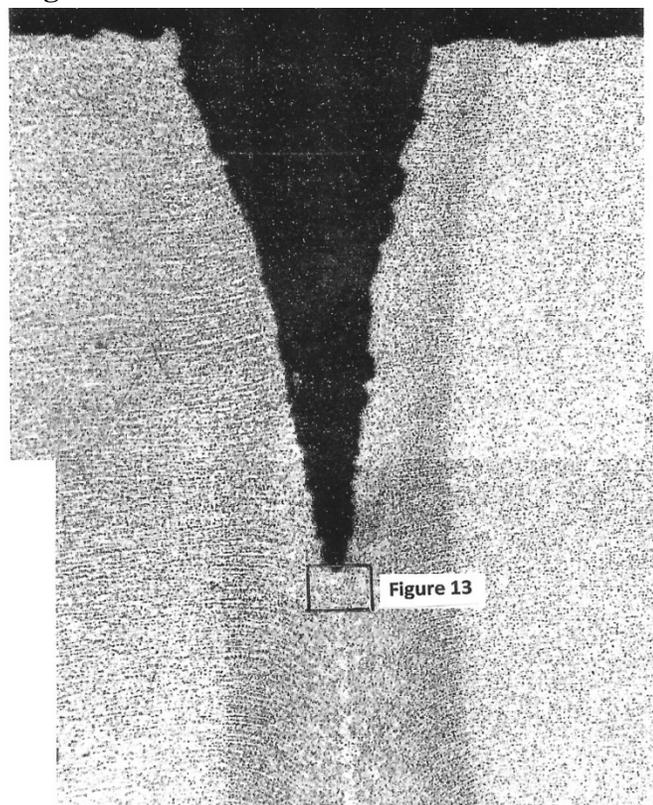
**Figure 12 – Same Cross Section of Groove Corrosion as Seen in Figure 11 Illustrating Three Distinctly Different Metallographic Appearances. Magnifications 15X.**

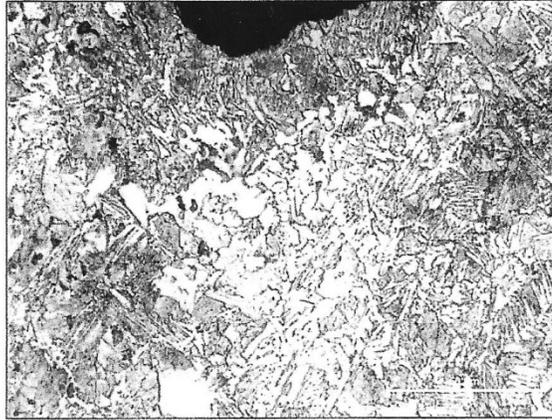
**Figure 13 – Higher Magnification View of the Bottom, Tip Area of the Corrosion Groove Shown in the Box of Figure 12. Magnification 500X.**

Figure 13 is a photomicrograph of the boxed area seen in Figure 12 at increased magnification. This region did not show any linear manganese sulfide inclusions that are often seen in steel with high sulfur content, although the EDS analysis confirmed high sulfur content in this steel. The high percentage of sulfur was a clear harmful factor in accelerating corrosion. The centerline of the weld contained a higher concentration of ferrite (white phase that is void of carbon) than the surrounding HAZ that is a mixture of ferrite and various heat transformation products that contain carbon (white and dark phases). Exposures to different temperatures during the overall ERW process created the mixed microstructure areas.

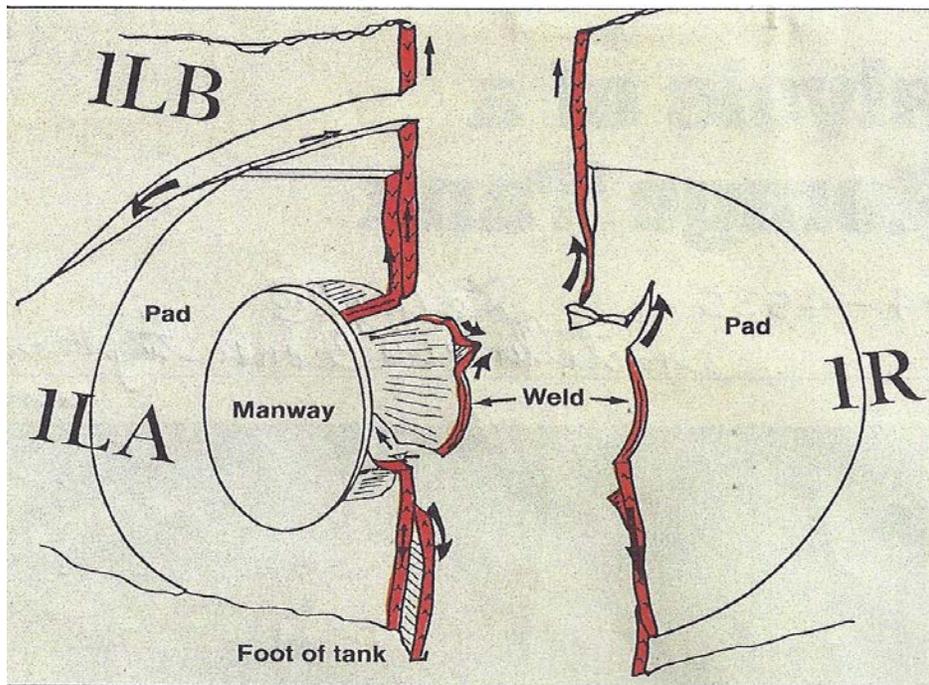
The failure originated at the welded manway and reinforcing pad on the bottom, vertical section of the tank. The major vertical rupture occurred as shown, schematically, in Figure 14.

**Figure 14 – Fracture Surfaces At and Around the Tank Manway.**

The initial site visit showed there was little plastic deformation of the steel in the manway area, which indicated brittle fracture of the material. The blown apart wall and roof plates were located approximately 180 degrees from the manway on the tank's circumference. Black arrows in

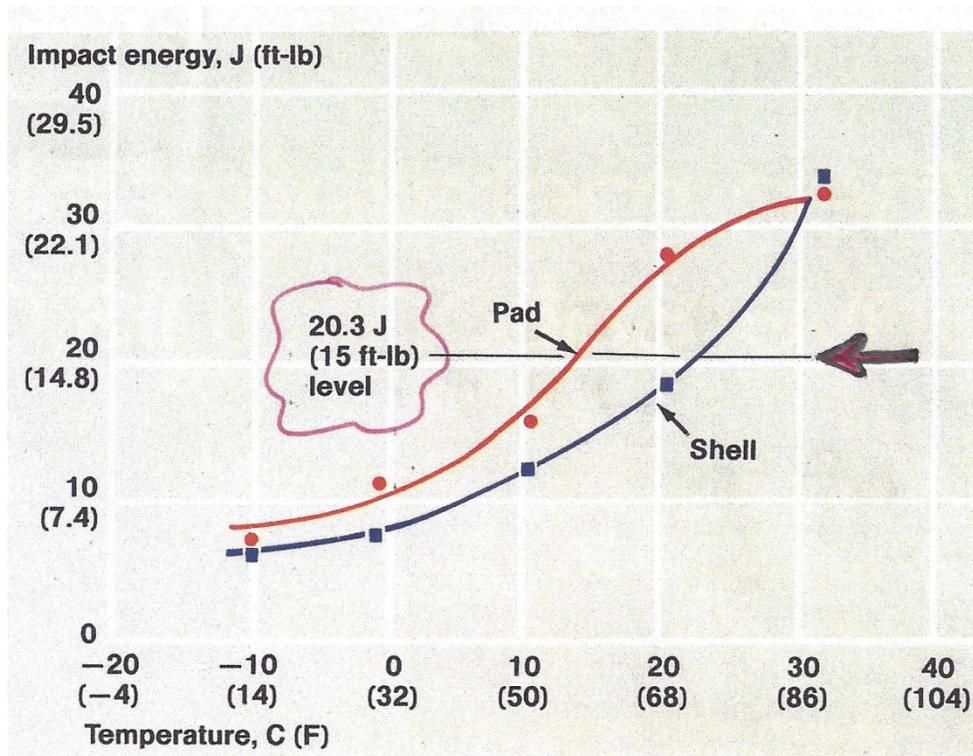
**Figure 15 - Charpy V-notch Impact Energy Data Used to Define DBTT Values of the Tank's Steel at the Reinforcing Pad and Shell Plates**

The data indicated that the DBTT's for the pad and shell steel in the tank were approximately 57 and 72 degrees F, respectively, at the 15 ft-lb energy level. Both values are extremely high and indicate there would be no resistance to brittle fracture at normally expected winter temperatures in this location. Investigation indicated that, during the night of the failure, the ambient air temperature was approximately -17<sup>0</sup> F after a daytime value of approximately 29<sup>0</sup> F. The oil in
