Forensic Engineering – Part D  
**Case Histories: Corrosion Failure Analyses**

Gerald O. Davis, P.E.

## **Failure of a Fire Protection Sprinkler System**

### **Corrosion of Natural Gas Steel Piping in a Small Industrial Facility**

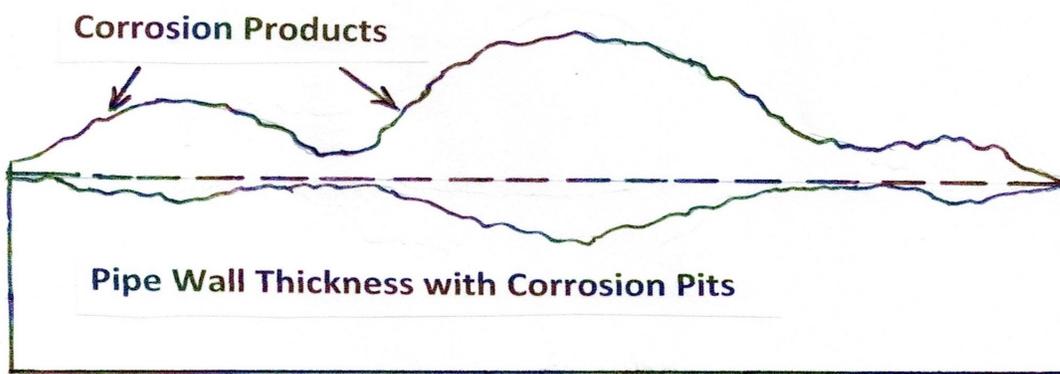
Patterson found that all the gas piping was plain carbon steel and specified to be standard Schedule 10. He scraped off voluminous corrosion product deposits at multiple locations on bare sections of the gas piping with some volume variations at different spots. See Figure 1. Typically, there were corrosion pits to various depths at the inspection sites. He used an ultrasonic non-destructive evaluation (NDE) instrument to measure pipe wall thickness at spots with little or no pitting. This indicated the non-corroded piping of each size was Schedule 10, as specified. A manual pit gauge was used to measure the depths of the pits at the various inspection sites. He saw that the deepest pit was approximately 5/64 of an inch (0.078-inch), and this was on a 3-inch diameter pipe. A manual corrosion pit gauge can correctly measure to this accuracy if handled carefully.

**Figure 1.** Schematic of a cross-section of corroded pipe wall  
Figure 1 shows the approximate size of corrosion products (iron oxide hydrates) formed from the corrosion pits indicated. These products are sometimes called “Rust Bloom”. No dimensional scale is intended in Figure 1.

A conservative maximum, average corrosion rate on the unpainted sections of the piping can be estimated by dividing the maximum measured pit depth (5/64-inch) by the time period (seven years) when the pipe paint was in marginal or poor condition. Doing this calculation produces a corrosion rate of about 11 mpy. Patterson knew that this is not a high corrosion rate for plain carbon steel exposed to only fresh water at normal ambient temperatures. Even so, here the temperatures in the refining room were somewhat raised and that might have increased the rate slightly. Other pits Patterson measured had smaller depths and, therefore, would be associated with a still lower estimated corrosion rate for the same exposure period of seven years. If the exhaust system did not have enough capacity to remove most if not all of the acidic vapors those vapors would have mixed with the condensed water and created a much more aggressive corrosive environment. Therefore, he concluded that a corrosion rate higher than 11 mpy would have been expected.

Patterson advised the plant owners to protect all the gas piping in the refining room from future corrosion upsets, such as a malfunctioning acid vapor removal system, by repainting the piping and maintaining its updated condition. He indicated the repainting should start by completely removing all peeling paint, cleaning all bare and previously peeling surfaces and finally applying a primer and top coat(s) as recommended by a competent coating contractor.

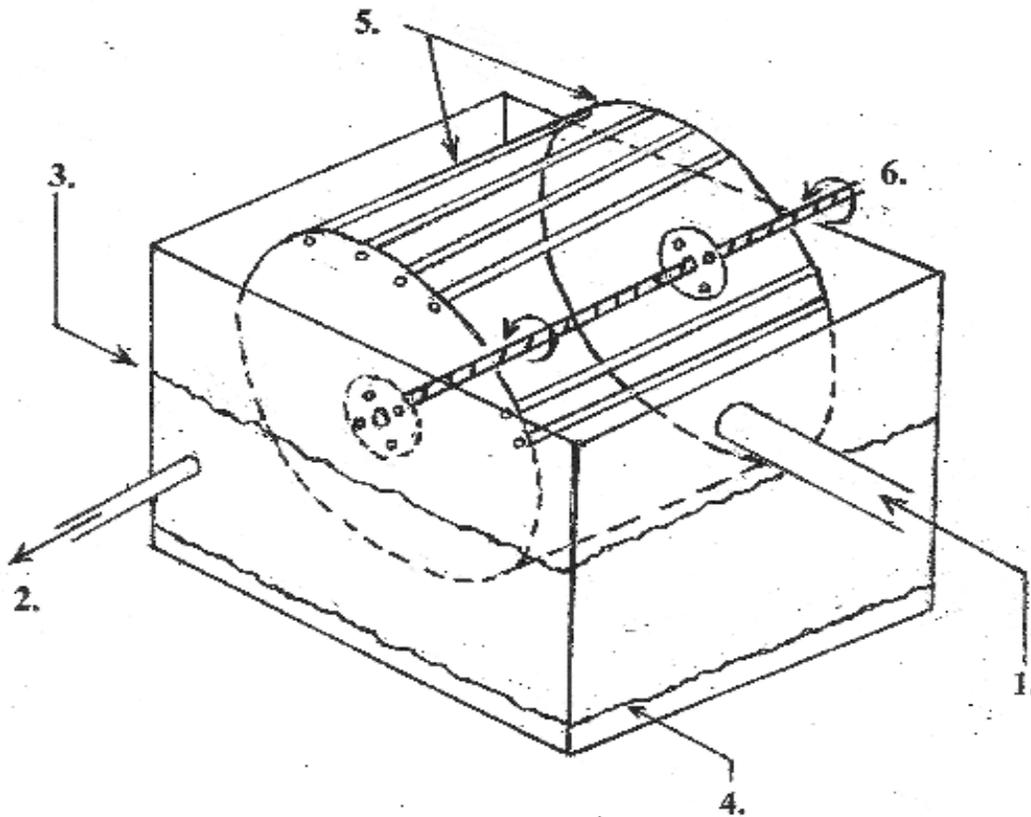
**Figure 2.** Schematic sketch of the confirmed characteristics of each of the corroded rotating drum water filters inside, open-top “boxes”, each 10 x 6 x 4 - feet, made of aluminum plates.

Ridout completed visual inspections of the two units during periods when each was temporarily taken out of service. There was considerable pitting corrosion inside the aluminum “box” of each unit. There was also significant corrosion on the end plates especially around most of the stainless steel bolts used to attach the stainless steel slats to the aluminum end plates. She saw that no electrical insulators were installed between these bolts and the end plates. The slats and the drive shaft had also suffered significant pitting corrosion

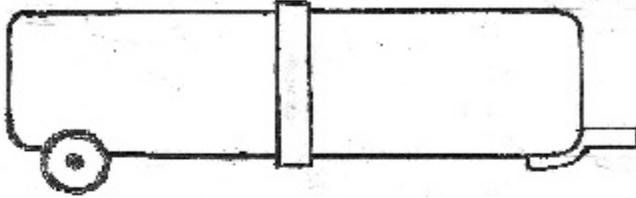
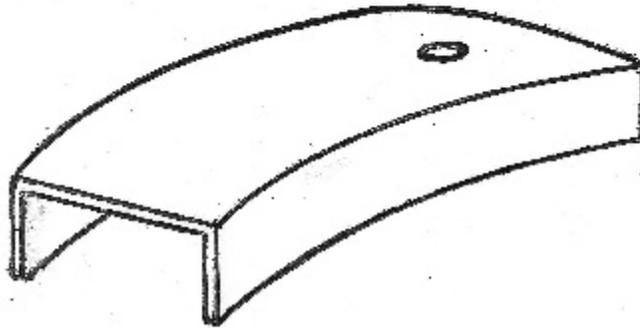
**Portion of Reinforcement, Inverted**

**One 1-inch Hole on Bottom**

**Figure 3.** Schematic of the trailer plus one section of the rolled carbon steel reinforcement that was welded all around its base onto the trailer shell

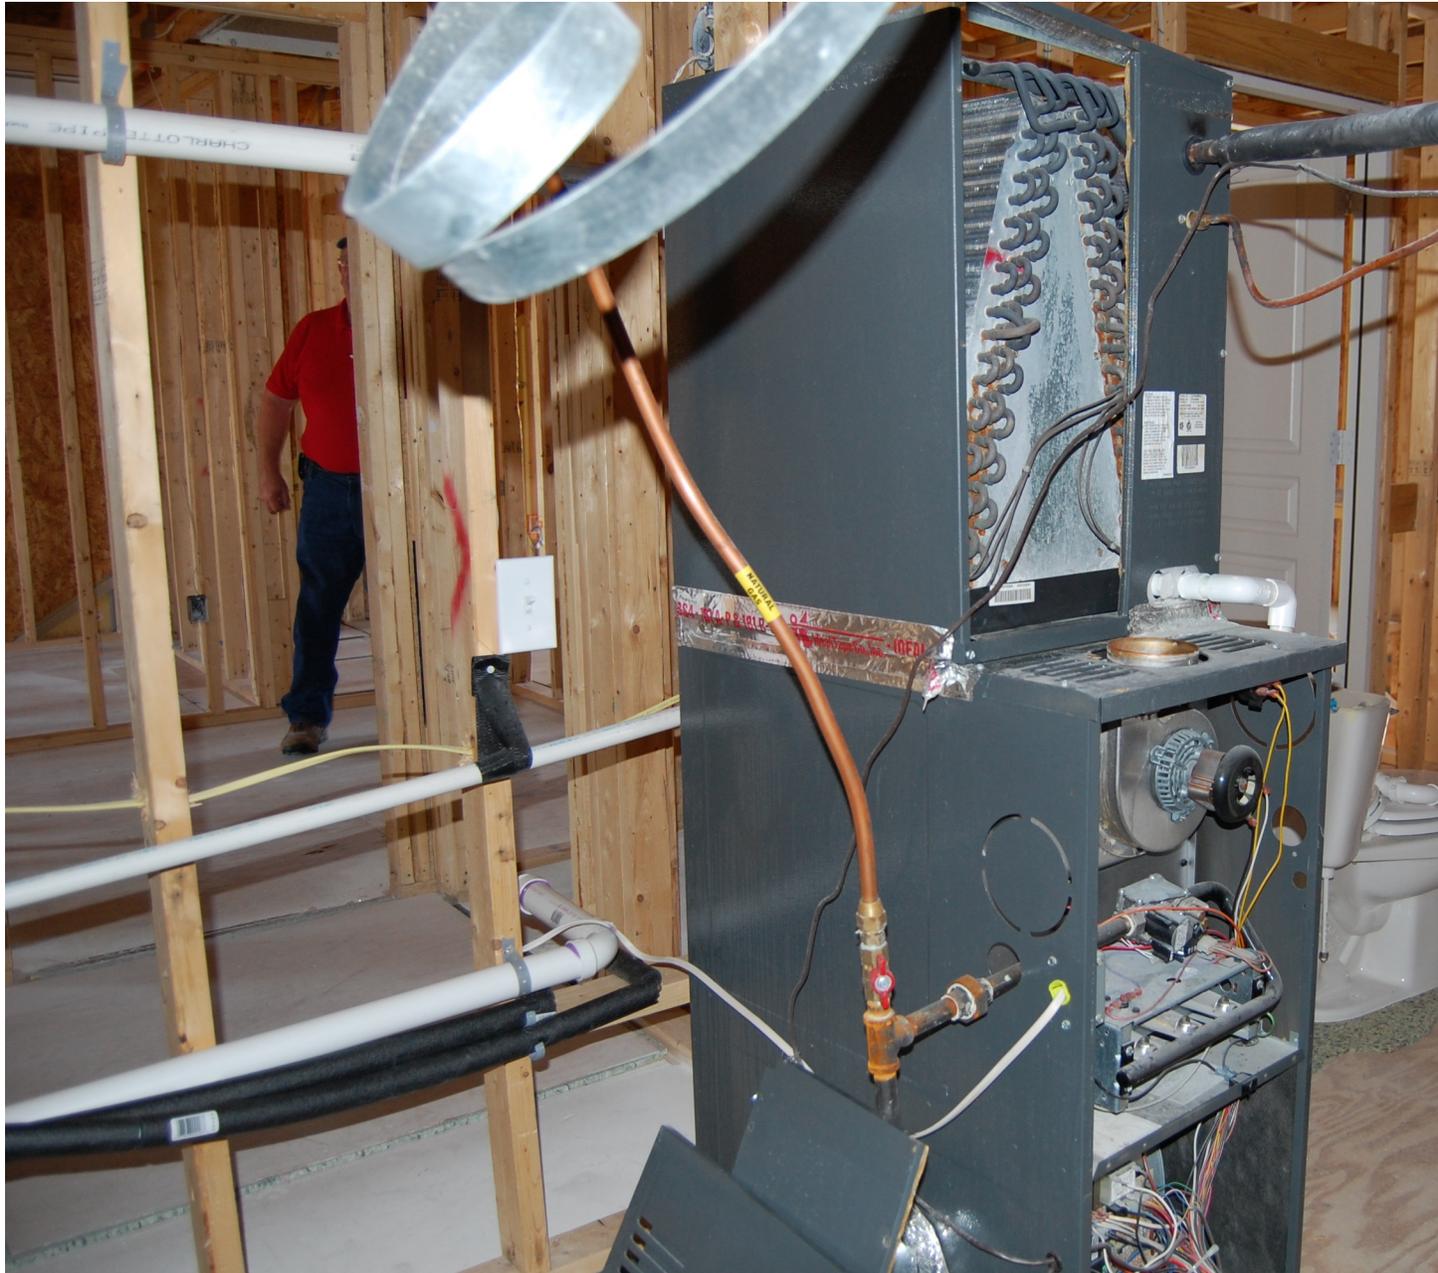
**Figure 4** - A damaged HVAC unit (enclosures removed) showing the evaporative coil in the upper area with copper U-bends. This unit had failed and was later replaced..

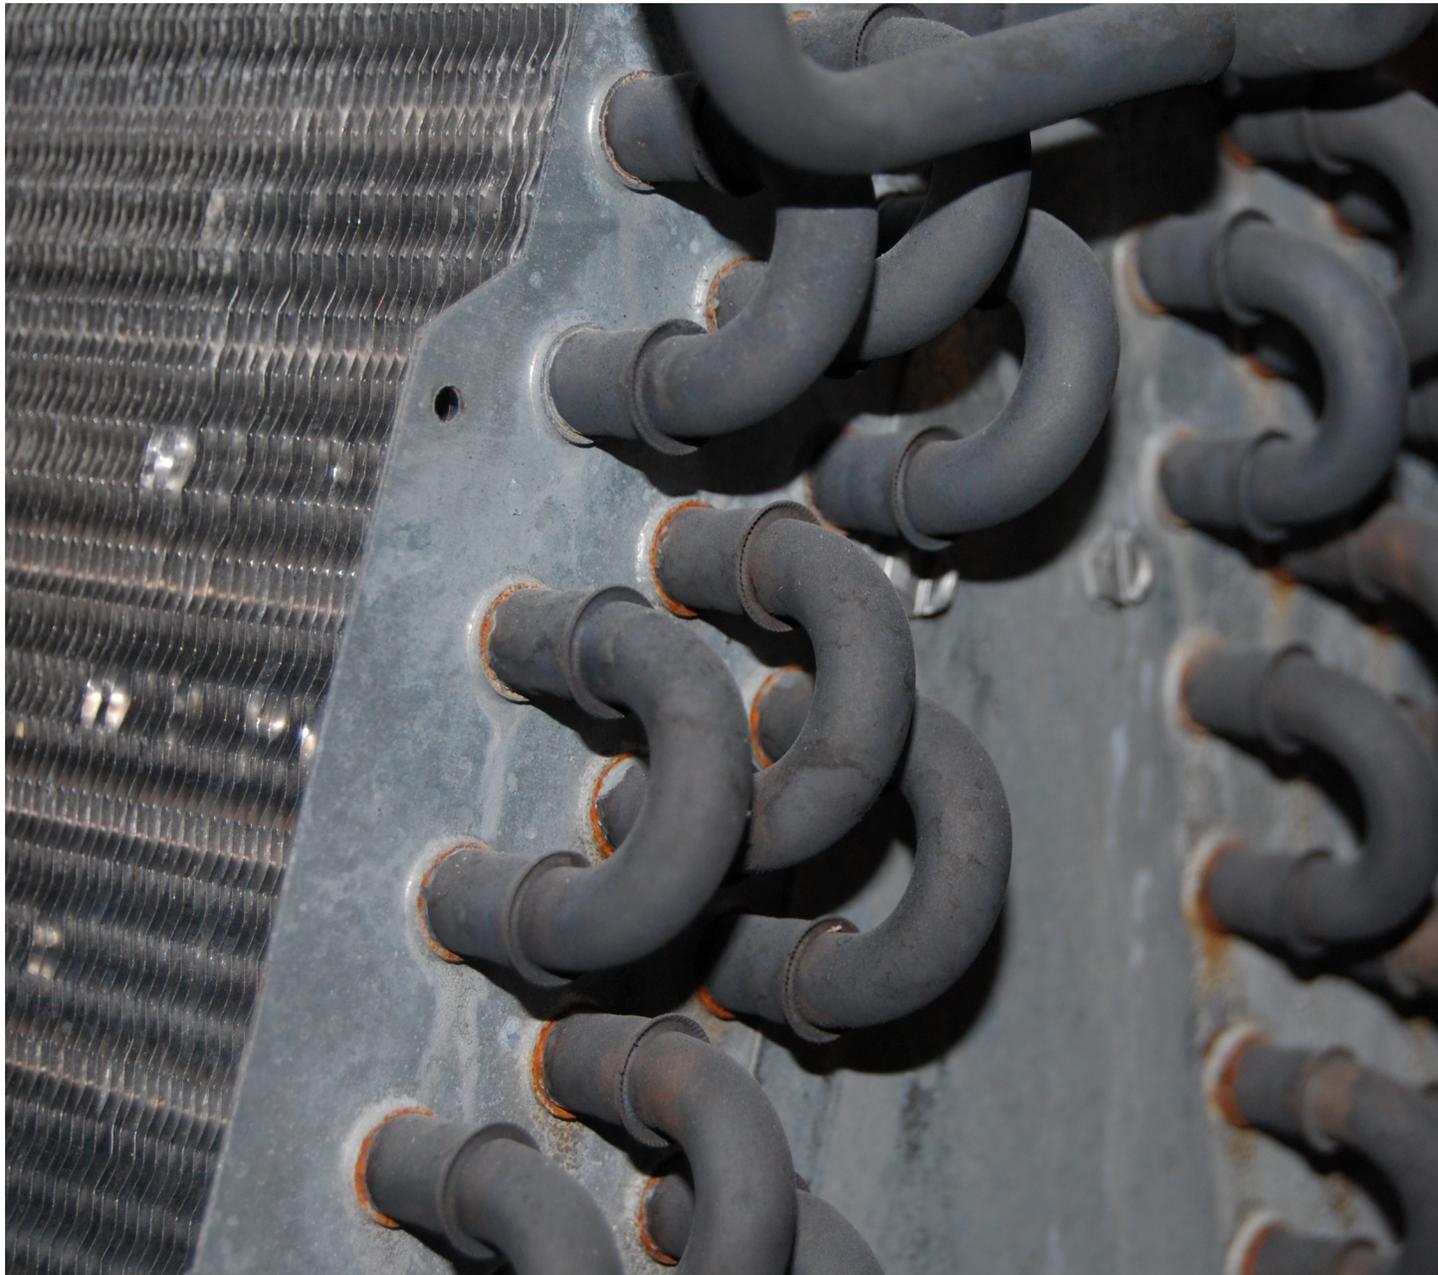
**Figure 5** - Close-up view of the blackened copper U-bends on the end of the evaporative coils shown in Figure 4. Some of the bends were later cut out and examined in a laboratory.
