A SunCam online continuing education course

The Citicorp Tower

Professional Ethics and Disaster Averted

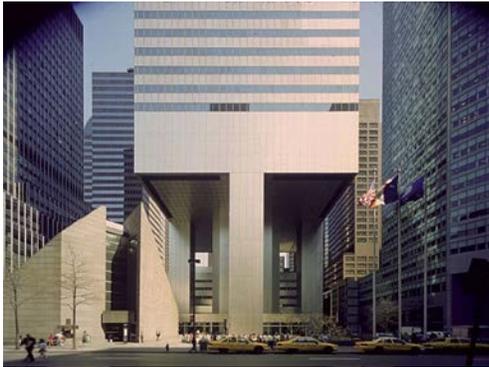
Figure 1. - The cantilevered corners and mid-face supports of the Citicorp Center.

faces of the building, with cutout cantilevered corners nine stories high on adjacent corners making room for the entrenched church below on one side and public space on the other. At the time, New York City offered monetary incentives for creating privately owned public spaces and the project used the second cantilevered corner to take advantage of this.
