**Forensic Engineering – Part C**  
**Case Histories: Metallurgical & Mechanical Failure**  
**Analyses**

Gerald O. Davis, P.E.

**Case 1- Superheater Tube Failures in a Large Steam Boiler**

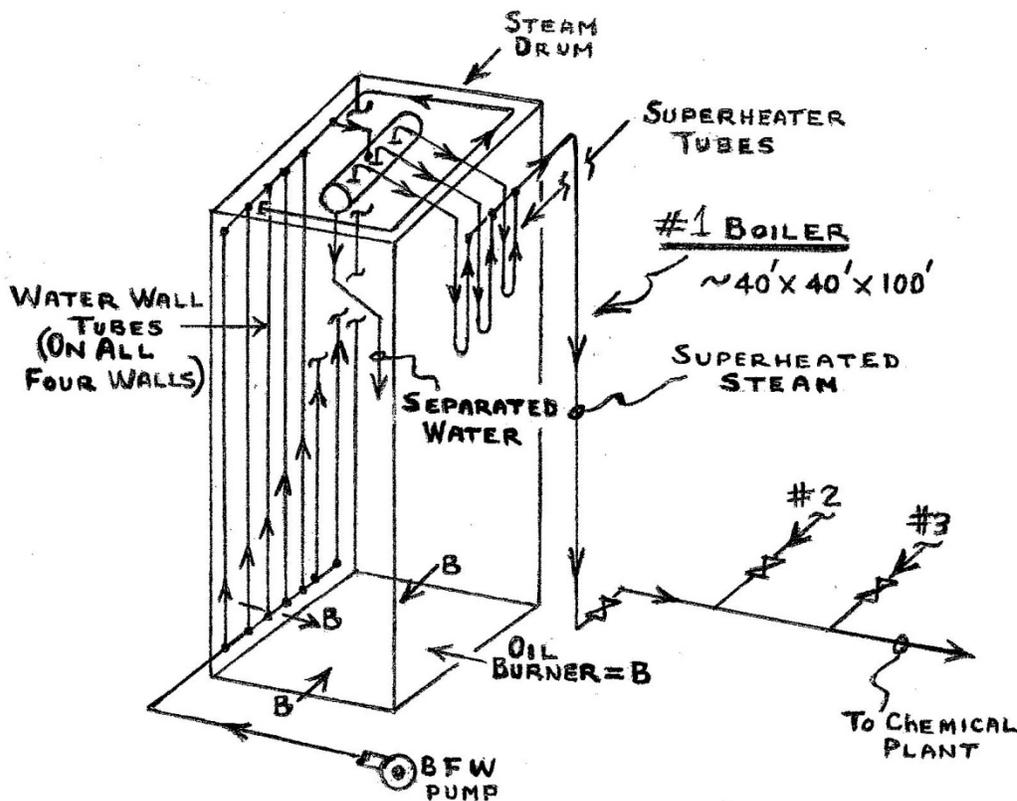
Figure 1 – Simplified Schematic Drawing of Boiler # 1 and Essential Components

Over a recent three month period, four tubes failed and had to be plugged. Three other tubes in #1 had been previously plugged during the first years after start-up. Also, three bulged, but not yet ruptured, tubes were found during a recent shutdown of #1. Most of the seven failed tubes plus the bulged tubes were all located in or near the north end of the boiler's fired combustion volume. The chemical plant's reliability engineering department was directed to conduct a root-cause failure investigation of Boiler #1 to define the cause of the tube problems and to make recommendations.

The black deposits in the bulged tubes were primarily located immediately around the bulged areas. The failed tube samples had fish mouth-shaped openings parallel to the longitudinal axis of the tubes. The sizes of the openings varied from 2 X 3/8 inches to 4 X 3/4 inches.

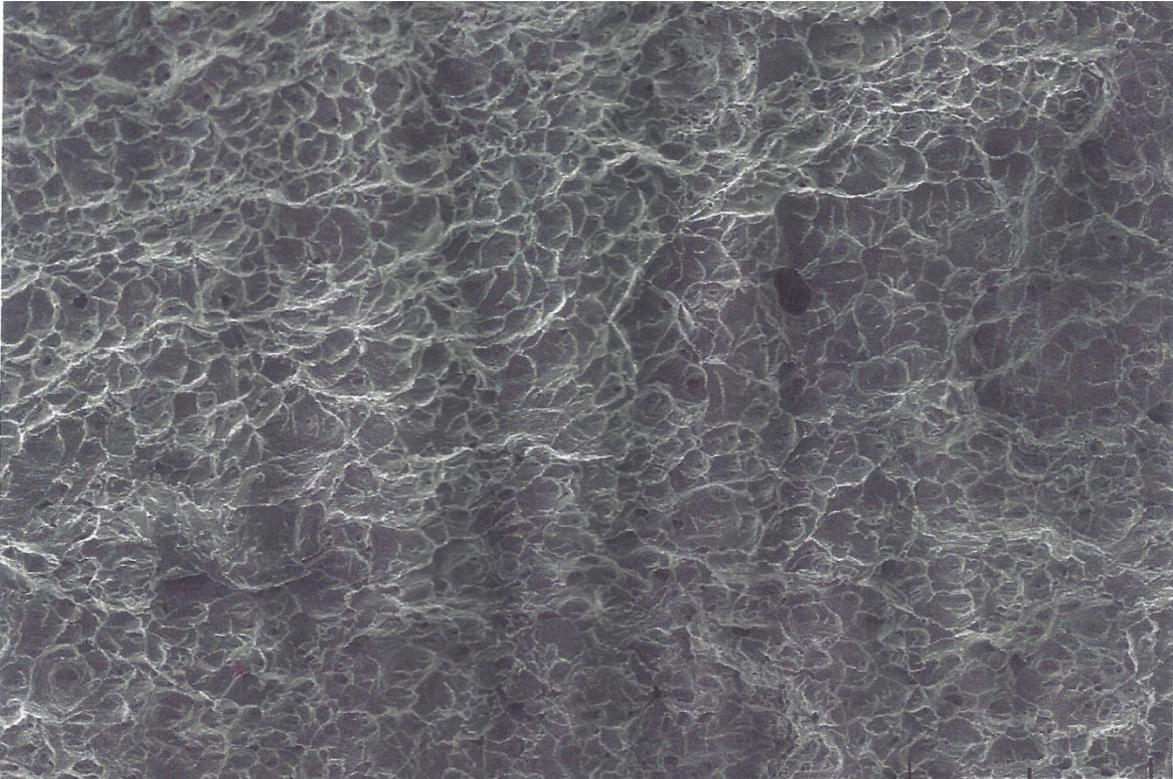
For comparison to Figure 4, the SEM photomicrograph in Figure 5 is from another source and is not part of the present case. It is a fracture surface of a copper component showing the normal ductile surface appearance most common for copper. The surface is not smooth like the brittle fracture in Figure 4. Instead, it has a series of uneven dimples that are characteristic of ductile fracture in many metals. Different magnifications will indicate different sizes of the dimples seen.

**Figure 5 – SEM Photomicrograph of the Typical, Dimpled Ductile Fracture Surface of Copper. This Copper Was Not Part of Case 3. 250X Magnification.**

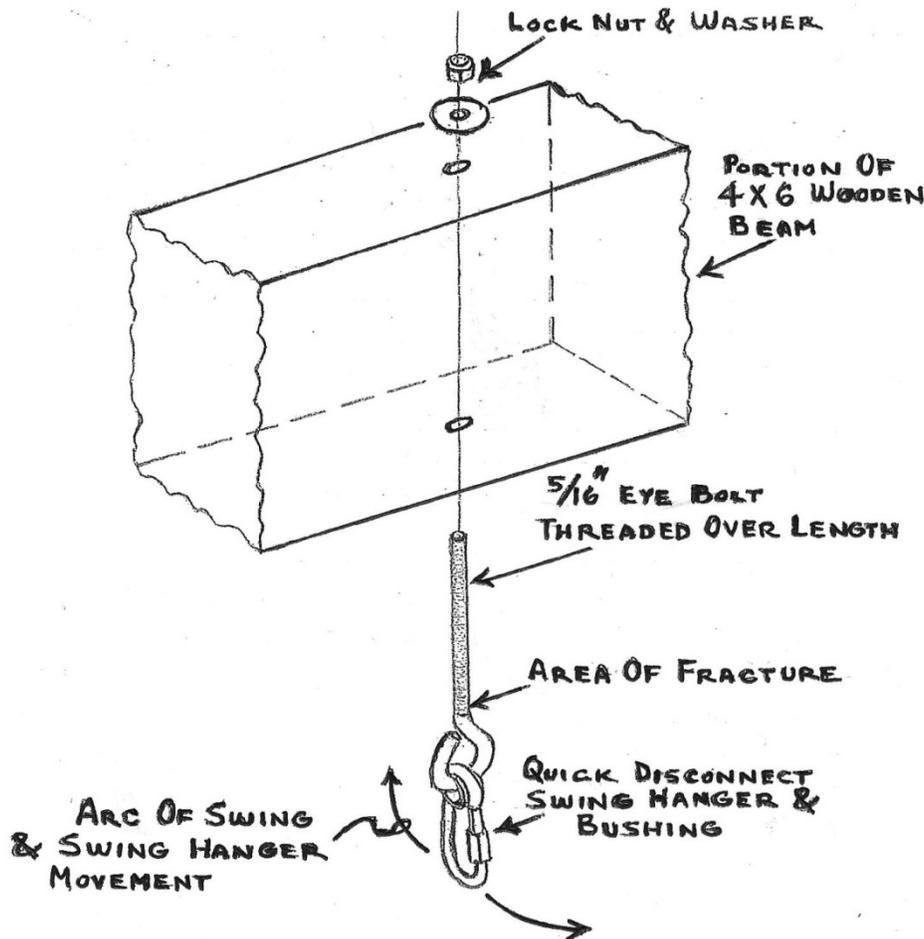
Figure 6 provides a sketch of the general assembly of the suspension components for the swing near the wooden beam. When assembled with the lock nut tightened, the outer top edge of the eye of the bolt just touched the bottom surface of the beam. As indicated, the fracture of the installed bolt occurred very near the bottom of the beam in the lowest threads of the eye bolt.

Figure 7 – General Assembly of the Swing's Components Near the Area of Fracture

The bottom and top portions of the fractured bolt were recovered at the accident site. The fracture occurred in the threaded portion and specifically in the first two or three threads above the eye of the bolt very near to the bolt’s original contact point with the bottom of the beam as seen in Figure 7. Both portions of the bolt had what appeared to be a galvanized coating. A review of the hardware manufacturer’s on-line sales literature later confirmed this. The galvanizing in the threaded portion of the bolt, i.e., over most of its total length, appeared

The final area investigated as a possible cause of this failure was the general configuration or design of the bolt as supplied by the hardware manufacturer. As shown in Figure 7, the supplied bolt was threaded over most of its straight length. This was not required or desirable. The threaded section could have been confined to only the top portion of the bolt so as to allow engagement with the lock nut on the top of the beam. Many mechanical engineering design references make the point that threaded portions of stressed components act as stress risers. They concentrate and increase any applied stress beyond the level in non-threaded sections by a factor that varies with the specific type of threads. This effect is especially important when the applied stress is dynamic, i.e., fatigue loading.

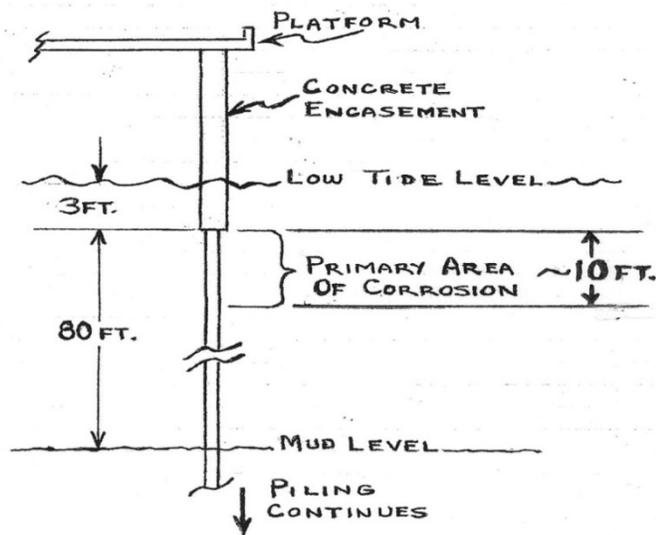
Several welded steel pipes serving as pilings to support a dock-side platform in a harbor had not yet failed but had various extents of localized corrosion confined to their longitudinal welds. Some spots of corrosion penetrated as much as half of the 0.5-inch pipe wall thickness. The form of corrosion is known as grooving attack. The longitudinal welds were made by the electric resistance welding (ERW) process and completed by the manufacturer of the pipe. The nominal diameter of the pipe was 14-inches. All the pilings were installed and had been in service at the harbor site at least thirty years since their manufacture in 1970. Recent underwater inspections found the grooving corrosion. Initial installation of cathodic protection (CP) controlled corrosion of the pilings, but in recent years, its operation was uncertain. Figure 10 is an approximate cross-sectional representation of one of the many installed pilings.

Figure 10 – Cross-sectional Configuration of an Installed Pipe Piling

The amount of dissolved oxygen in the water decreases as distance below the free water surface increases. Therefore, it is not unusual that the variable amounts of grooving corrosion were found just below the concrete and relatively close to the water surface as shown in Figure 10.
