# Life Cycle Mechanical Integrity Of Piping Systems

Gerald H. May, PE

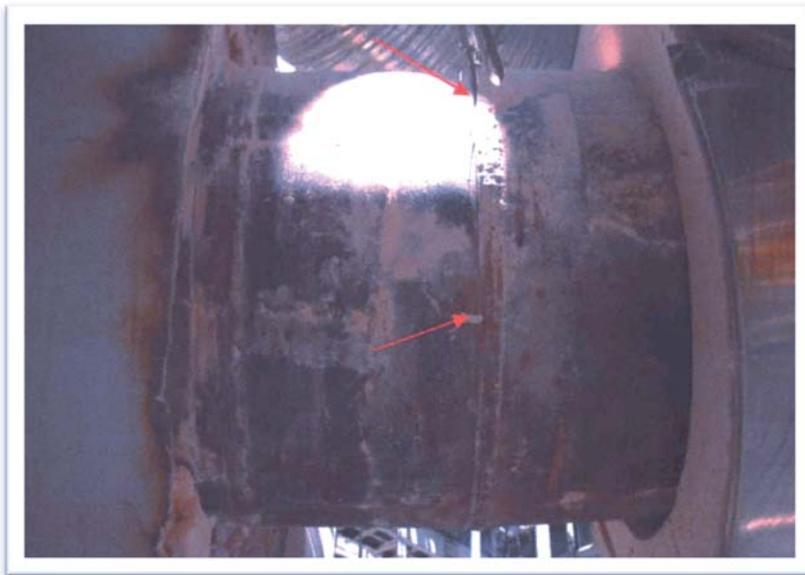
This through wall failure of a high temperature steam line luckily did not cause any injuries, but it took several hundred MWe off the power grid during the hottest part of the summer. A strong contributing cause of the failure was malfunctioning pipe supports.

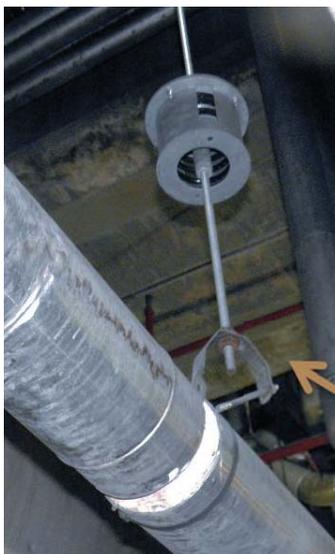
Pipe Clamp off pipe

An example of Rule 1 is this variable spring hanger with the pipe clamp broken and completely disconnected from the pipe. The clamp should be on the pipe where the insulation is separated (white). The clamp was apparently on the pipe once, and is badly bent and above the pipe by 6”.

1. This could be a poorly designed or poorly installed pipe support with a faulty clamp. If the support is the root cause of the problem, the failure of the support causes higher stress in the pipe, excessive sagging of the pipe, and potentially failure of other pipe supports since the load must be picked up by the adjacent pipe supports.

2. The second possibility is that the pipe support was properly designed and installed, but it has still failed. If this is the case, the support has been over loaded to failure because some other unexpected event happened to the pipe. A partial list of possible root causes is:

- a. This or other pipe supports malfunctioned, including bottomed out or topped out spring hangers
  - b. Unusual operating event caused a high dynamic load

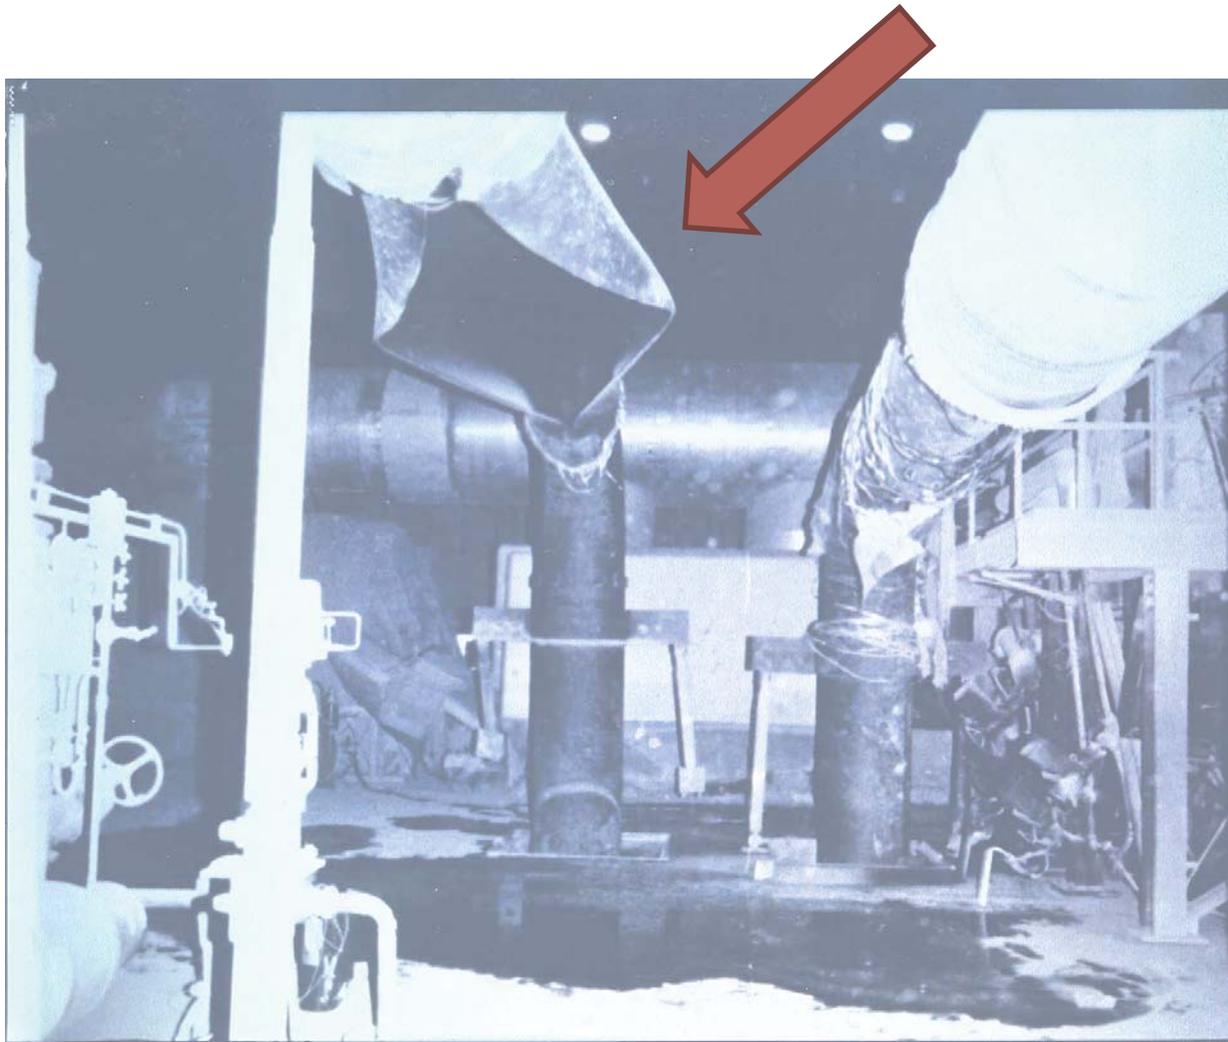
Catastrophic failure of a seam welded high temperature steam pipe, which killed 6 workers.

1. High temperature seam welded pipe may fail due to creep or creep-fatigue. If there is a piping system operating in the creep temperature range that is seam welded rather than seamless, it is susceptible to creep degradation in the seam weld and may fail catastrophically. With seam weld damage, the visual inspection may provide little or no forewarning. Based upon current industry understanding, the only reliable method is to inspect periodically to determine if the material is developing cracks in the seam weld. Special consideration should be provided to any high temperature seam welded pipe.

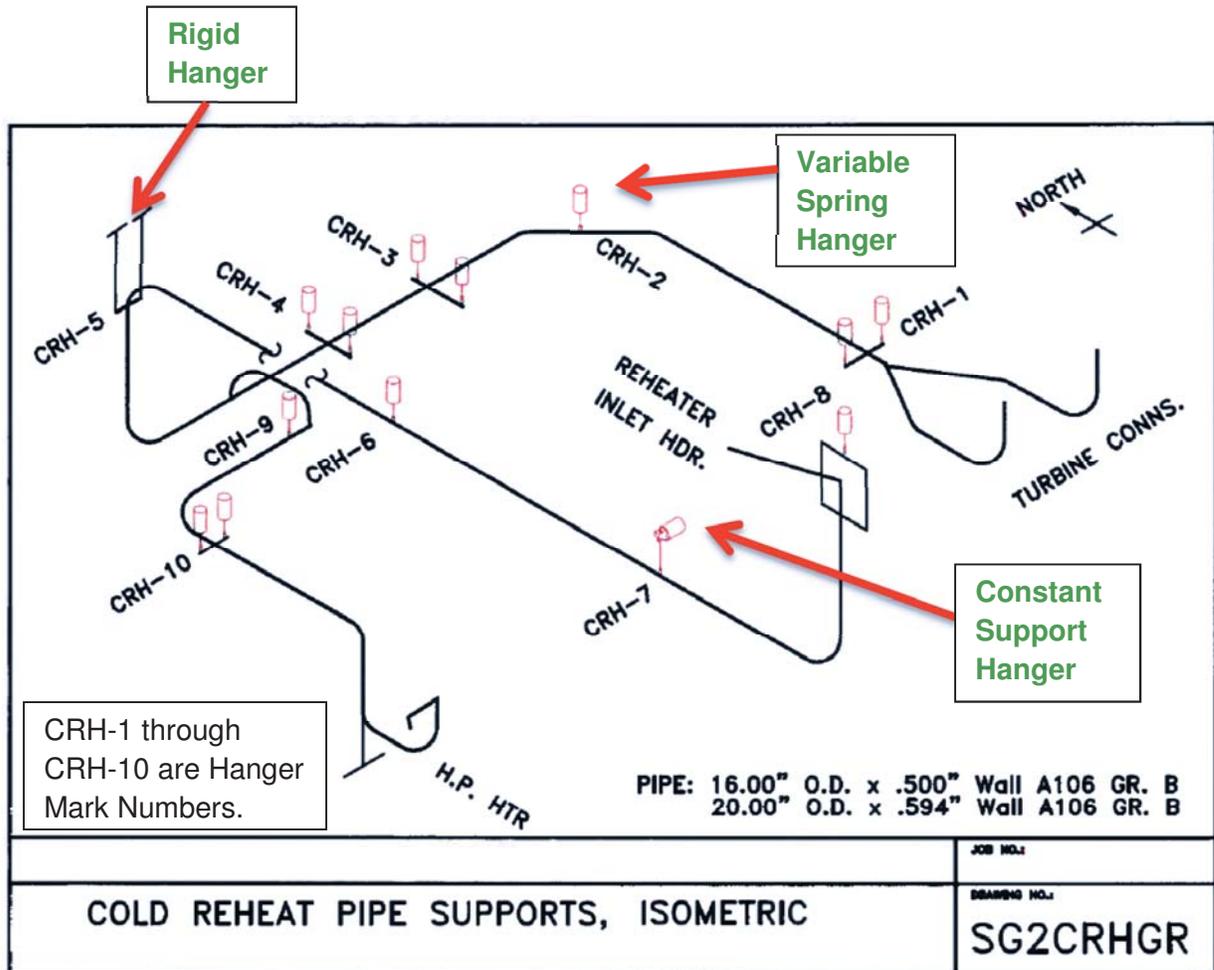
Fig. 4.1 Isometric sketch shows the pipe routing and location of all pipe supports. Different symbols are used for variable spring, constant support and rigid pipe supports.

1. Isometric sketch shown the pipe support mark number and location of each support. See Figure 4.1 for an example.
2. Pipe Support Visual Inspection Checklist, Table 4.1.
3. Spreadsheet showing each pipe support design information and the ambient and operating readings. See Table 4.2 for an example.

Using the checklist, Table 4.1 and the isometric sketch, Figure 4.1, view each pipe support. The best documentation is to complete one checklist for each support and provide one or more photos. If pipe support detail drawings are available, the top portion of the checklist can be completed prior to the visual inspection, except for the operating temperature which needs to be provided by the control room at the time of the observation. During the baseline inspection, confirm the nameplate data, if the nameplate can be read. Sketch any differences between the installation and design.

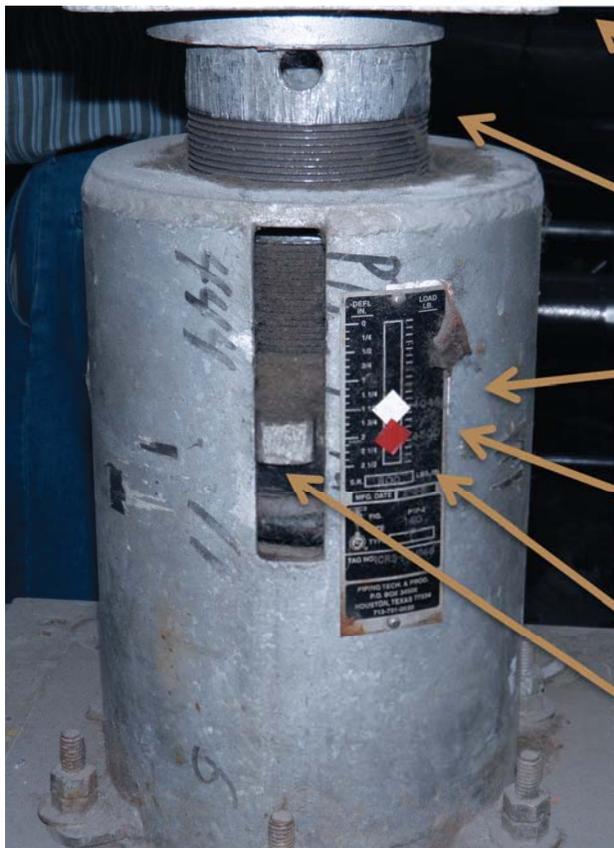
A typical variable spring floor support can and label

Load Flange

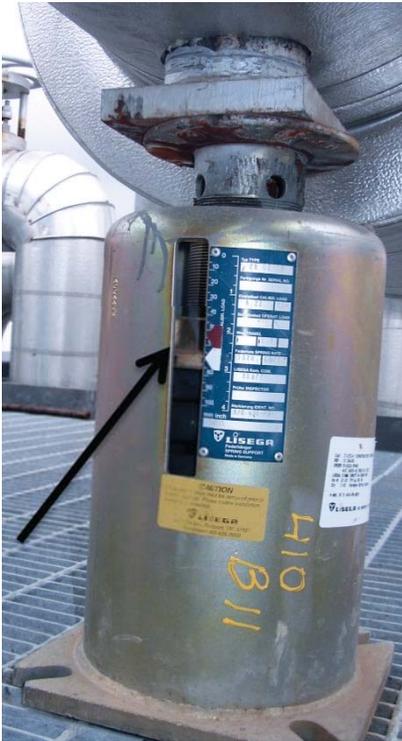
Lisega F style variable spring hanger. Scale has both inch and mm marks. There is no indicator tab. It should be read from the top of the load plate inside the can. In this case it is at 66mm or about 2-5/8".

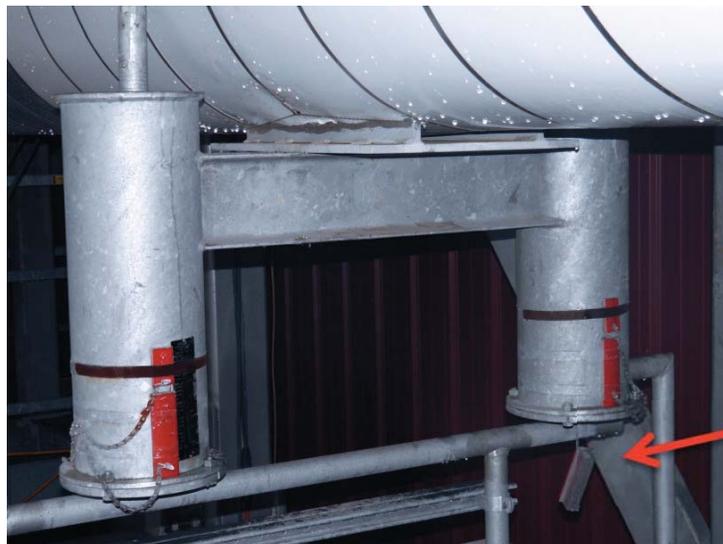
Variable Spring Hangers have travel stops installed at the factory. With this vendor's design, each can has 4 travel stops, 2 on each side with stops limiting compression and tension. In can on right, 1 travel stop has been removed from the back side and is hanging loose below the can. **The travel stops must be removed before operating the system.** Note also on these types of cans, as the spring compresses, the indicator tab will move up, not down. Other vendors may use pins or other devices for travel stops.

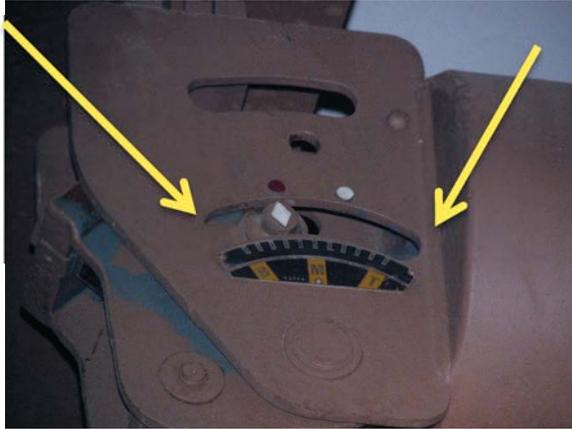
A typical constant support can travel scale from 0 (same as T for Top) up to 10 (same as B for Bottom). Read at center of diamond, or 6.9. Red button is design hot location, 6.5, and white button is design cold (ambient) setting, 3.5.

Actual topped out and bottomed out is when the indicator has locked into the curvature of the slot, yellow arrows.

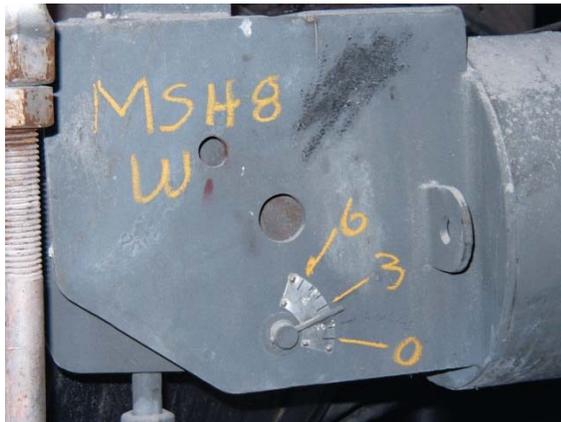
An old constant support can with a travel scale from 0 to 6. The indicator is a pin that can easily break off. It is recommended to paint the scale and scale numbers on a can when it is difficult to read or unusual. This will provide more consistency in later observations.

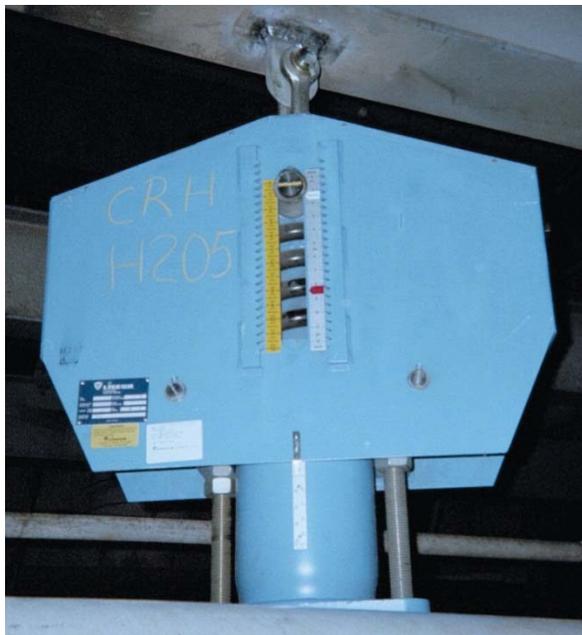
A typical Lisega constant support hanger: Its internal mechanism is completely different than other manufacturers. When reading the travel scale, it is typically in inches or mm, 0.25" in photo. As with other constant support manufacturers there is a red and white mark for the ambient and hot design locations.

Read from the center of the indicator bar. Client painted a yellow line to help, but unfortunately the pin may rotate with time. The silver scale to the right was by the vendor. Client added the yellow inch scale because it is more visible in a dark building.

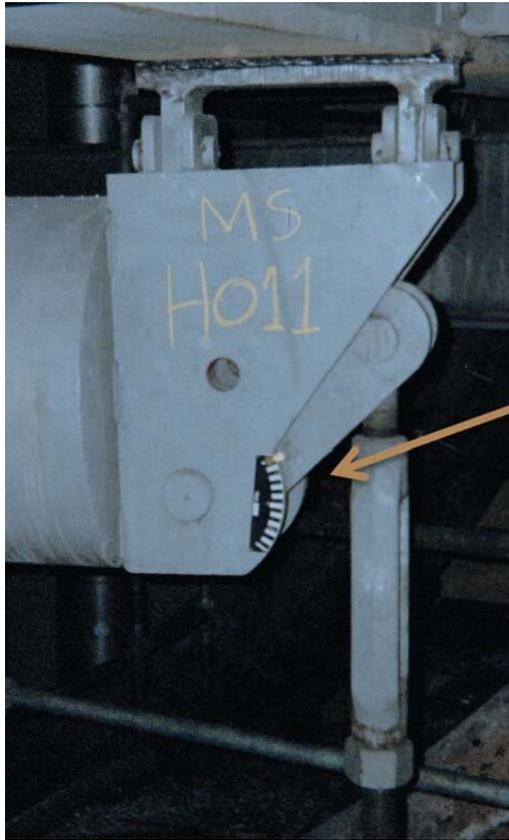
Another manufacturer's constant support travel scale. The indicator is just a piece of metal attached to the lever arm, which is susceptible to bending or breaking off. Note the scale has no numbers and observer has to visualize the direction of movement to assure which end of the travel scale is 0. In this case, as the rod goes down, the lever arm and indicator go down, so topped is 0 at the top of the scale and 10 is bottomed at the bottom of the scale. Reading in photo is 0.0.

With these types of indicators, it is almost impossible to determine where the actual topped out and bottomed out setting is since it is based on internal stops on the spring which are not visible.

If there were cold and hot marks on the travel scale, they are not visible in this photo.

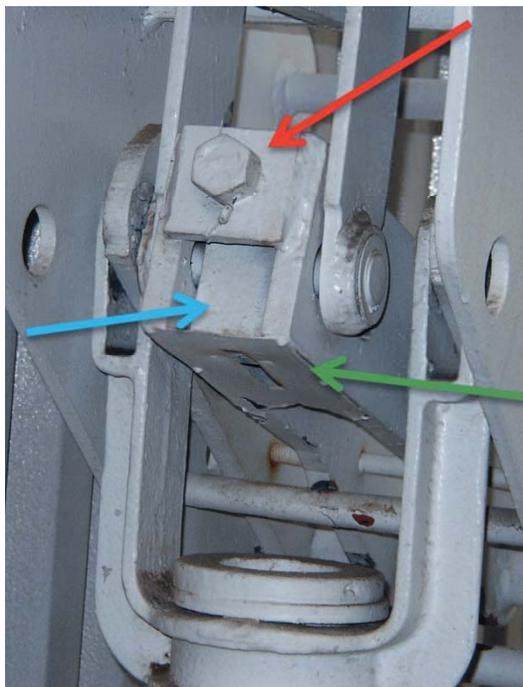
A constant support showing one style of load adjustment

Red arrow, load adjustment bolt

Green arrow points to the load scale, facing down and painted over as typically found

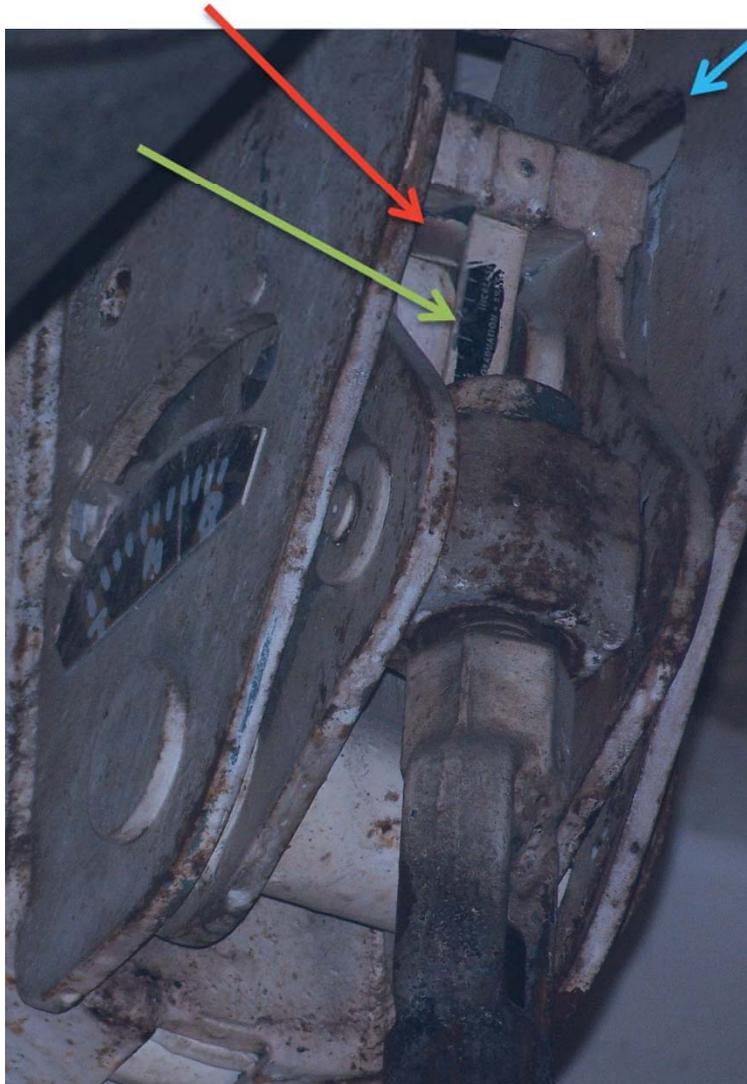
Another style constant support load scale shown by green arrow. Load bolt is behind scale, red arrow, and accessible only through the slot on the back side of the can, blue arrow.

As noted, scale is difficult to read and adjustment accuracy is not reliable.

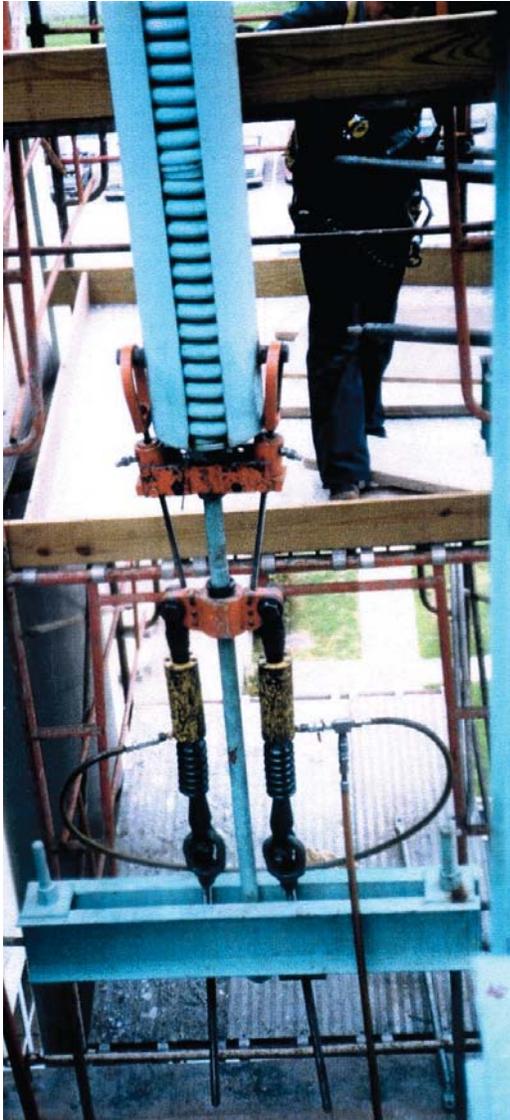
An example of a test set-up to measure the load on a variable spring hanger: The orange yokes and yellow hydraulic cylinders are arranged to unload the rod below the spring as the hydraulic cylinders are shortened, the load is transferred from the rod into the hydraulic cylinders. When the rod is unloaded, the force in the hydraulic cylinders times the area of the cylinders equals the load that the spring is carrying.

This technique can be used to measure the initial observed load in a rigid rod, variable spring or constant support rod hanger. If load adjustment is needed, then adjustment and testing is repeated until the adjustment matches the recommended load.

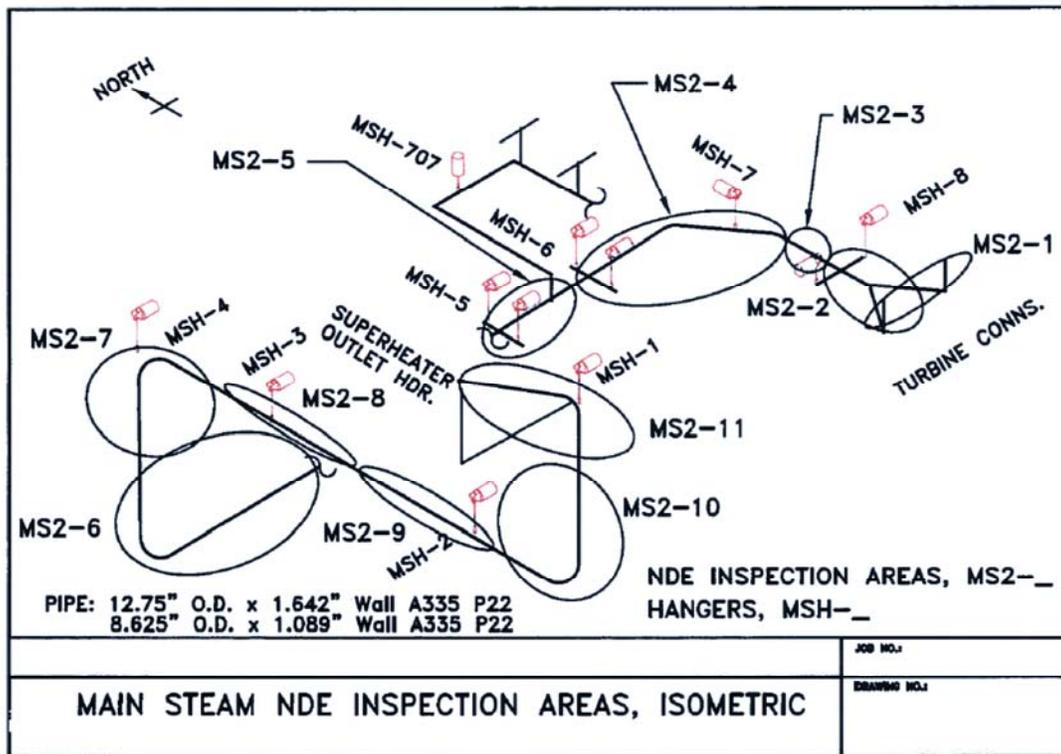
Figure 5.1 Example Inspection Isometric Showing Inspection Areas

Create an overall isometric of the piping system, and then create inspection areas for the entire piping system. For each inspection area, create an inspection sketch that shows every known weld, with an identification number. If original pipe fabrication spool drawings are available, they can be used. All sketches should be 8-1/2" x 11" for ease of use in the field. See Figure 5.1 for an example inspection isometric showing the inspection areas. Figure 5.2 shows the details for an inspection area.

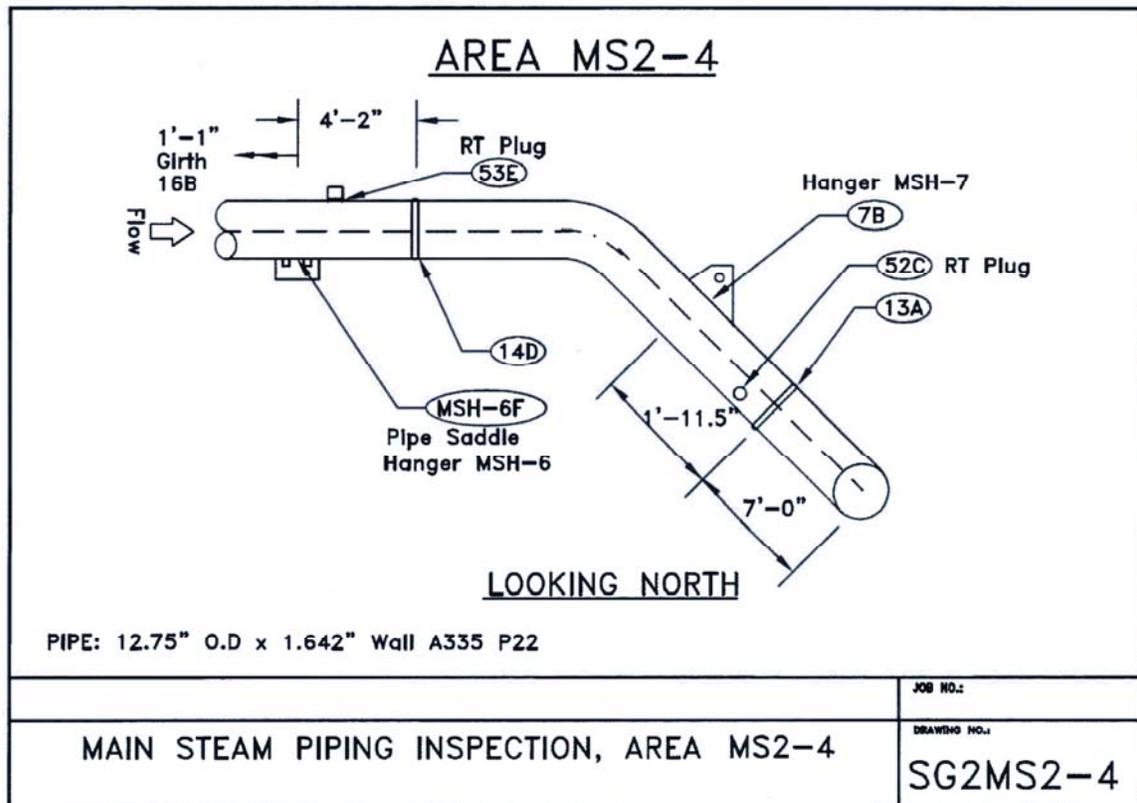
Figure 5.2 Example Of Inspection Sketch Showing The Location Of Each Weld In The Inspection Area.

For welds with well - defined locations, such as the upstream and downstream side of elbows, thermowells, flanges or at welding TEE's, the locations do not need to be dimensioned. However, for welds that are typically hidden by the insulation, the sketches should show the dimension from a location that is clearly visible through the insulation, such as an elbow, TEE or pipe support, as shown in Figure 5.2. This will allow re-inspection of a weld for the minimal cost of removing the insulation.

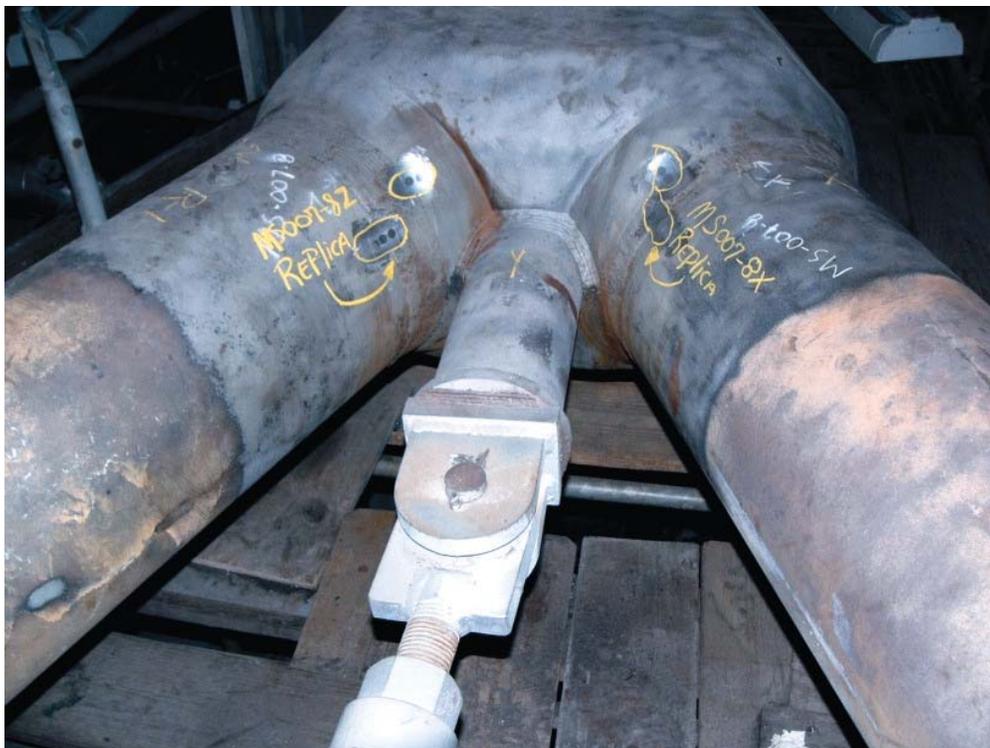
General Photo that shows the orientation, some of the weld numbers, and even the exact replica locations. With this general view and the weld numbers readable on the photos, there will be clear identification to any future observers of the orientation and location of the welds.

Document all inspection locations with photographs. While detailed photos may be helpful, assure that there are some overviews that show enough other adjacent pipe and equipment that the weld location can be oriented visually in the field later. Before taking the photos, use paint marker to mark the weld identification on the pipe. This is helpful not only for relating the photograph later, but for the inspector who will not necessarily be familiar with all of the locations.

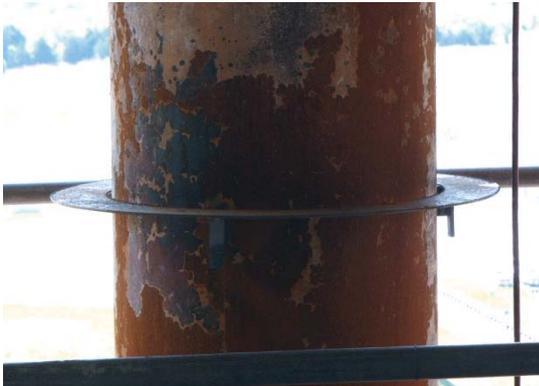
A photo of an insulation support ring installed on the pipe riser. This photo has minimal value as there are no indications of the weld number, or even where it is on the riser.
