Repair Techniques for Metal Plated Wood Trusses

Part 1: Introduction and Simple Repair Concepts

Derek L. Rhodes, P.E.

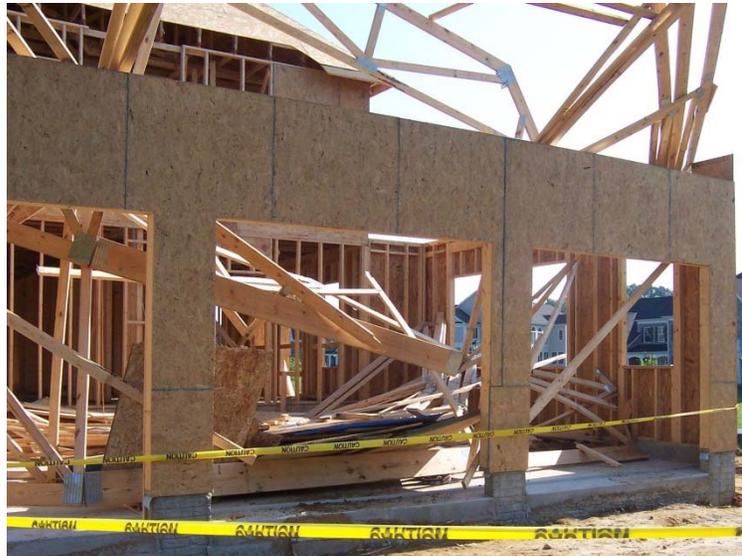
A key decision for the repair designer is whether to replace the original truss or repair it. The photograph to the right shows a situation where a series of attic trusses fell during erection due to inadequate bracing. It is generally accepted practice within the wood truss industry to replace any trusses involved in a collapse. Beyond the collapse situations, the question of whether to replace the truss or not should be evaluated on a case by case basis with considerations for the structural integrity of the remaining truss, the

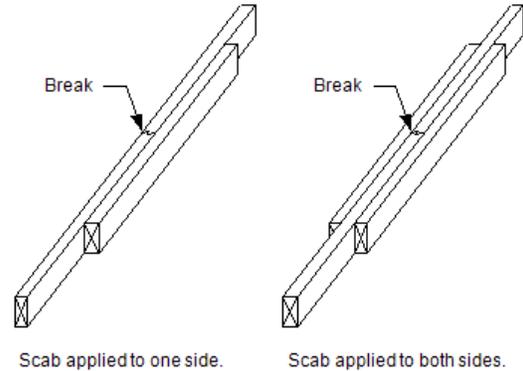
The scab is a very useful concept in truss repair design and provides the basis for many basic as well as complicated truss repairs. The diagrams to the right show both single and dual scabs applied to a broken truss member where the break is away from the joint. The length of the scab member is usually determined by either a minimum size that the repair designer specifies or the development length of the required connection.

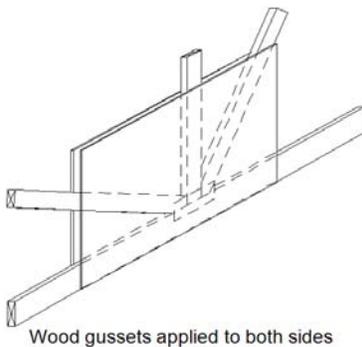
The wood gusset is often useful for truss repairs. A wood gusset is a wood sheet product such as plywood or Oriented Strand Board (OSB) that is cut to the necessary shape and applied to one or both faces of the truss. The diagram to the left shows a roof truss joint with wood gussets applied to both sides. OSB has higher strength values than commonly available plywood and therefore, OSB will be specified in this course whenever a wood gusset is the best option for the truss repair.

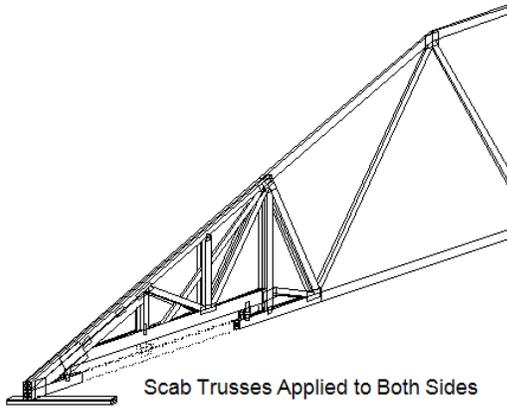
The scab truss is a useful repair technique when the repair encompasses a larger area than the OSB gusset can cover or the development length for the connection for some of the truss members is too long to be able to specify OSB. The scab truss is designed to work with the remaining part of the original truss to complete the structural functionality of the truss. The scab truss is generally used for volume ceiling changes that affect approximately half or less of the truss span. The figure shows a scab truss attached to both faces of the original truss. Some of the webs of

the scab truss are designed to line up with the webs in the original truss while others do not. The dashed lines represent the part of the original truss that is to be removed to form the box ceiling detail.

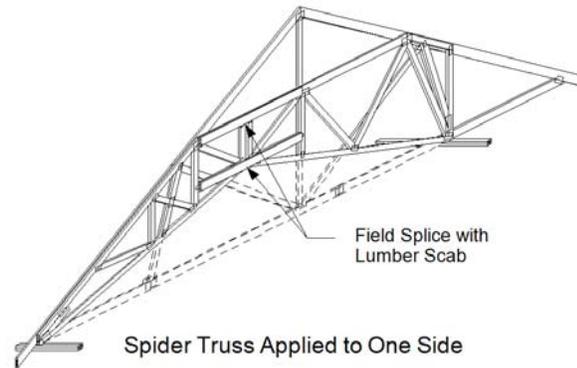
The spider truss is similar to the scab truss except that the spider truss is designed to almost completely replace the structural functionality of the original truss and usually needs to span from one bearing to another. The spider truss is usually designed in at least two parts for ease of installation. The parts of the spider truss are erected next to and attached to the original truss. A field splice connection would then be applied to complete the truss installation, sometimes using the remaining portion of the original truss as part of the field splice connection. Examples of truss repairs using scab and spider truss designs will be provided in part 3 of this course series. (The distinction is made in this course between scab and spider truss for instructional purposes. In practice, the term scab truss may apply to both design practices.)

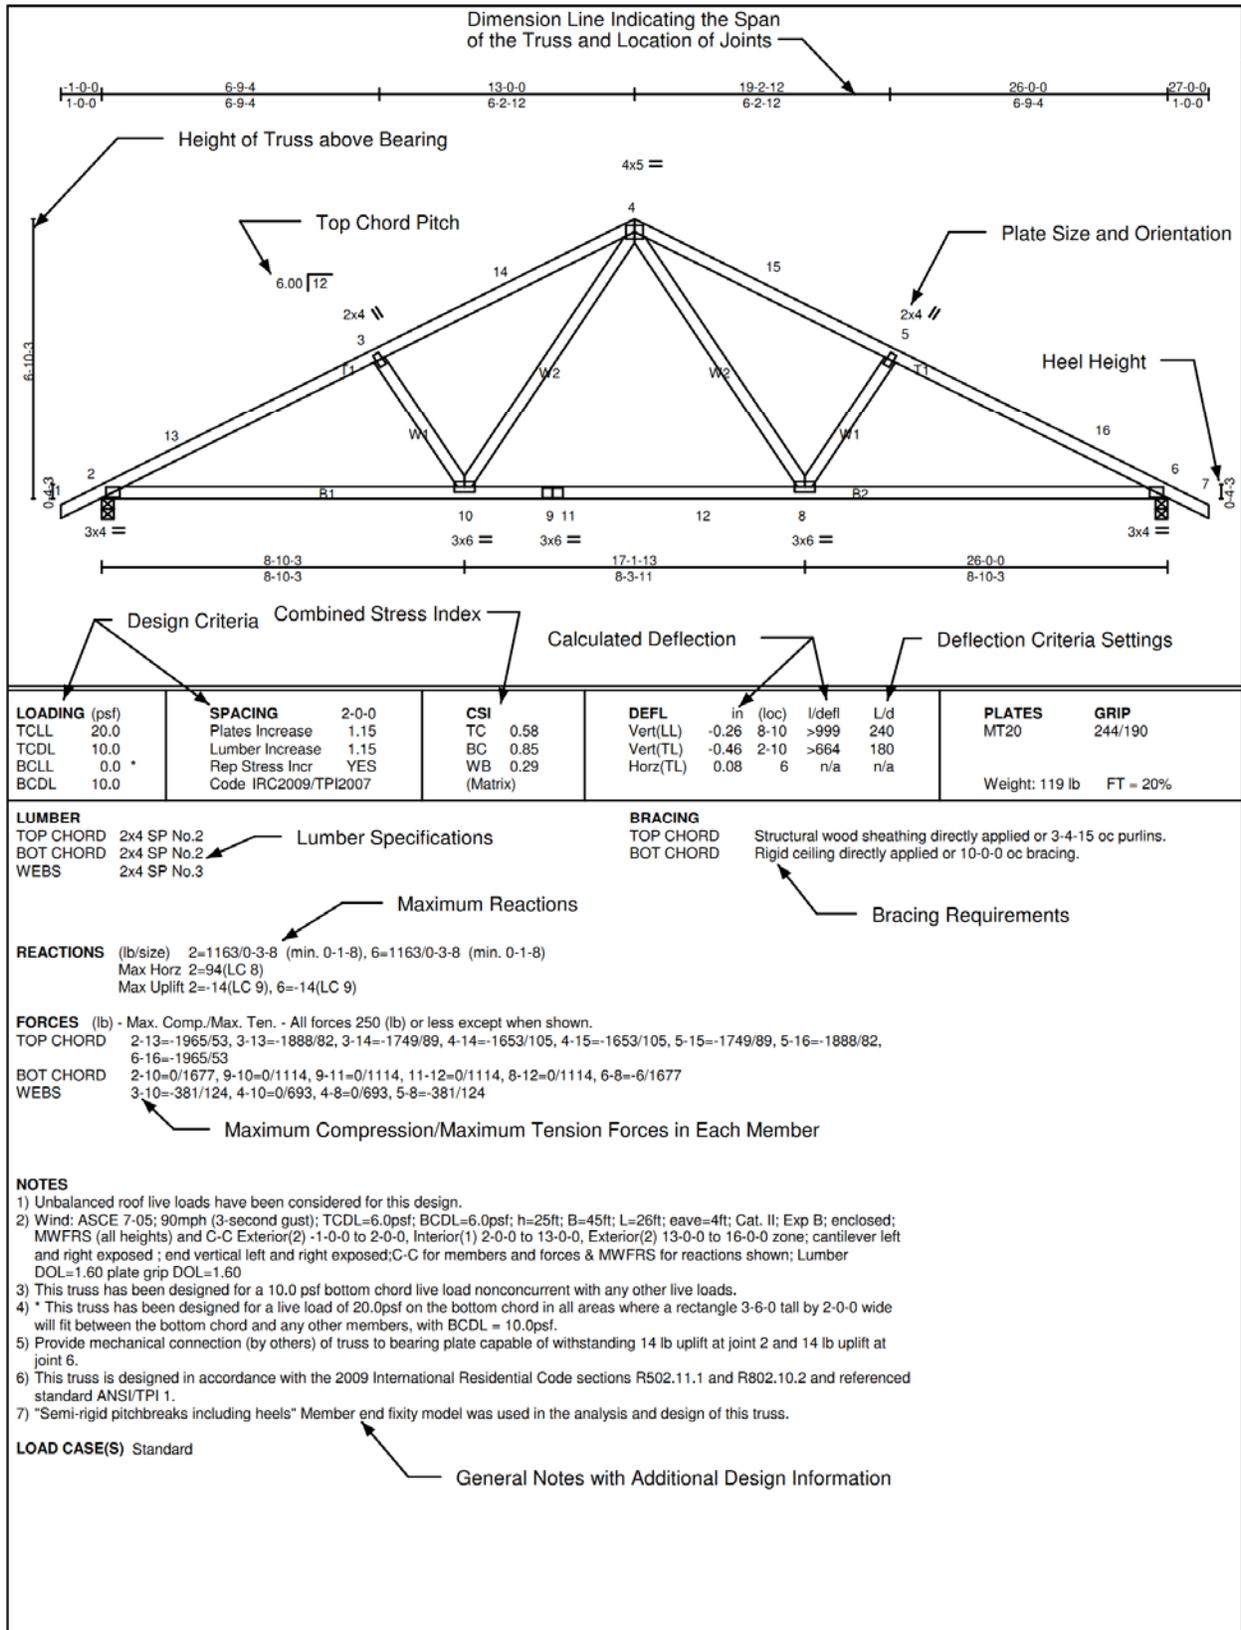
The TPI 1-2014 requires that all truss design drawings provide certain minimum information such as design criteria, dimensions to joints, lumber size and grade, combined stress index (CSI), deflection criteria, truss plate size/gauge, truss reactions, and maximum compression/tension forces. The CSI number shows the maximum stress index for each category of material and represents a ratio of the calculated to the allowable stress. A CSI over 1.00 would be considered failing. It is often useful to know how much extra stress a member can take when designing the repair. Truss fabricators are required to provide the truss design drawings with each shipment, so, they should be readily accessible at the job site. The figure on the following page shows an example of a truss design drawing with the most critical information highlighted.

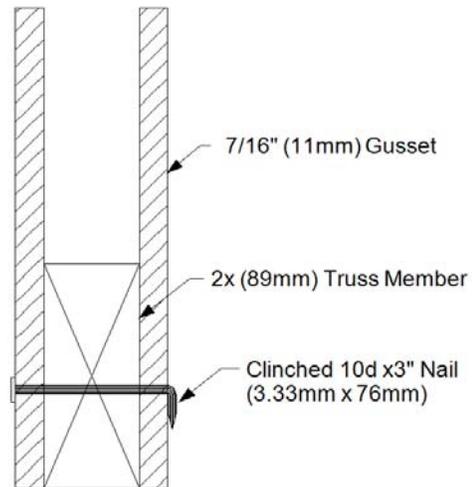
It should be noted there is one entry in the table that shows a Double Shear connection. This entry is the 1.5" (38 mm) SP main member with 7/16" (11 mm) OSB side members. In this case, if the 7/16" (11 mm) OSB is applied to both sides of a roof truss then the total thickness would be approximately 2 1/2" (63 mm). The 10d nail is 3" (76 mm) long, so the nail would extend approximately 1/2" (13 mm) beyond the wood members allowing the nail to be bent over, or clinched, producing a double shear connection and greatly increasing the allowable shear capacity of the nail.

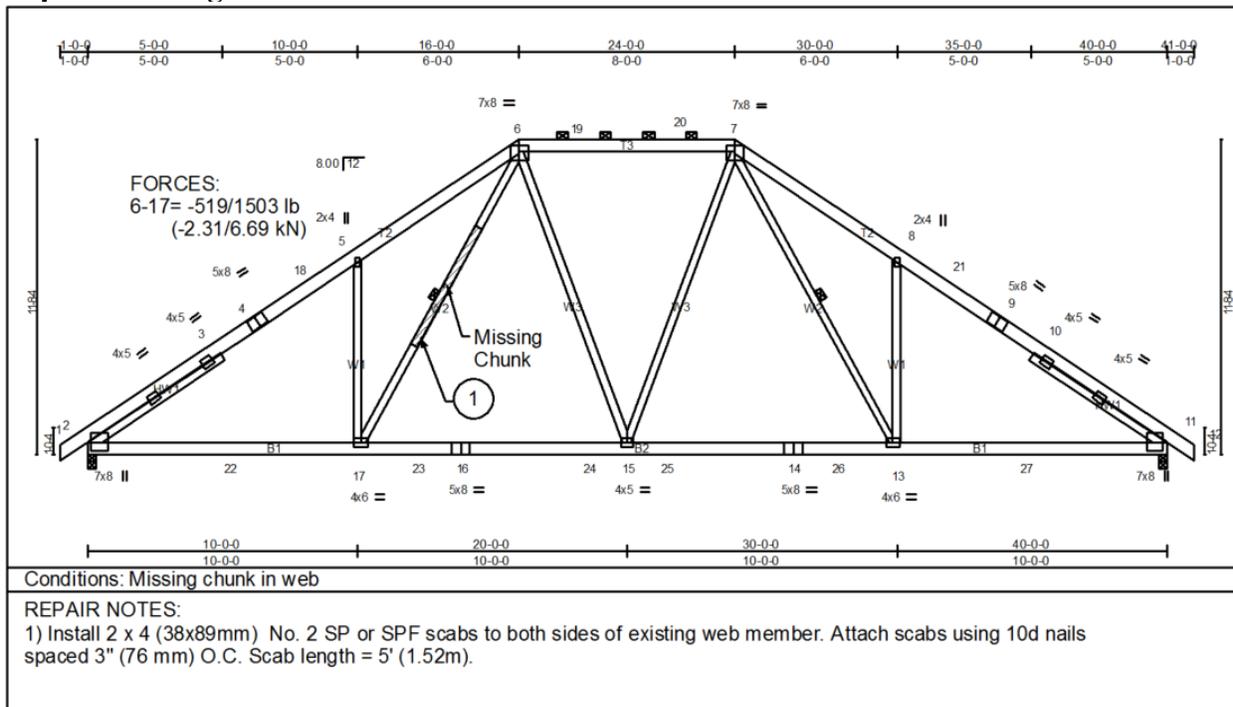
Example 4-1 Simple Web Break/Damage

The web, W2, between joints 6 and 17 is damaged near the middle of the member.

In the market where this truss was fabricated, SP (Southern Pine), lumber is used for the trusses, but SPF (Spruce-Pine-Fur) is more readily available at the jobsites in the geographic region, and so even though nails in SPF lumber have a slightly less shear capacity, SP or SPF are specified whenever possible. The maximum compression force in the damaged web member is 519 lbs (2.31 kN) and the maximum tension force is 1503 lbs (6.69 kN). From Table 3-1, the shear capacity of each 10d nail in SPF lumber for a roof application is 106 lbs (0.47 kN). Therefore 15 nails with 16 spaces would be required on each end of the break. With the nails spaced at 3" (76 mm) o.c. the total required scab length would be 8' (2.44 m) for a one sided repair or 4' (1.22 m) for a two sided repair. To allow for some tolerance in the application of the repair and to account for the possibility that the length of the damaged region may be as much as 12" (0.30 m), 5' (1.52 m) scabs were applied to both sides of the web member. Experience has shown that it is good to allow for some tolerance or rounding up of the member lengths due to the inherent uncertainty in wood construction.

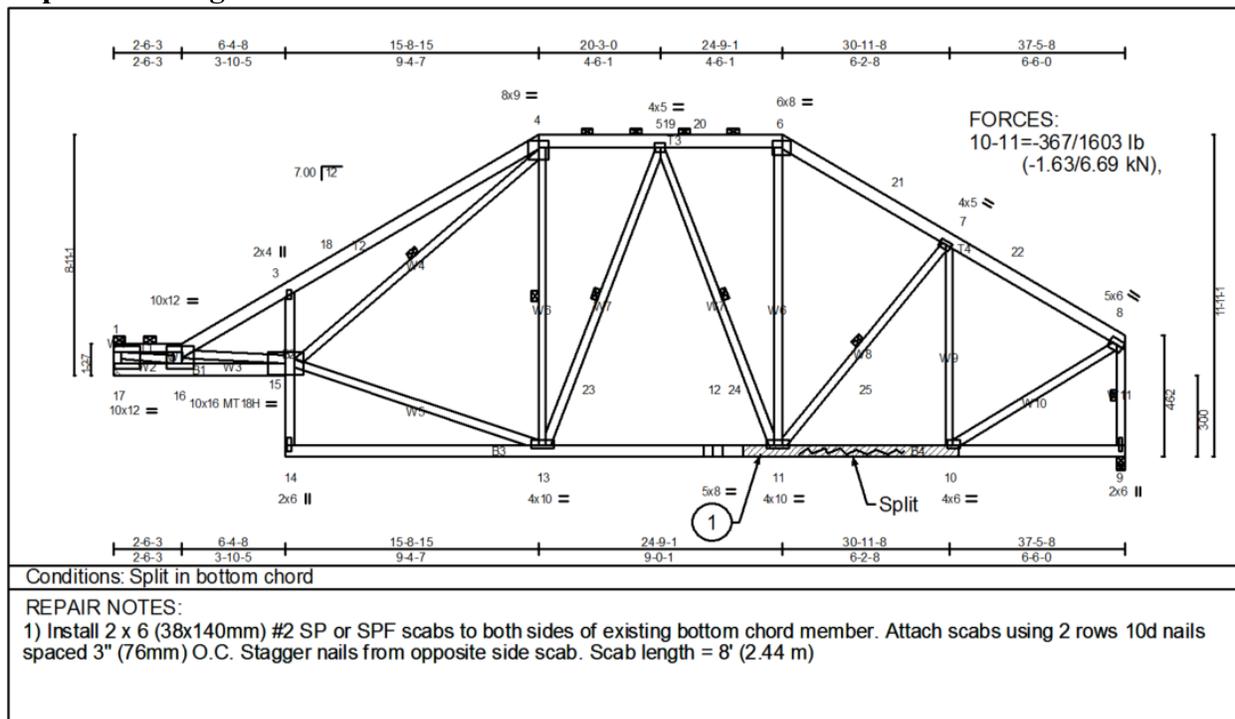
The bottom chord member between joints 10 and 11 has a horizontal split that is approximately 4' (1.22 m) long.

This repair is very similar to example 4-1 except for the length of the damage and the member size. The controlling force in the affected member is the maximum tension force of 1603 lbs (7.13 kN). From Table 3-1, the shear capacity of each 10d nail is 106 lbs (0.47 kN). Therefore 16 nails would be required beyond the extent of the split at both ends. Two rows of nails were used for the 2x6 (38x140 mm) bottom chord member. With the nails spaced at 3" (76 mm) o.c. in each row, 8 nails with 9 spaces or 27" (686 mm) of development length would be required beyond the split for a one sided scab repair yielding a minimum scab length of 8.5' (2.59 m). For a two sided repair, 4 nails with 5 spaces or 15" (381 mm) would be required beyond the split, yielding a total length of 6.5' (1.92 m). An 8' (2.44 m) long two sided 2x6 (38x140 mm) scab was chosen for this example due to potential uncertainty as to the actual length of the split.

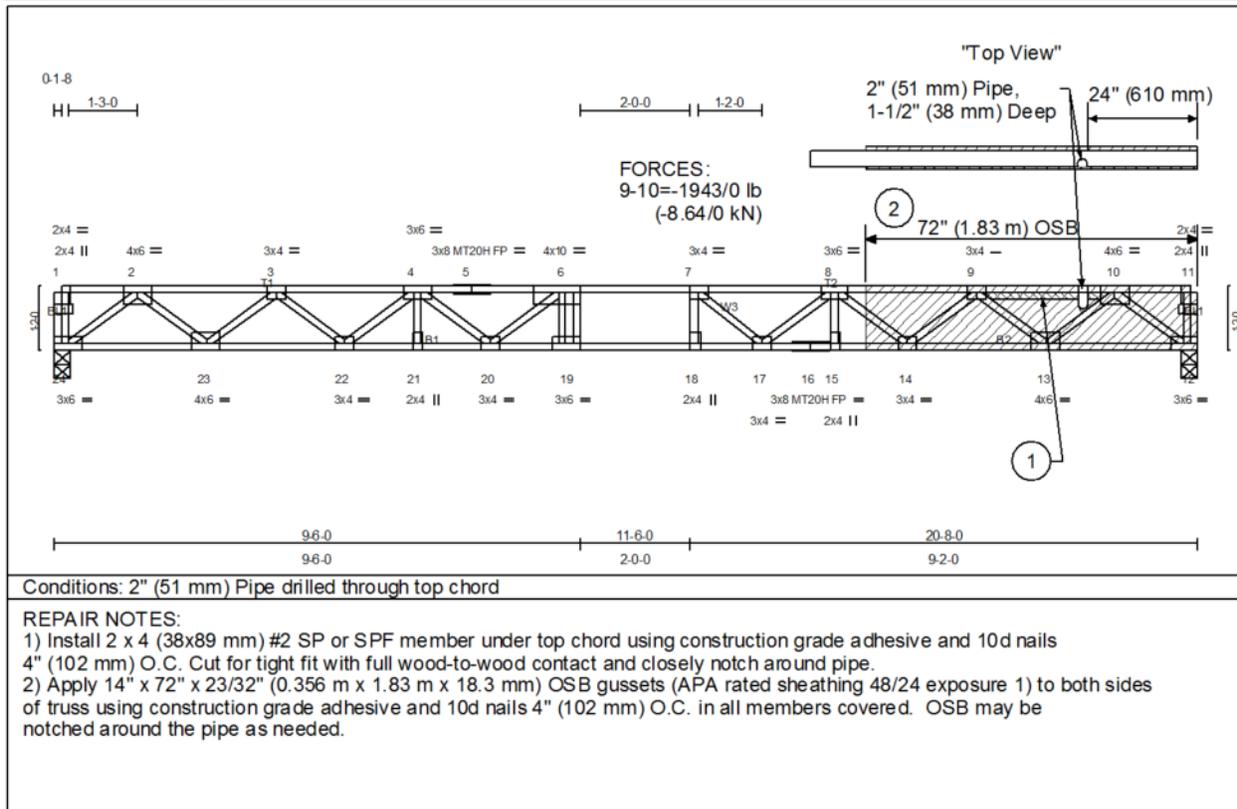
Example 4-3 Damaged Top Chord of a Floor Truss

A notch for a pipe was cut into the top chord member between joints 9 and 10.

The repair must be designed around the pipe that needs to remain in place. The controlling force in the damaged member is the compressive force of -1943 lb (-8.64 kN). According to Table 3-1, the shear capacity of a 10d nail in a floor application using an OSB gusset is 91 lb (0.40 kN). With the nails spaced at 4" (102 mm) o.c. and the OSB gussets applied to both sides, the required development length beyond the damage is 44" (1.12 m). Since the damaged area is only 24" (0.61 m) from the end of the truss, the required development length can only be achieved to the left of the pipe notch. A block was added under the top chord member to augment the development length. It is standard practice to make gussets the full depth when applying OSB gussets to floor trusses because the perimeter nailing makes the combination of the truss and OSB into a box beam with increased stiffness and improved performance. The 24" development length on the right side was deemed sufficient considering the increased stiffness of the box beam, the reinforcing block, the web nailing, and the fact that less than half of the width of the top chord was damaged.

This repair is similar to Example 4-3 in that for both repairs, the pipes had to remain in place and the repair had to be designed around them. In both cases, the repair would have been avoided altogether had the trusses been shifted slightly to avoid the location of the pipes. The difference is that for the current example, the bottom chord which has a controlling tension force is cut in addition to the top chord which has a controlling compression force and that the forces involved are approximately three times greater than the other example. The forces are so much higher for this example because it supports a corridor in a multi-family dwelling and according to the IBC2015 table 1607.1, corridors should be designed for 100 psf (4.79 kN/m²) whereas the individual residential units need only to be designed with 40 psf (1.92 kN/m²).

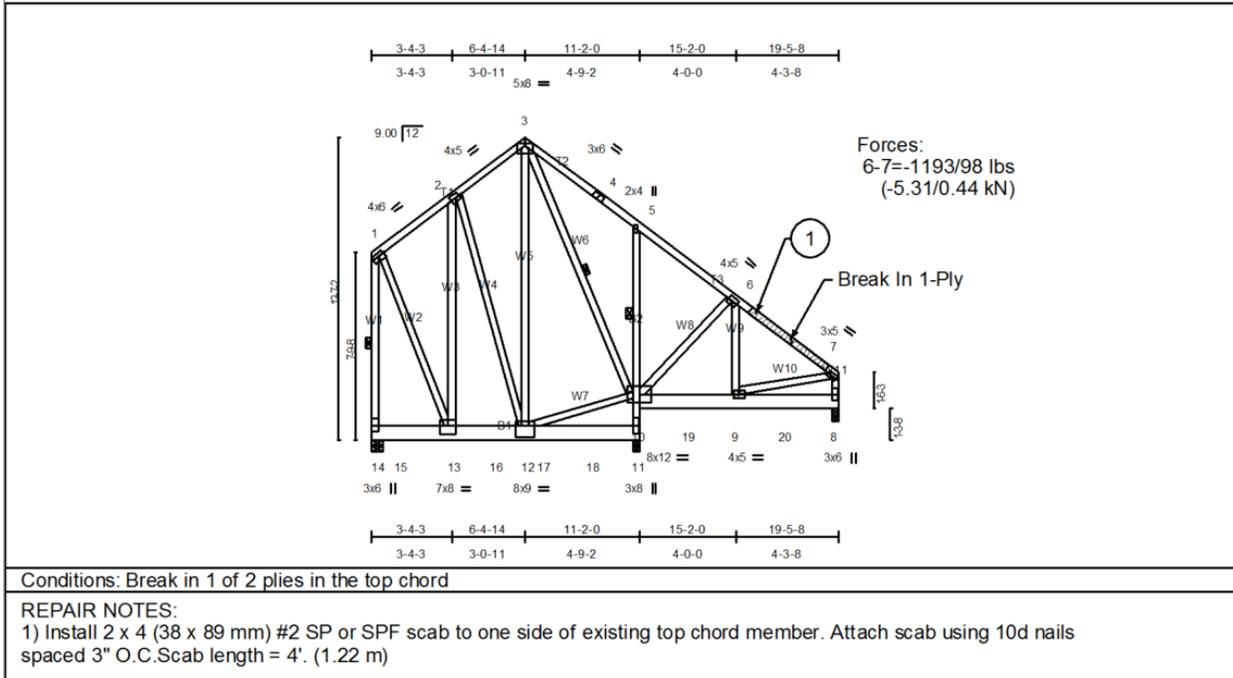
One ply of a 2-ply girder truss has a break in the top chord member.

The presence of an interior bearing in the truss causes the forces in the damaged member to be relatively small for a girder truss. A one ply member would be sufficient to carry the load for that one panel, so technically no repair would be needed. However, a broken member, especially on a girder, is easily noticeable and would cause concern to most people. Therefore, the appropriate course of action is to apply a minimal repair to the member to remove future concerns, and a one sided lumber scab was chosen.

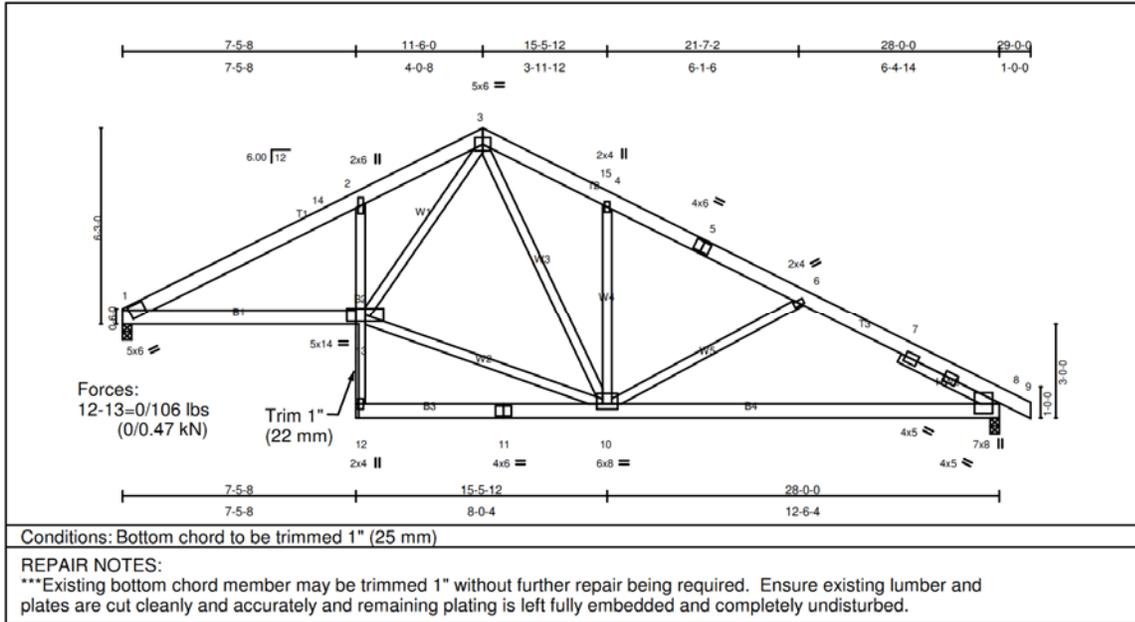
Truss member at step-up does not line up with the wall below.

This type of repair is common when different ceiling heights are present due to the nature of wood construction. Fortunately, the vertical bottom chord member below the raised ceiling has a tension force of only 106 lbs (0.47 kN). The repair is simply to trim the member because in this situation and other similar repairs, the vertical piece can usually be completely removed without adversely affecting the truss. If the raised ceiling step-up needed to shift to the point where the W2 web needed cutting, a much more substantial repair would be required because that member usually has a high tension force.

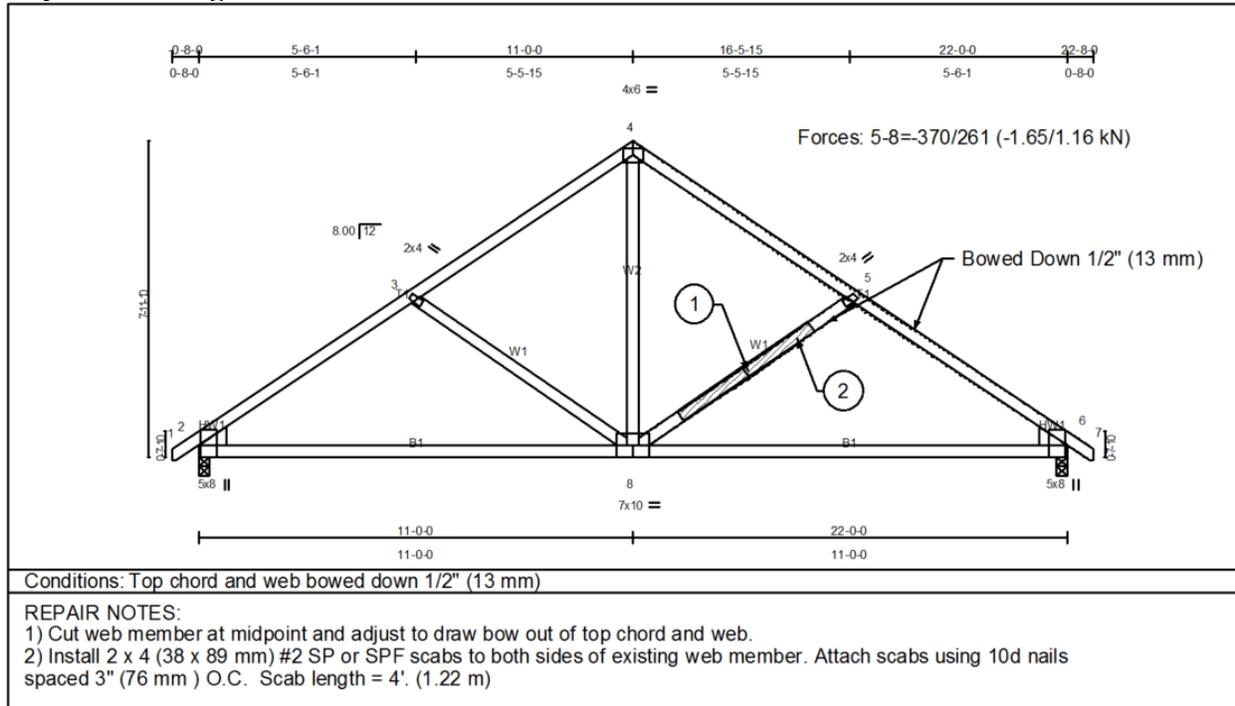
Top chord of truss bowed and the roof sheathing is already attached.

The first thought for a situation like this would be to scab a new member on the side of the top chord member, but with the sheathing already attached, that connection would need to be severed in order to apply a scab to correct the bow. A better solution is actually to cut the web, push the top chord to the desired position, and repair the web. Before the cut is to be made, consideration should be given to see if temporary support is needed for the truss and what method should be used to push the top chord out to the desired position. This is a fairly small truss and so a temporary support would be useful to provide something firm to push against, but it would not be required. Since the bow is relatively small, the pushing force could be accomplished by applying shims at the cut in the web member. Also, the location of the cut is important. The easiest repair technique is the application of lumber scabs. In order for the scabs to work, the cut has to be far enough away from the joint to develop the connection, and so the midpoint of the web was chosen as the location for the cut.

This repair concept can be used to correct a bowed bottom chord as well. In the truss shown, if joint 8 was bowed down, all three webs would need to be cut in order to shift the joint. So, a prime consideration for this type of repair is the number of webs coming into a joint.

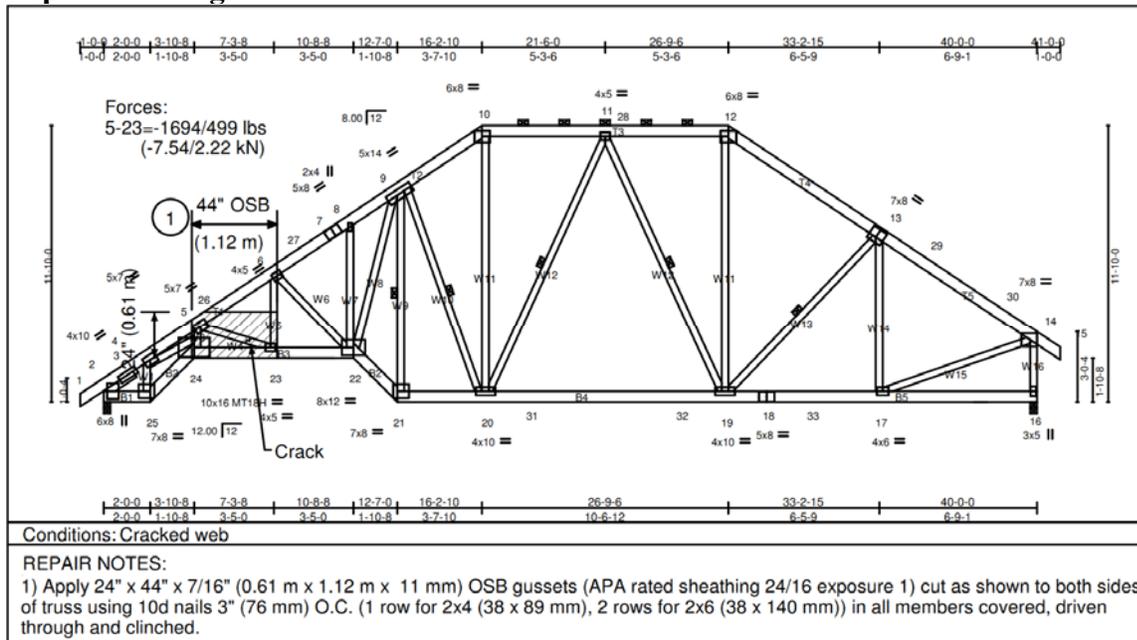
A web is broken, but the length of the member is too short to develop the connection for a lumber scab.

From Table 3-1, the shear capacity of a 10d nail in a roof application with OSB gussets on both sides with clinched nails is 173 lbs (0.77 kN). The controlling force is the compressive force of -1694 lbs (-7.54 kN) and therefore 10 nails are needed beyond the break. The OSB gussets allow the connection to spread into the other members at joint 23. The height of OSB gussets allow 5 nails to be installed in the vertical web member (W5) leaving 5 nails for the bottom chord member which can easily be installed in the 2x6 (38 x 140 mm) member using 2 rows of nails.

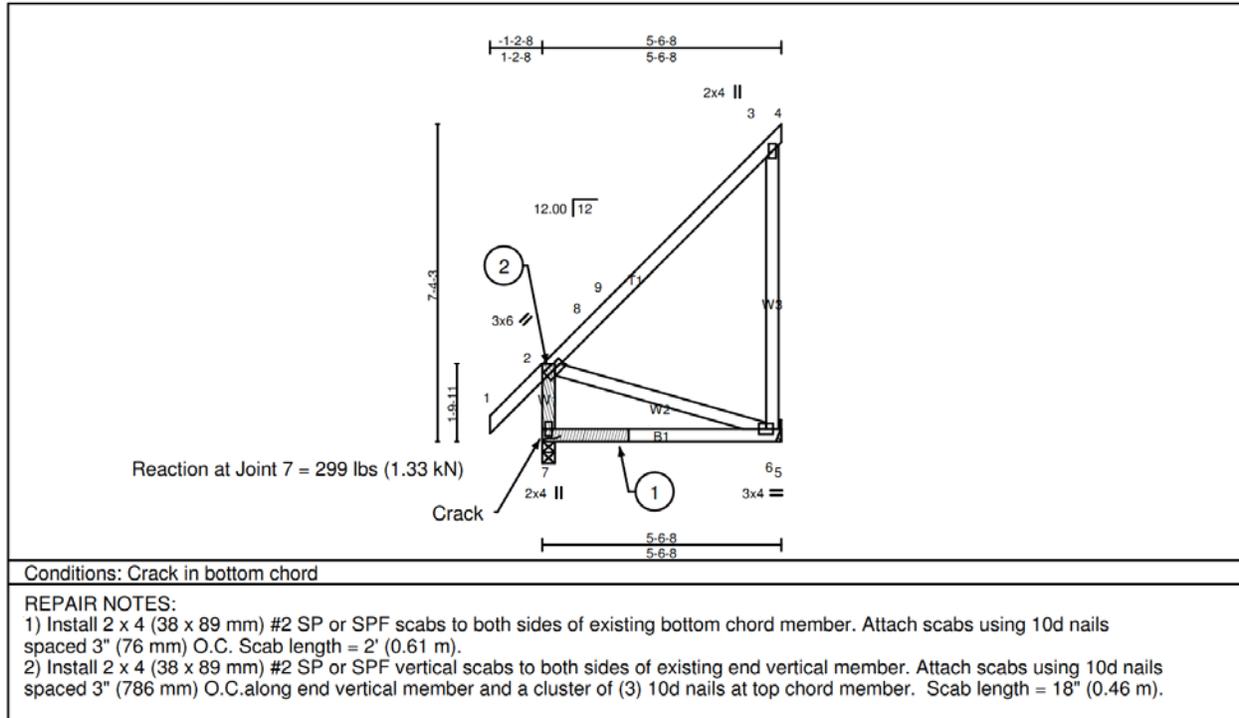
Example 4-8 Crack at the bearing

The bottom chord of a small mono truss is cracked just above the left bearing.

Having a split at a truss bearing is a common issue. The split is often caused by the nails from the hurricane clip. The photograph to the right was supplied by the builder and it shows the crack in the bottom chord adjacent to the hurricane clip. As is often the case in these situations, the truss plate that connects the end vertical to the bottom chord was undamaged and remains fully embedded. Therefore the connection between those members did not need to be addressed, but the repair did need to address transferring the forces into the wall. The combination of the horizontal and vertical scabs provide good vertical force transfer from the roof and shear force transfer from the bottom chord, and they are applied to both sides to prevent any eccentricity at the bearing surface. The hurricane clip is rendered ineffective due to the location of the split and will need to be removed. For this small truss, the hurricane clip can be reinstalled and connected to the scab members after the repair is complete.

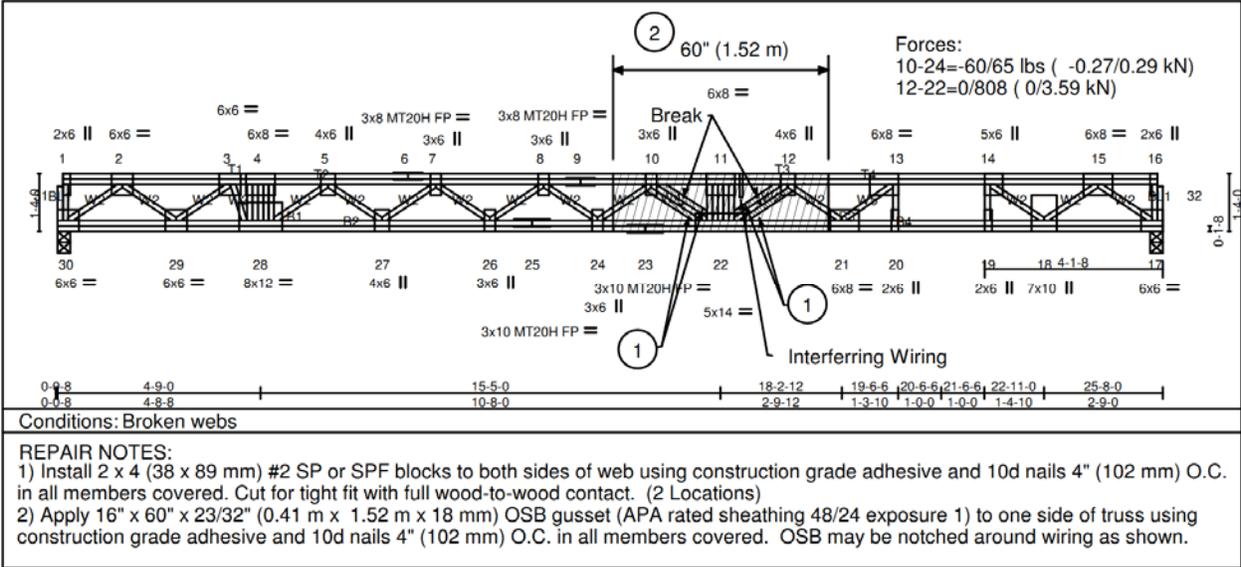
Two webs of a floor truss girder are broken.

The builder provided the two photographs shown below to aid in the preparation of the repair documents. The floor girder truss supports a beam and is up against a stairwell on the opposite side of the truss from what is shown, so only one side of the truss is accessible. From Table 3-1, the nails connecting the 23/32" (18 mm) OSB gusset to the truss would have a shear capacity of 91 lbs (0.40 kN). To achieve the full nailing with the OSB gusset, nine 10d nails would be needed above and below the break in the web from joint 12 to joint 22. Nails in the top and bottom chord members in the area near the web can be included in the count because the web is too short to develop the connection. The blocks were added to both sides of the broken webs to secure the damaged members and to augment the connection with the OSB gusset, but by themselves, they could not achieve the required nailing because of the close proximity of the other truss members. The OSB gusset was sized to symmetrically cover both breaks and was also notched for the wire shown in the photograph.

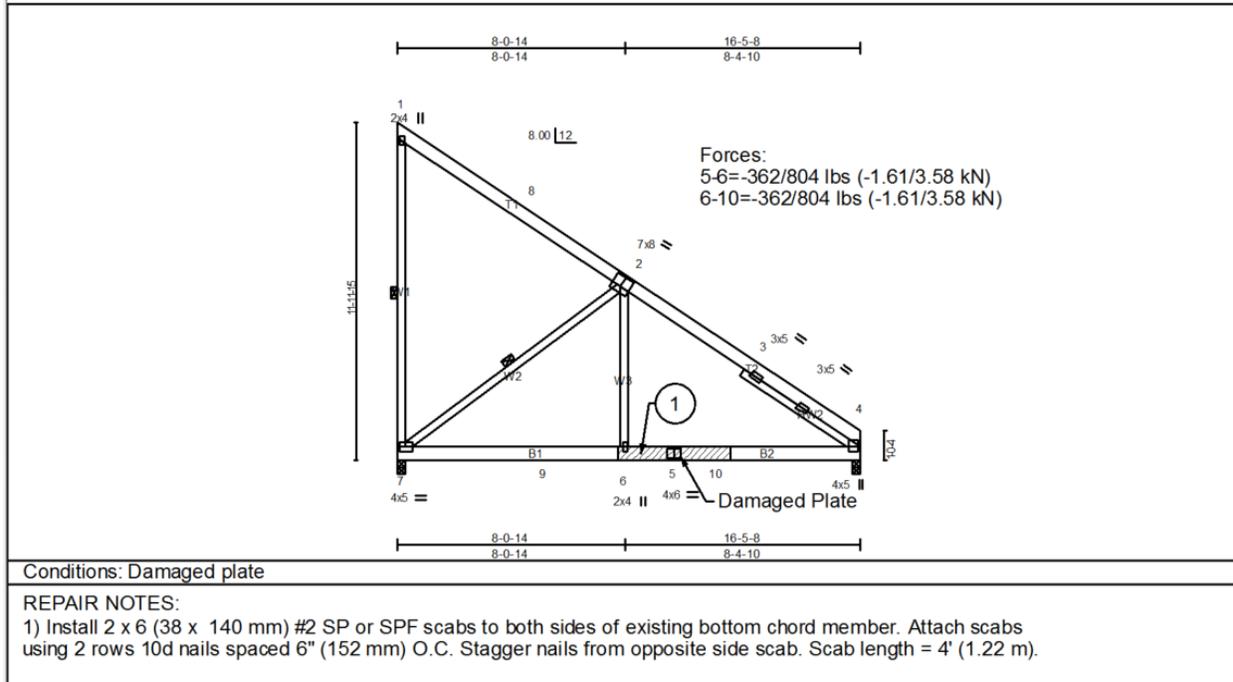
Example 5-1 Damaged Bottom Chord Splice Plate

The plate on the bottom chord splice has been damaged.

A damaged splice plate can be treated just like a broken member when it is out in the panel away from web members, and a lumber scab can be used as the repair. For a roof truss with a lumber scab, the shear capacity of the 10d nail from Table 3-1 is 106 lbs (0.47 kN) and therefore, 8 nails would be needed beyond the splice on both ends. In theory, a single 4' (1.22 m) long 2x6 (38 x 140 mm) scab would be sufficient. However, the repair designer prefers to use a two-sided repair whenever possible and therefore, specified the double scab solution.

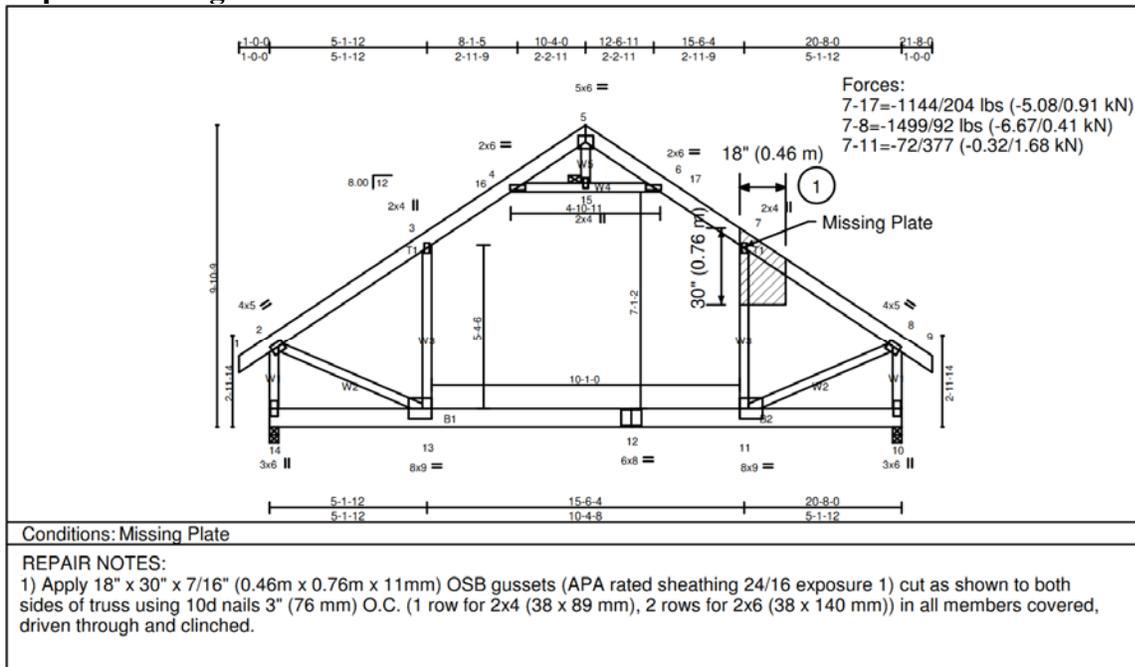
Example 5-2 Missing Plate

The plate at a top chord joint adjacent to an attic room is missing.

Having only a two member joint with a missing plate makes this a good example to continue the discussion regarding damaged plates. Since the top chord member is continuous through the joint and is not broken, the full axial force of the top chord does not need to be developed with the connection. Therefore, the critical design force is the tension force of 377 lbs (1.68 kN) in the vertical web member from joint 7 to joint 11. With the controlling force for the connection being relatively small, there are several possibilities for repairing this joint with the missing plate. In this case, OSB gussets with a thickness of 7/16" (11 mm) were chosen to provide the required reinforcement. From Table 3-1, for a roof truss repair with 7/16" (11 mm) OSB gussets, the 10d nail would be subjected to double shear and have a capacity of 173 lbs (0.77 kN). The connection requires a minimum of three 10d nails in each member. The OSB gussets are sized a little larger than required because of the repair designer's preference to provide a minimum gusset size for this type of joint. Normally, the gussets would have been centered on the vertical web member. However, in this application, the gussets were shifted to avoid the attic room.

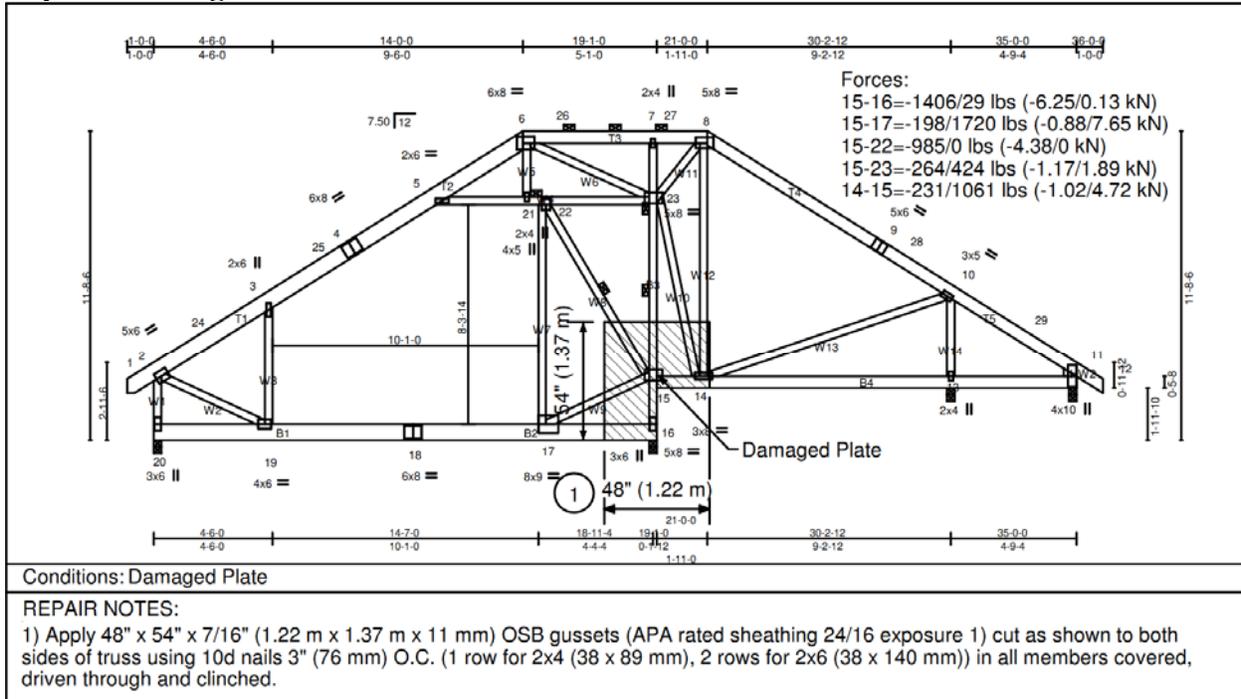
Example 5-3 Damaged Plate

The plate at the bottom chord step-up has been damaged.

When a damaged plate connects several members, it is useful to start with the assumption that OSB gussets are a good option for the repair and then to assemble the required forces and gusset development lengths in a table. This compilation of forces and gusset development lengths assists in determining the best placement of the gussets and also to confirm that OSB gussets can be used. According to Table 3-1, the double shear capacity of the 10d nails is 173 lbs (0.77 kN). The table below presents the required development lengths in a clockwise manner:

tension web from joint 15 to 17, then some other repair technique such as a scab truss would be required instead of the OSB gusset because of the 48" (1.22 m) limiting sheet width.

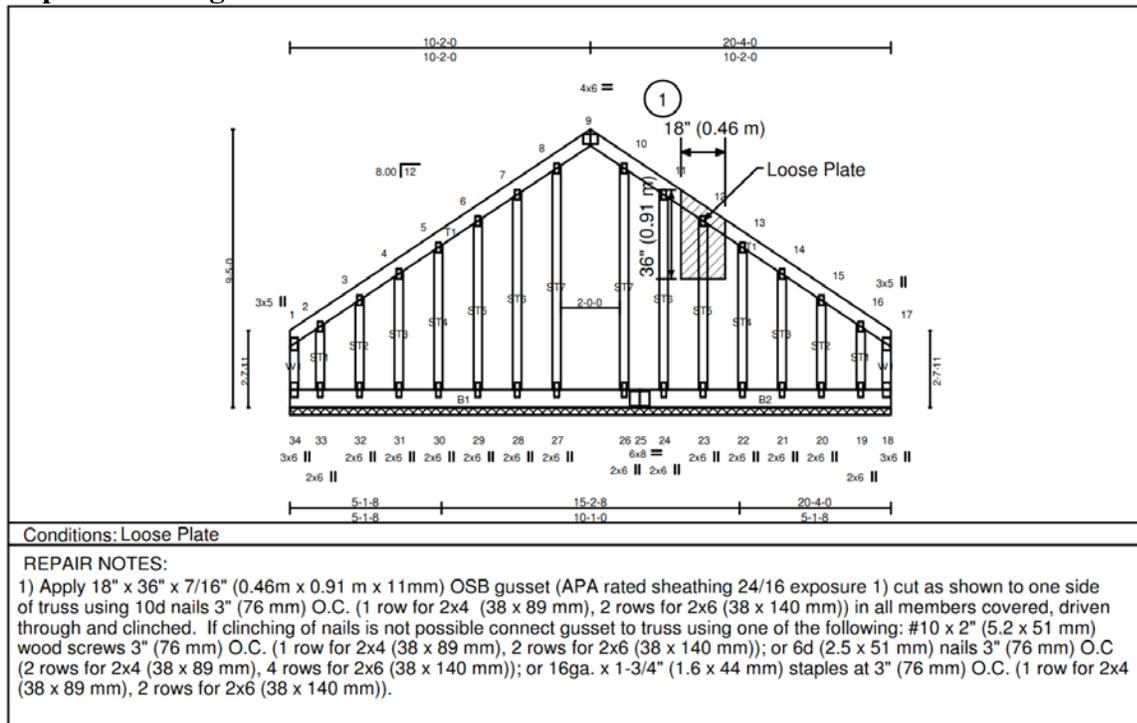
Example 5-4 Loose Plate on a Gable Truss

The plate at a top chord joint in a gable truss is damaged.

Gable truss repairs require unique solutions to stay within the confines of the building exterior. The size of the OSB gusset for gable truss repair members is usually based on the geometry of the truss rather than the forces in the members. The thickness of the gable truss and exterior sheathing limits the length of the connector. The connector must either be clinched if installed prior to the exterior sheathing or be no more than the thickness of the exterior sheathing plus 2" (51 mm) long so that it does not protrude to the outside of the structure.

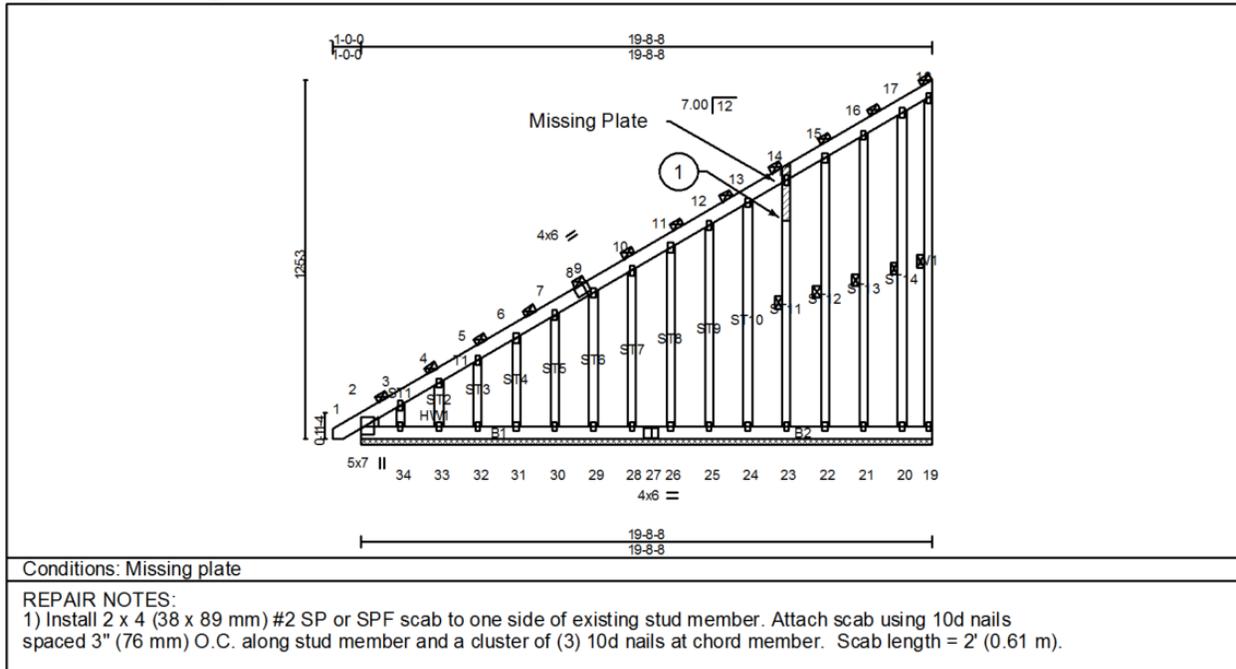
Example 5-5 Alternate Gable Truss Joint Repair

The plate at a top chord joint in a gable truss is missing.

This example is presented as an alternate approach to repairing gable truss joints to the previous example. The main advantage of using a lumber scab repair for a missing or damaged plate on a gable truss instead of the OSB gusset repair presented in the previous repair is that the thickness of the assembly is now 3" (76 mm), and therefore the standard 10d gun nail can be used to attach the scab without the nail penetrating the exterior of the structure.

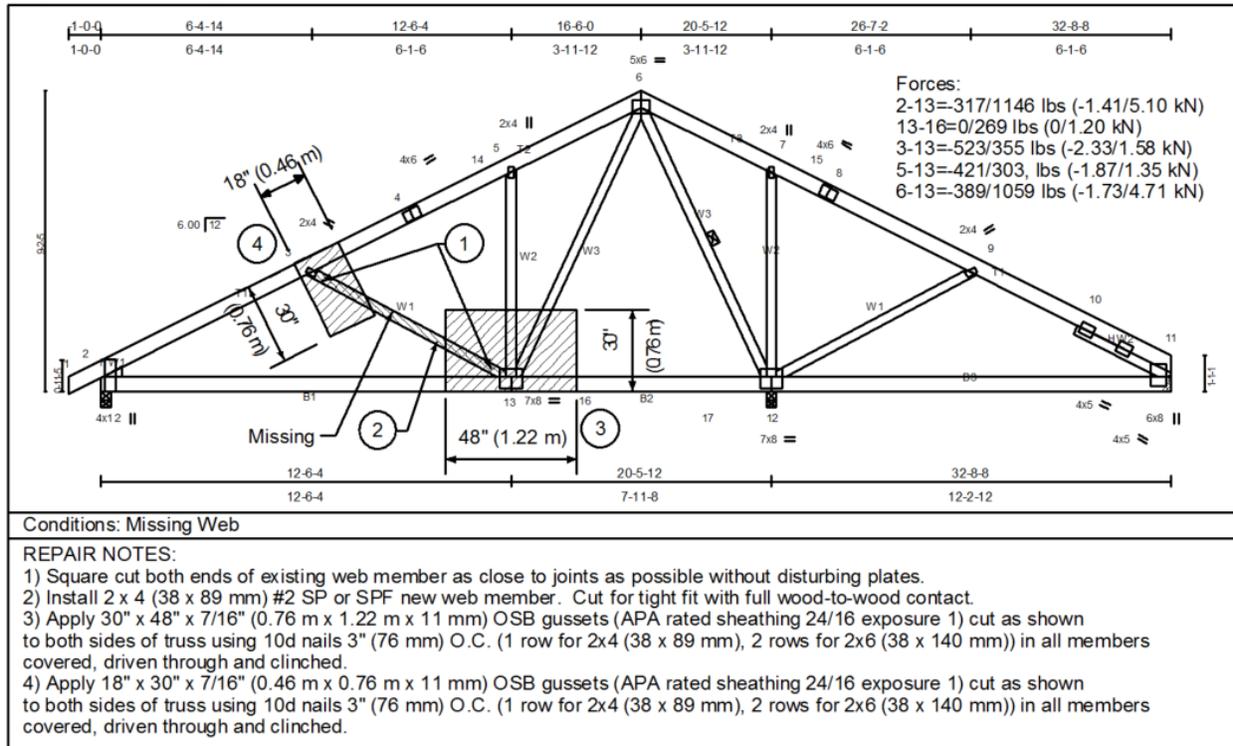
Repair Drawing

A web is broken and missing from the truss.

When a member has been broken out of a truss, the pieces that are left behind are often jagged. The first step in replacing a member that left jagged edges would be to square cut the pieces to allow for a clean splice joint. Also, in order to reduce the size of the OSB, this cut should be made as close as possible to the joint.

When a member is missing, it is advisable to consider what else may have been damaged. This web being torn from the truss would likely also damage the plate at the critical bottom chord splice joint 13. So, in addition to considering the forces in the missing member, the forces in the other members at joint 13 should also be considered when sizing the OSB gusset. Since this is a roof truss with OSB gussets, the double shear capacity for the 10d nail of 173 lbs (0.77 kN) applies. Proceeding clockwise around the joint, member B1 would require 7 nails in two rows for a development length of 15" (0.38 m), W1 – 4 nails requiring 15" (0.38 m), W2 – 3 nails for 12" (0.30 m), W3 – 7 nails needing 24" (0.61 m), and B2 – 2 nails using 6" (0.15 m). The controlling dimensions for OSB gussets at joint 13 would be the W1 web beyond the square cut splice and the W3 web. The OSB gussets at joint 3 only have to develop the force in the web member because the top chord member is undamaged and is continuous through the joint.
