Repair Techniques for Metal Plated Wood Trusses

Part 1: Introduction and Simple Repair Concepts

Derek L. Rhodes, P.E.

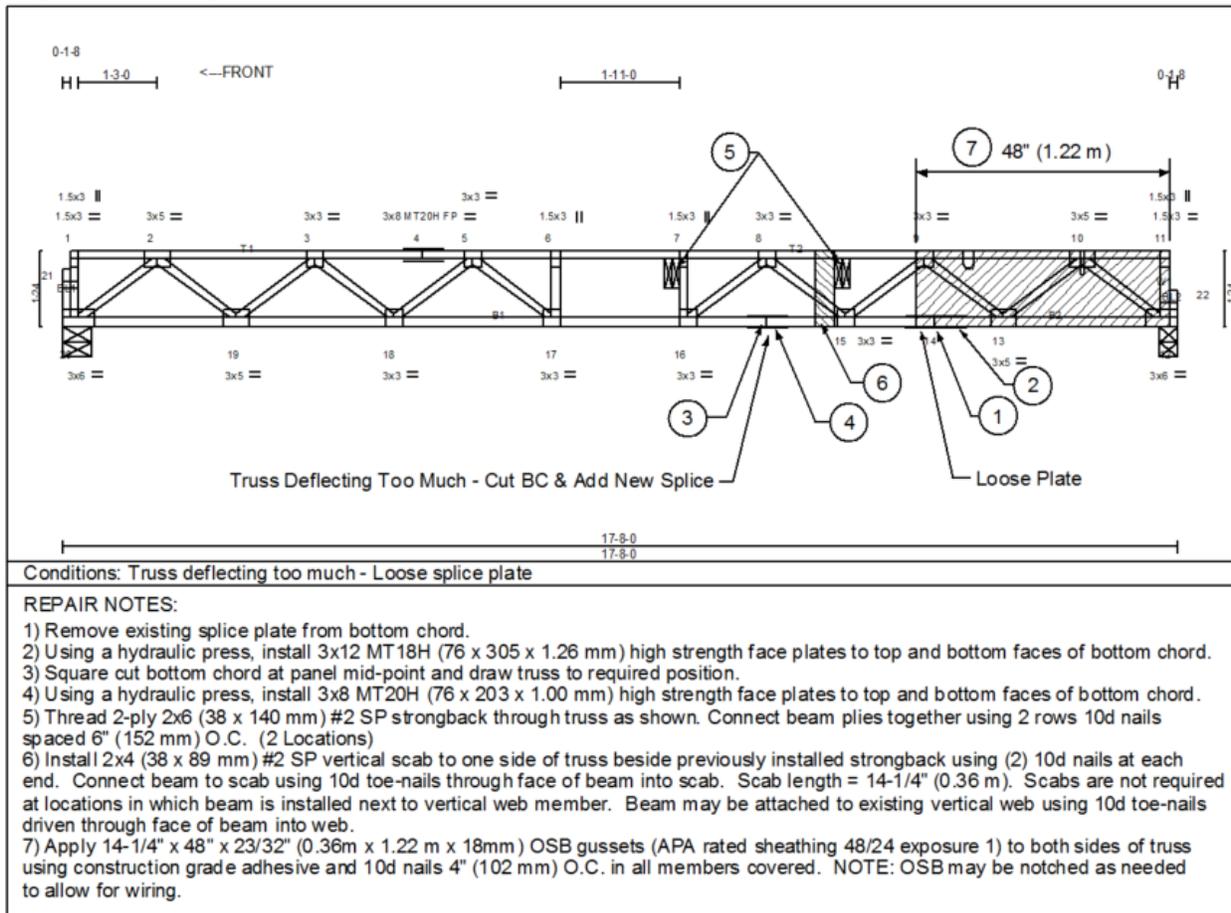
Repair Drawing

Unacceptable deflection was noticed in a few floor trusses in a residential structure after the home owner moved some furniture several years after the house was built. Upon inspection, the primary cause of the deflection was a bottom chord splice plate that had pulled out.

The first step in this repair is to remove the existing damaged bottom chord splice plate and install a new larger plate using a portable hydraulic press. ANSI/TPI 1-2014 Section 3.9.3 states that when a new plate is pressed into wood where there are tooth holes from a previously installed plate, then the plate grip value of the teeth in that area must be reduced by 50%. The original splice plate was a 3x8 (76 x 203 mm) high strength plate with each plate covering an area of 12 in² (7 742 mm²) for each bottom chord member. A new 3x12 (76 x 305 mm) high strength plate was chosen because it would provide a total of 18 in² (11 612 mm²) which takes into account the 50% penalty in the area of the existing tooth holes.

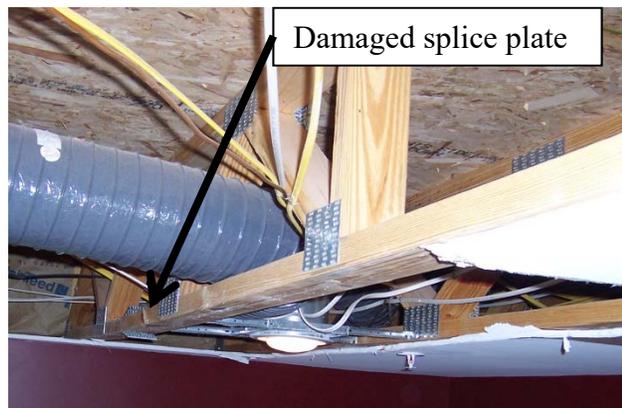
The photograph to the right shows the truss as it was found once the gypsum ceiling was removed. The damaged plate and the resulting deflection can be seen in the lower left corner of the photograph. Three adjacent trusses also displayed excessive deflection and required similar repairs. The four repairs were accomplished in concert by using the two 2-ply 2x6 (38 x 140 mm) beams with posts and jacks to raise the truss to its correct position. This truss repair example highlights several educational points as described below.

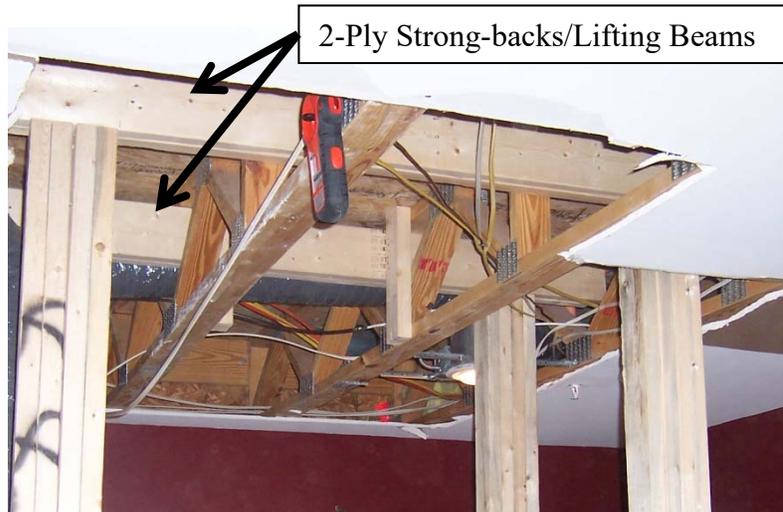
Once the 2-ply strong-back members with the supporting columns were in place, and the trusses were cut, the jacks were used to slowly and carefully lift the trusses back to the intended position. The jacks were placed on load distributing blocks to prevent cracking of the concrete slab in the basement. If there is a wood floor under the jacks, temporary supports should be provided to prevent damage to that lower floor system from the jacking force.

The photograph to the right shows the 2-ply strong-backs in place with the supporting columns before the trusses were cut. The laser tool was used to determine when the trusses were at the desired position.

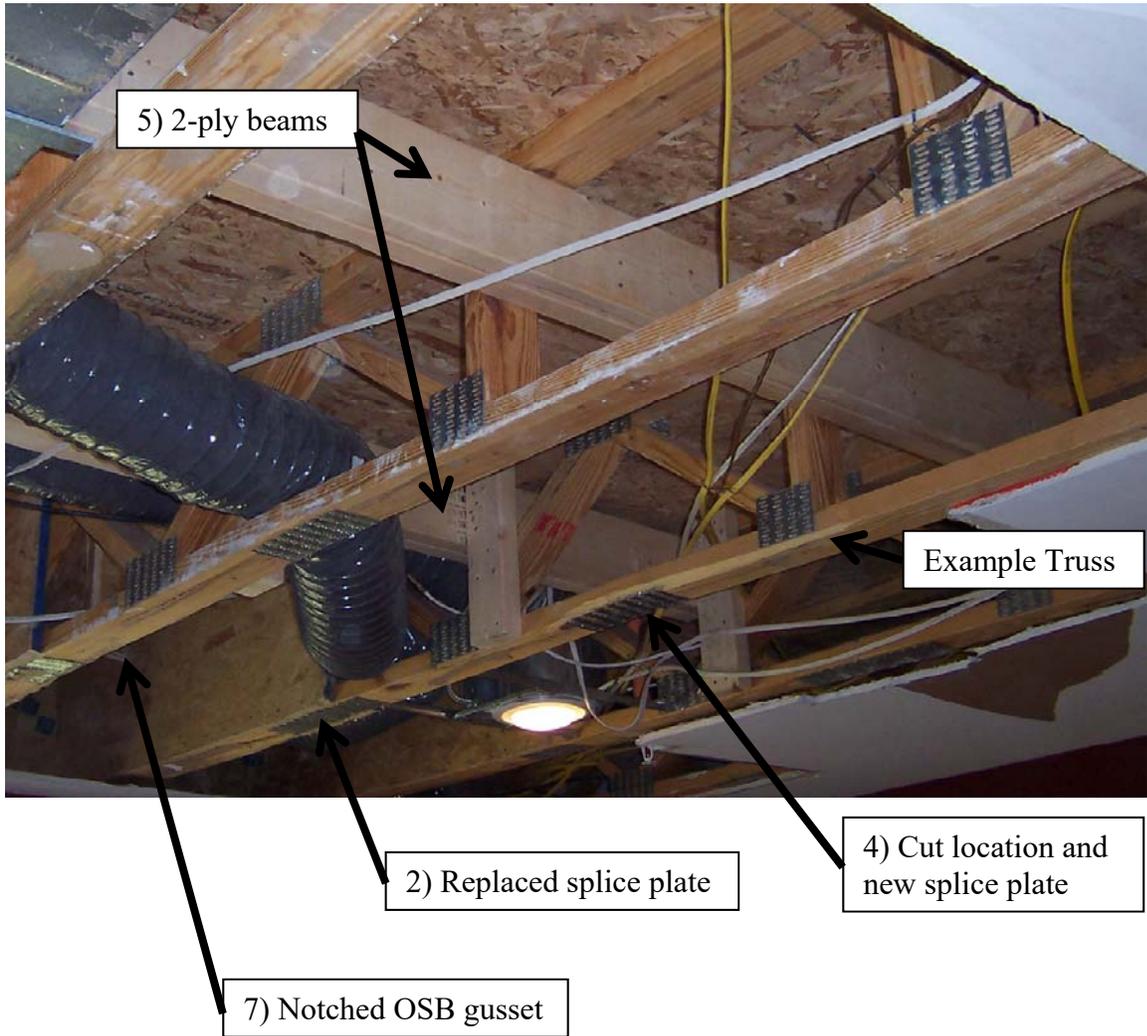
The following photograph shows the finished repair.
