*A SunCam online continuing education course*

# Repair Techniques for Metal Plated Wood Trusses Part 3: Complex Truss Repairs

Derek L. Rhodes, P.E.

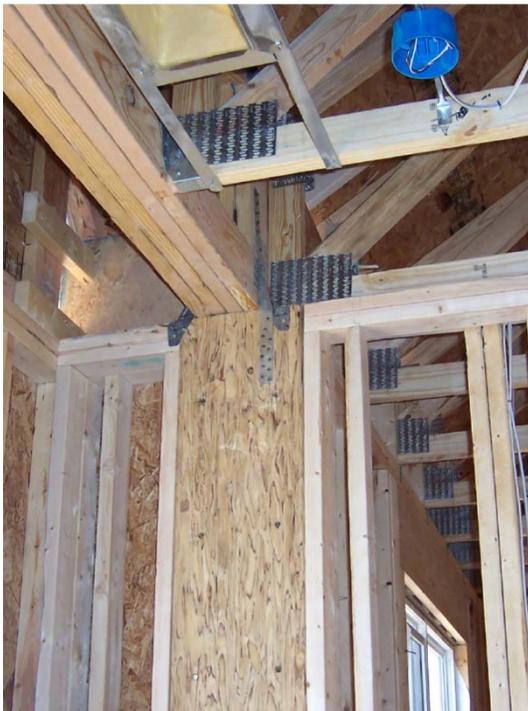
The connection of the girder to column required two separate connectors. The bearing enhancers were installed because the design reaction was greater than the allowable crushing strength of the bottom chord of the truss, but the bearing enhancers did not provide sufficient uplift capacity for girder truss.

The twist strap was installed over the bearing enhancers to establish the uplift connection.

The only item left was to make sure there was solid blocking through the two floors and wall to the foundation wall which was easily accomplished after the post was added. A photograph of the completed repair is shown to the left.

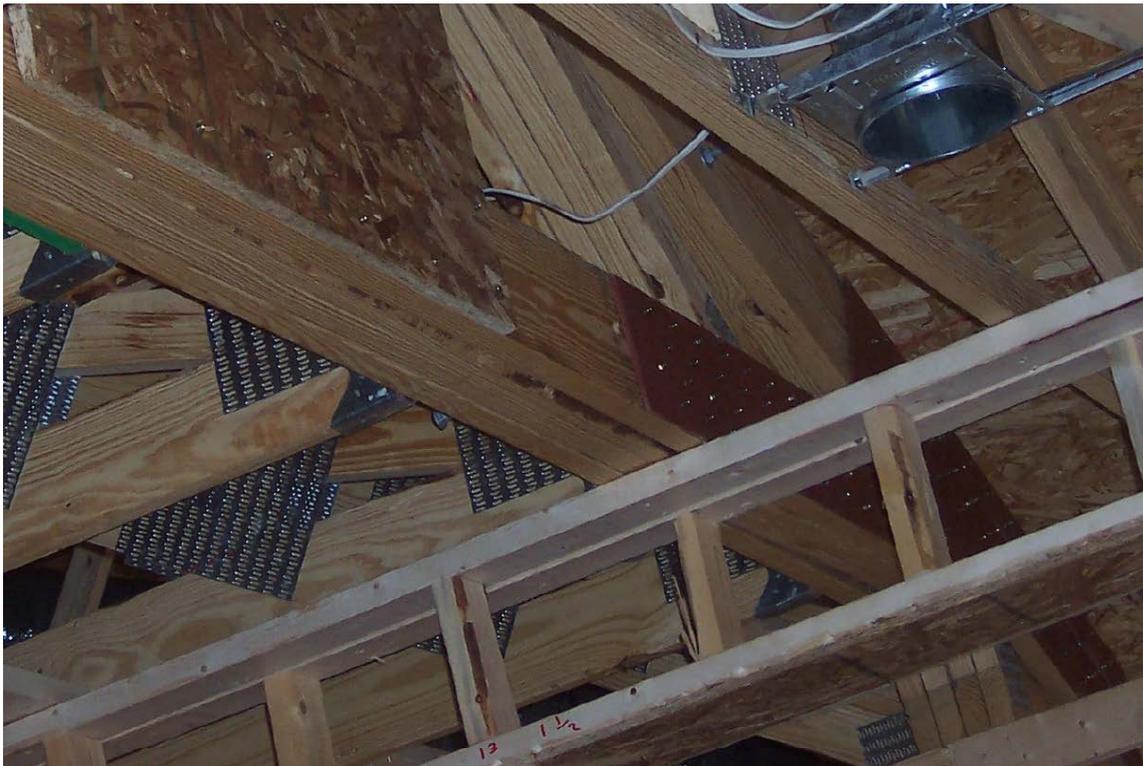
Several of the other joints had plates that were undersized as well. Each of these joints were able to be reinforced with OSB gussets cut to fit between the supported the trusses or on the opposite side of the truss fastened with the screws. The steel plate repair cost the customer about a week in the schedule for the design and manufacture of the steel plate, but it was felt that this solution was in the end better than replacing the girders due to less disruption in the overall construction process. The following photos show the steel plate prior to and after installation of the 4-ply girder.

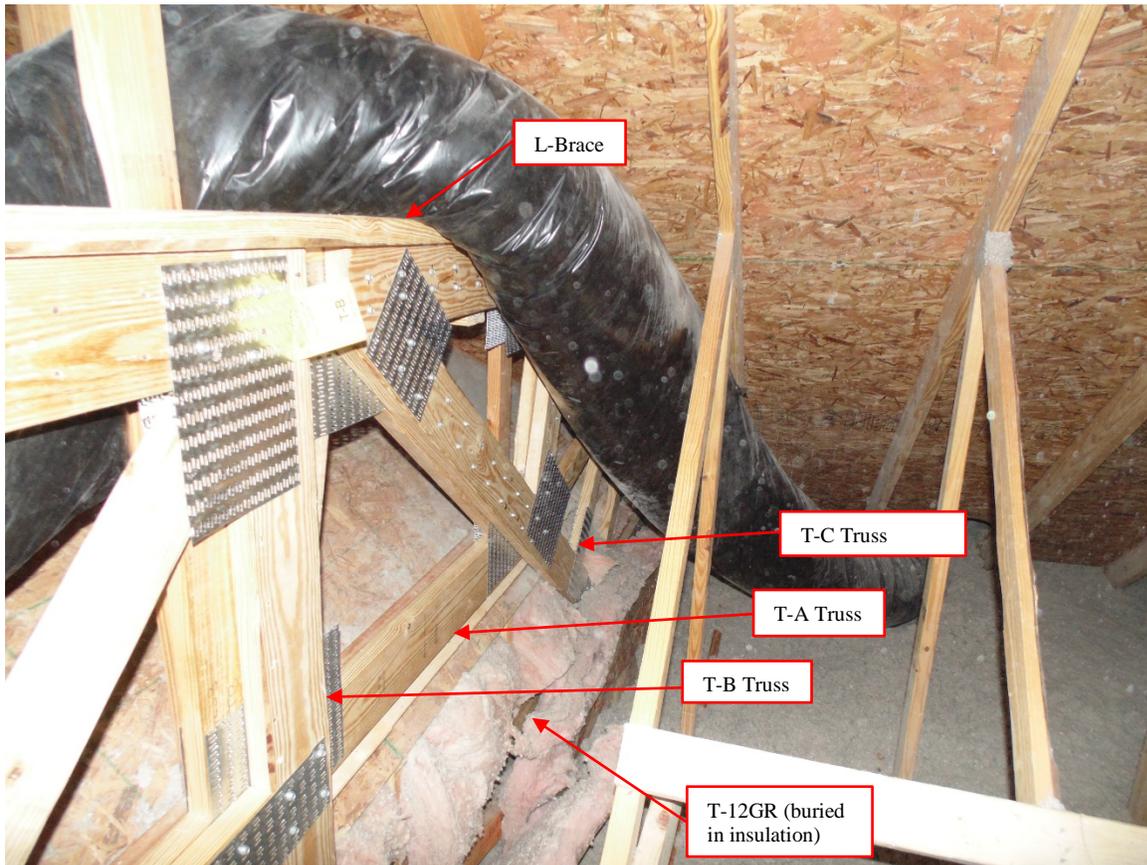
Very complex repairs of this nature should only be completed by competent individuals with years of experience in repair design, but this example is presented as part of this course to show that sometimes, the most effective repairs may be creative and unique. Photographs of the completed repair are shown on the following page.

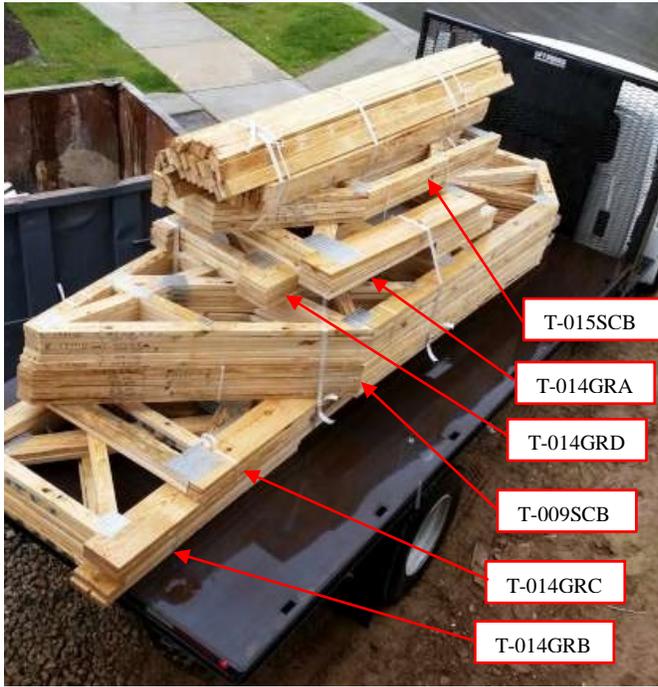
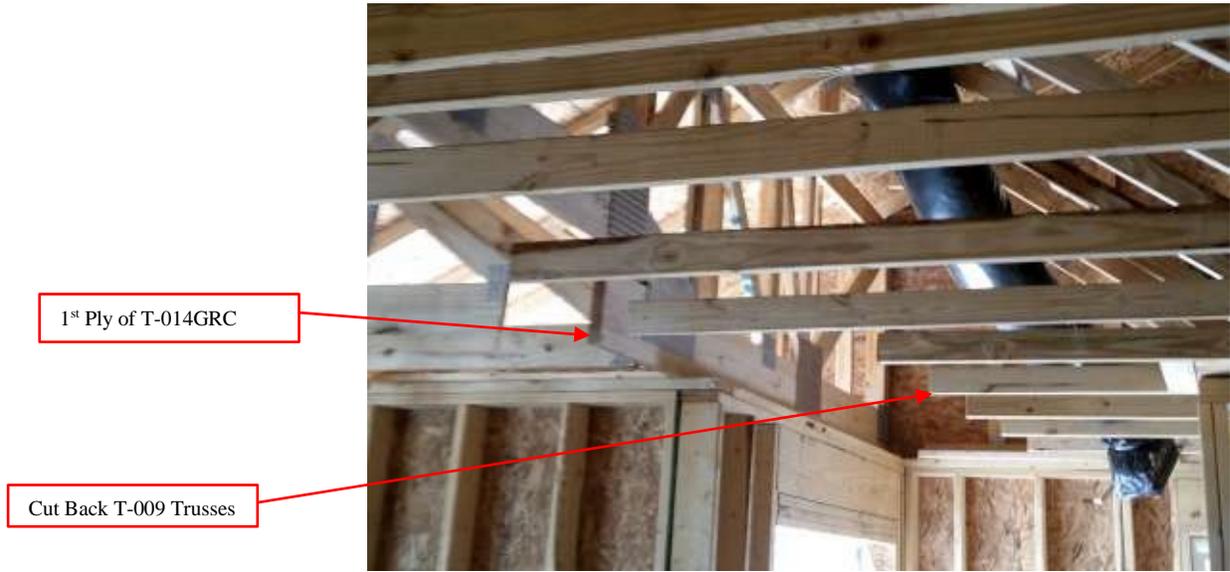
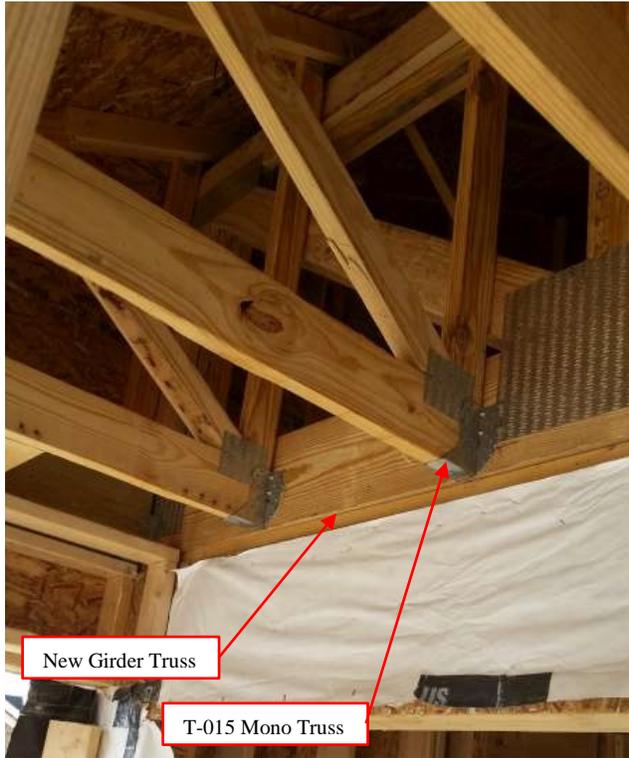
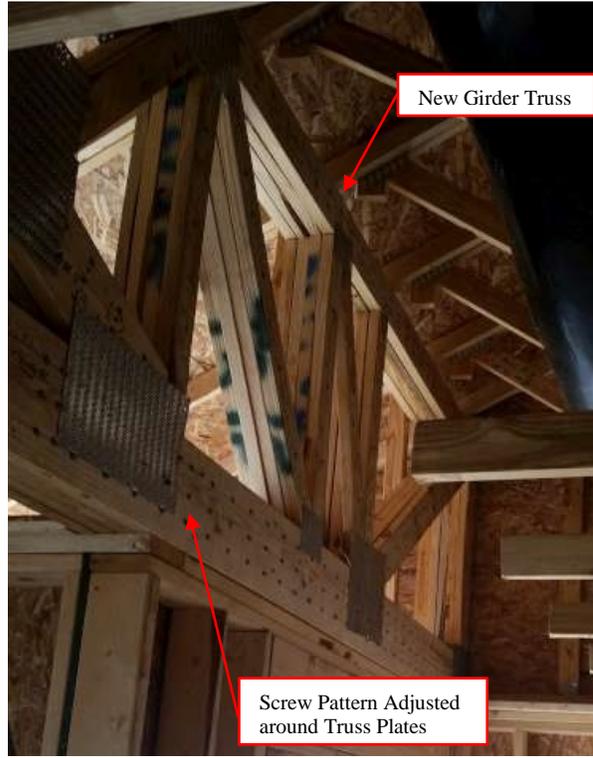
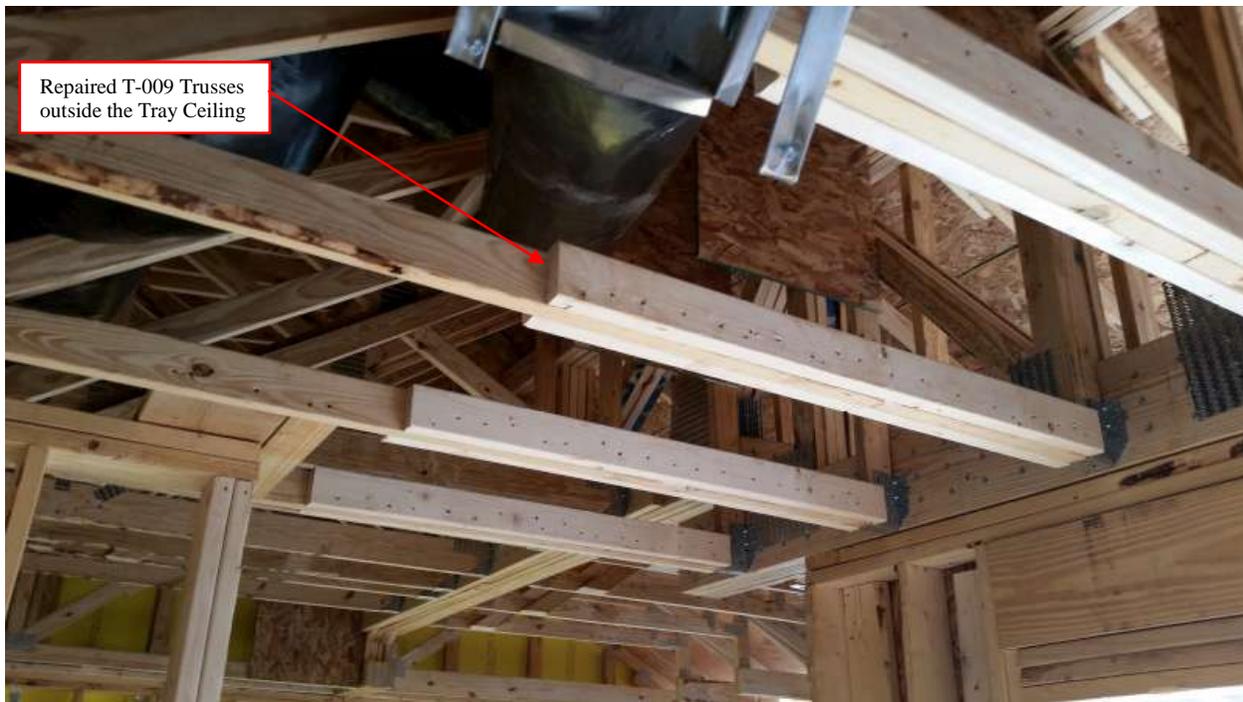
The repair was eventually completed successfully. The following photographs were taken during the implementation of the repair or after it was completed.

- The initial concept for this tray ceiling addition was to repair only the trusses in the area of the volume ceiling. The original idea was that the trusses outside the tray would have their hangers removed but would otherwise remain untouched while the girder truss was cut out and replaced by sliding the spider pieces into place between the trusses on either side. However, this proved to be ineffective because even fully embedded truss plates add thickness to the truss and snag items as they pass by. In this case, the last ply could not be inserted because the truss plates on that ply could not be slid past the truss plates of the adjacent ply. Due to the location of a wall it was decided to cut out the end of all of the trusses in the T-009 series not just the ones getting the tray ceiling. After the spider truss pieces were inserted into place. The ends of the T-009 were reconnected using lumber scabs and OSB gussets. These additional repairs are displayed in the photographs that follow.
