A SunCam online continuing education course

Florida's Mandatory Structural Inspections

Peter J. Tavino, Jr. PE

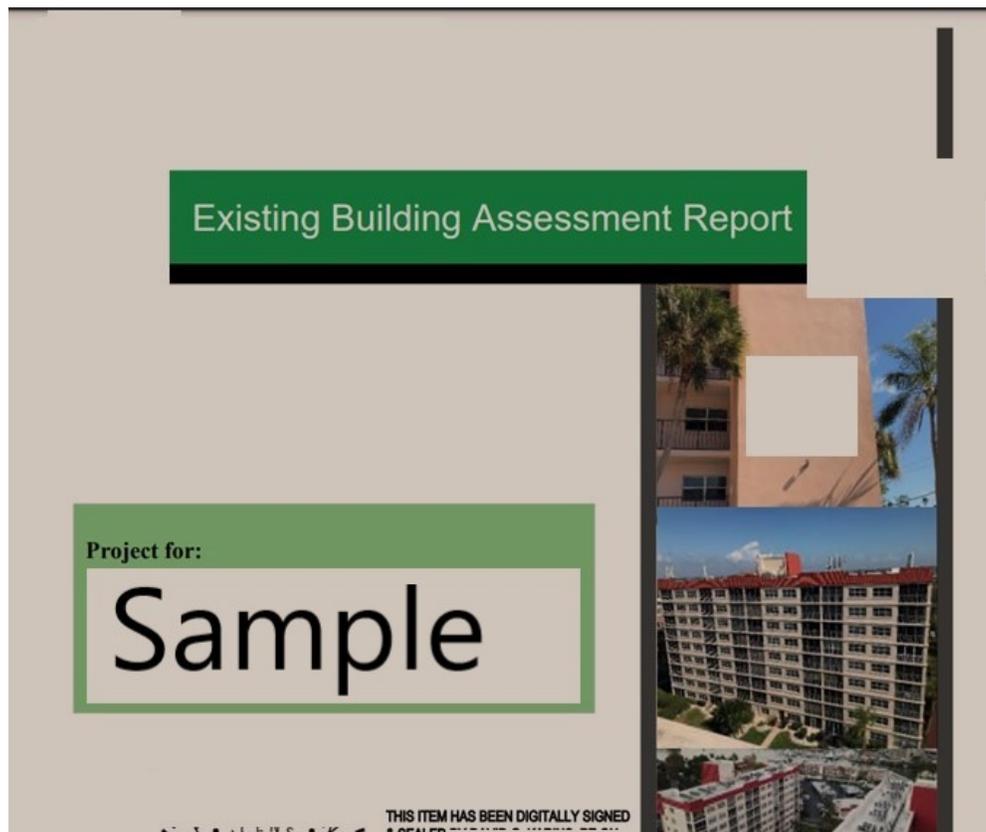
Report Sample Cover page before Statute enactment

Before the Statute was passed, the condo where I serve on the Board of Directors was requested by our Insurance Company to have a structural inspection performed by a PE before they would renew our policy with very high deductible. A sample redacted cover sent to me is attached for SUNCAM readers to see a typical front page.

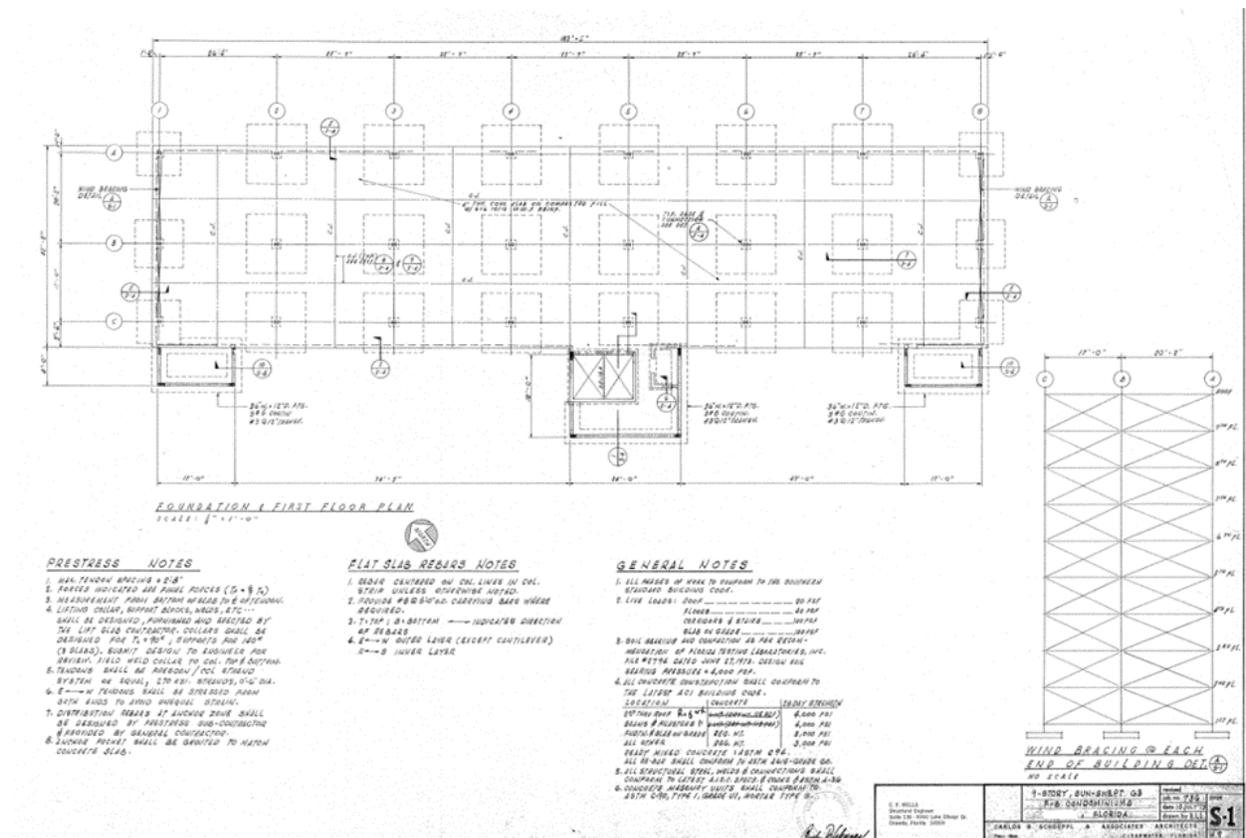
Based on this report as mentioned in the Commentary article, our Insurance Company renewed our policy before the Ian Hurricane. (But with a \$580,000 deductible per building, no claim was made for the approximately \$30,000 in storm damage to be covered by the condo owner quarterly fees.) This report for which our condo association paid the engineering firm showed that we have a good structure. (They used 4000 psi concrete with prestressed cable tendons in the 70's, and the parking garage structure is distant from the residential buildings. Foundations under each column line are on substantial spread footings. See Structural plan S-1 below.)

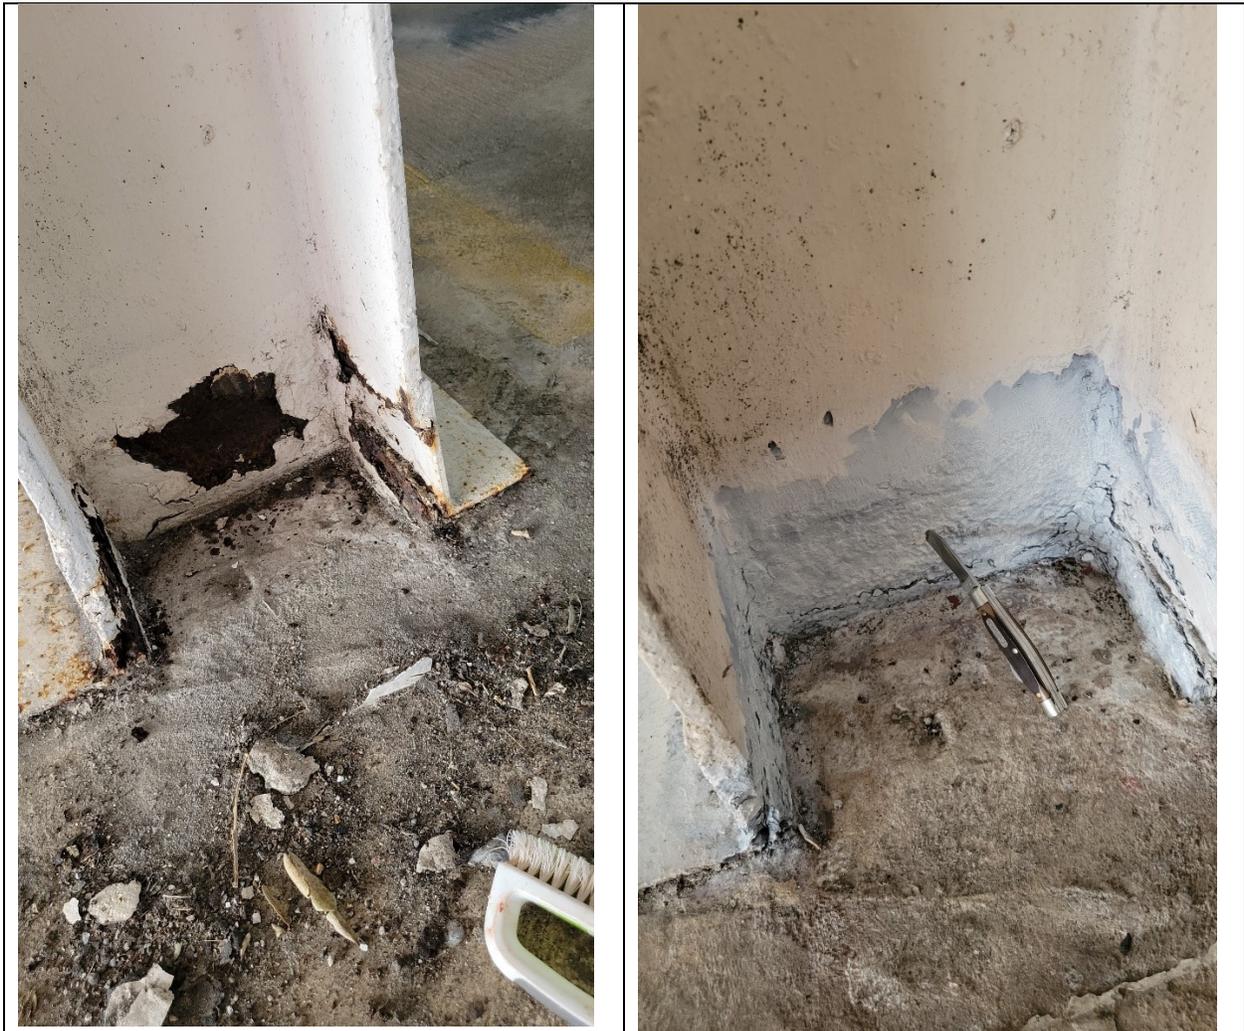
Above is a deteriorated column, with substantial rust at the base floor level, where sand and water accumulate. The all-important flanges have been repaired with welded angle irons and have some structural strength. But the web has distress.

While the web might not count toward compressive strength, it does hold the flanges together and assists in shear. It cannot just be eliminated for design strength. After the rust was removed and rust inhibitor coats were applied, the column was white spray painted. The inspector's pocketknife can be placed through a half inch diameter hole in the steel web.

This steel column is an example of substantial structural deterioration.

Fortunately, this column is located in a garage with a deck above and not a building. It is exposed to weather and drainage water on the concrete parking slab. It is not subject to Statute 553.899. If there was a building or habitable or non habitable (mechanical rooms and common halls, etc.) located above it, it would be subject to the new law. So open parking beneath two habitable floors above needs special attention. But from a practical standpoint, residents would have alerted their condo board and management company if such a condition existed beneath and supported their living space. If this was in a hidden closet not accessible to residents, the new law would discover it. A two or lower story building might also have support like this, but

Besides having substantial structural deterioration, the steel column shown above, if supporting a building above would be an example of a primary structural member and part of a primary structural system. These terms are defined by Statute 627.706.

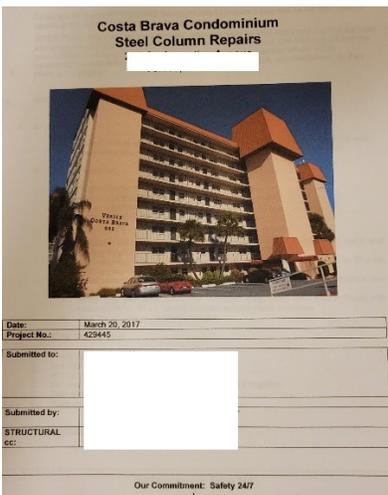
The Proposal was for steel columns in the parking garage supporting the single overhead prestressed concrete slab deck. But the paperwork cover shown on the left included a picture of the residential tower, not the subject garage space.

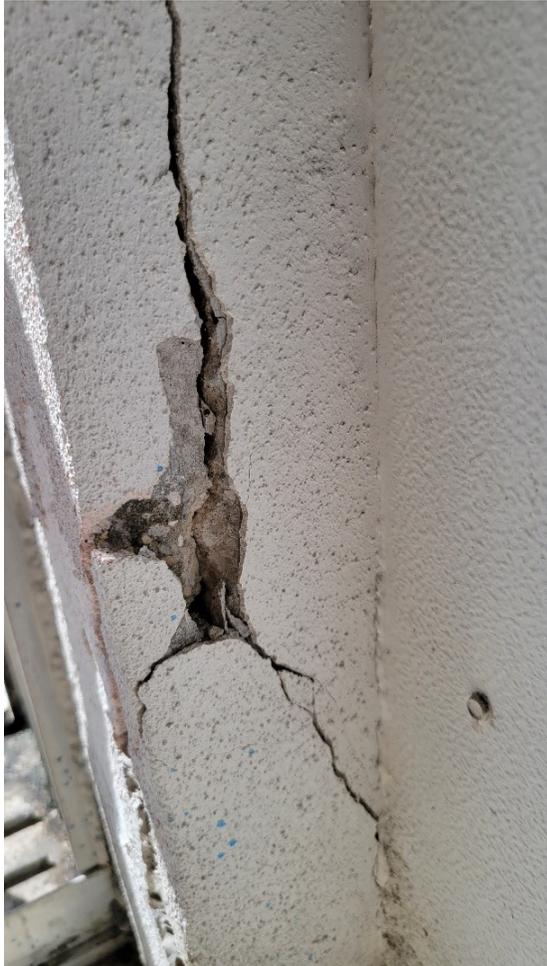
Here is a steel column encased in concrete. The PE knows this because the building design plan below shows the detail.

<p>This is located on the fourth floor and accessible through the condo unit at the lanai. The superficial stucco has cracked substantially, but this is cosmetic only and stucco is not a “primary structural member”.</p> <p>From a PE visual inspection, there is a hairline crack in the concrete encasement of the steel column.</p> <p>Referring to the Statute again, this only falls within the category of surface imperfections such as cracks. It has probably since been mortar caulked by the painter called in to repair and paint the stucco.</p> <p>In a phase one report, it is beyond the PE statute obligation to include this. But this is what PEs do to be thorough and informative beyond the scope of required work. The condo association paying for the phase one report must decide if this extra work is valuable or necessary.</p>
--	--

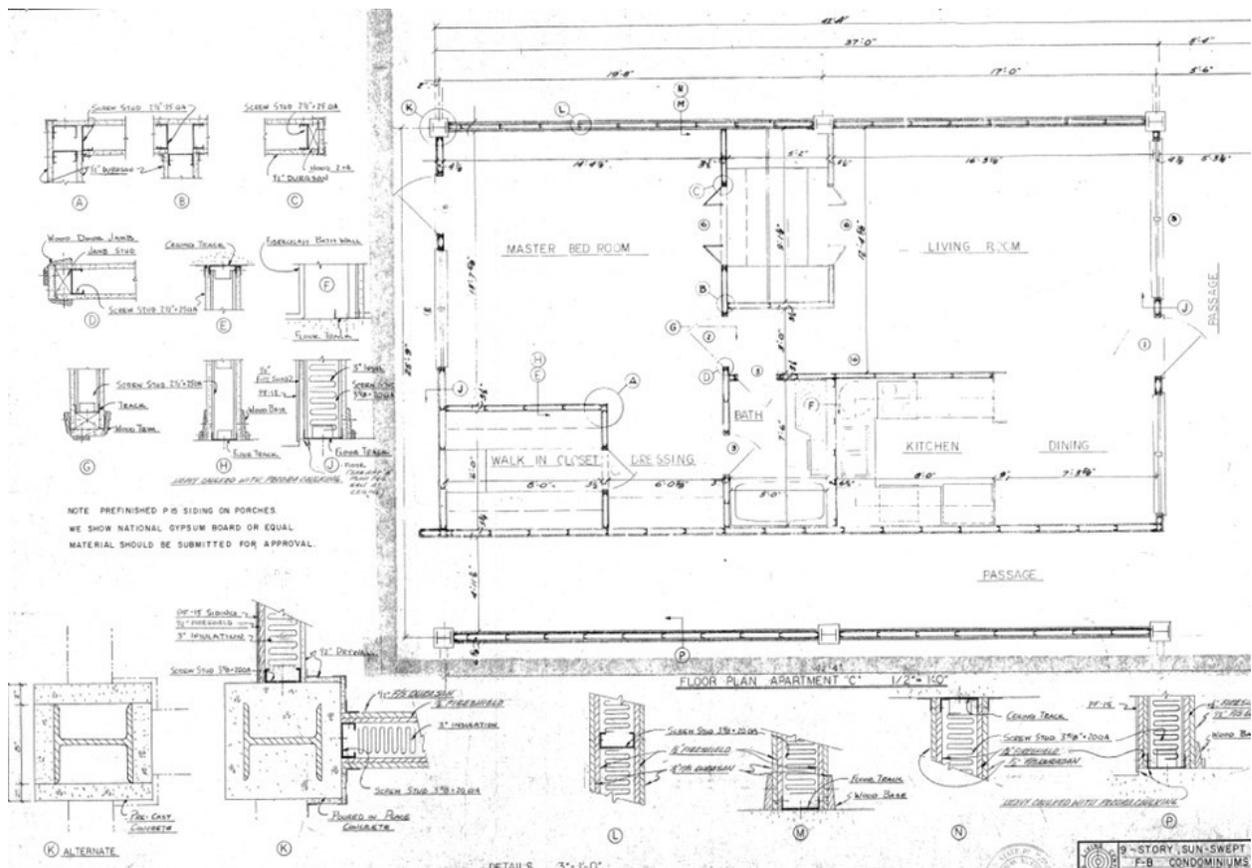
Below is the structural building plan from the 1970s associated with the column crack shown above. It is a typical design drawing for the 25- and 30-year-old structures being inspected. Note that AutoCAD was in its infancy when the subject plans were drawn manually. The complete set was obtained digitally from the City by written request. The image below is

part of a 44 page 42 mb .tif file opened with the Windows Photo Viewer program. The blueprints were also available in paper copy in the condo files. No As Built drawings were available for this project.

Note that there were two options for concrete encasing the steel "H" columns. But they are structural steel and not rebar. See detail K below in lower left-hand corner.

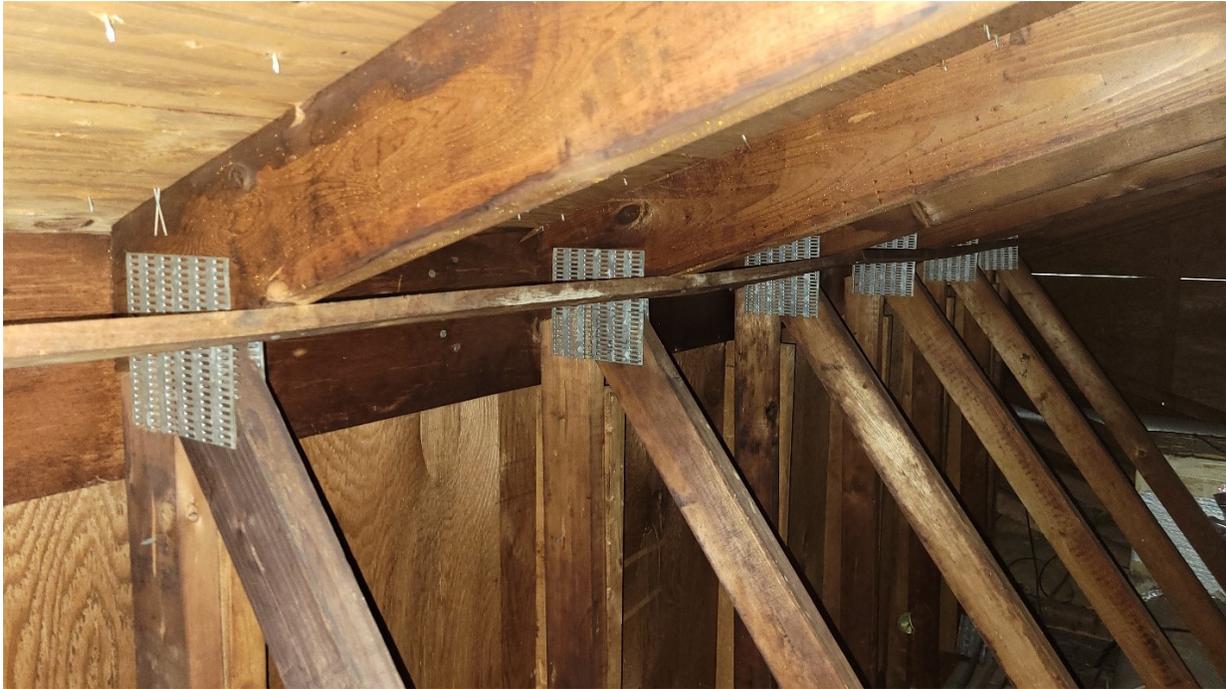
Timber trusses and roofing structure as seen from attic access

If this were a roof to a three-story condo building, the dark colored water stains on the 2 x 6 rafter could be of concern. Discussion with the board or maintenance manager revealed that it was indeed a failure of the plywood decking and roofing membrane above; but a report provided by the board showed that **the deck was replaced a few years earlier** and no further water intrusion was observed. The plywood above was found to be newer but the rafters needed no replacement. The old stains need not be considered occurring to a substantial structural member requiring Phase 2. Discussion in lieu of a Phase 2 should be considered.

If however the stains were substantial, and repairs were not made to plywood above, a phase two inspection could be ordered where a penknife could be used to see if there is substantial wood rot beneath the dark stain color surface. While the phase one PE might be tempted to probe the wood with a knife as is traditionally done, that is beyond the scope of the Statute.

The visual inspection of the intact metal galvanized steel truss connector plates reveals no substantial structural deficiency. There are not extensive visible shiner nails that did not embed into the rafter. Remember that phase one inspection is not to enforce code compliance.

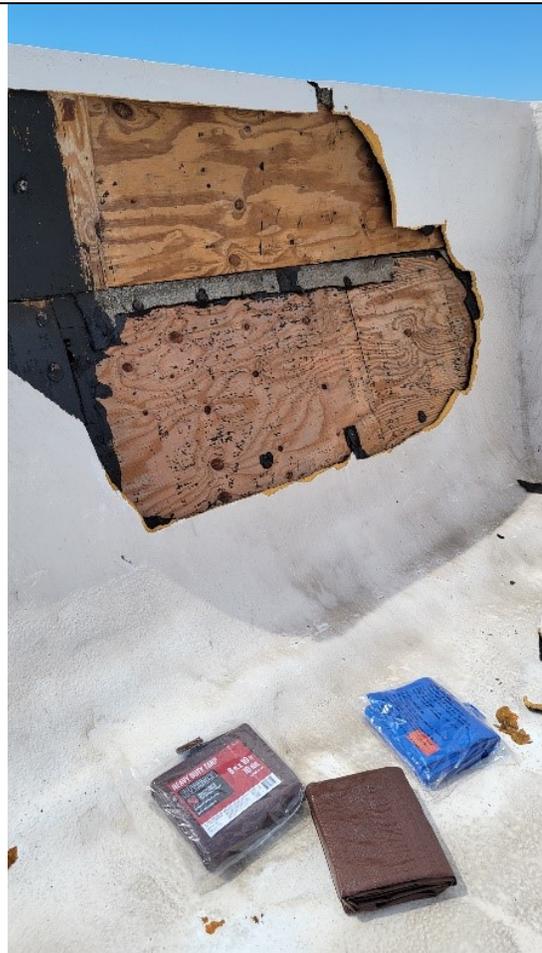
Hurricane Ian damaged the foam board protecting the plywood parapet rising above the flat roof.

Although this appears severe, the plywood is the structure, not the (fire rated?) one inch thick foam board with white acrylic elasometric roof coating. As long as the blue and brown roof tarps are applied to keep stormwater from deteriorating the plywood or 2" x 6" framing beneath it, this does not warrant a phase one report photo because it is not structural.

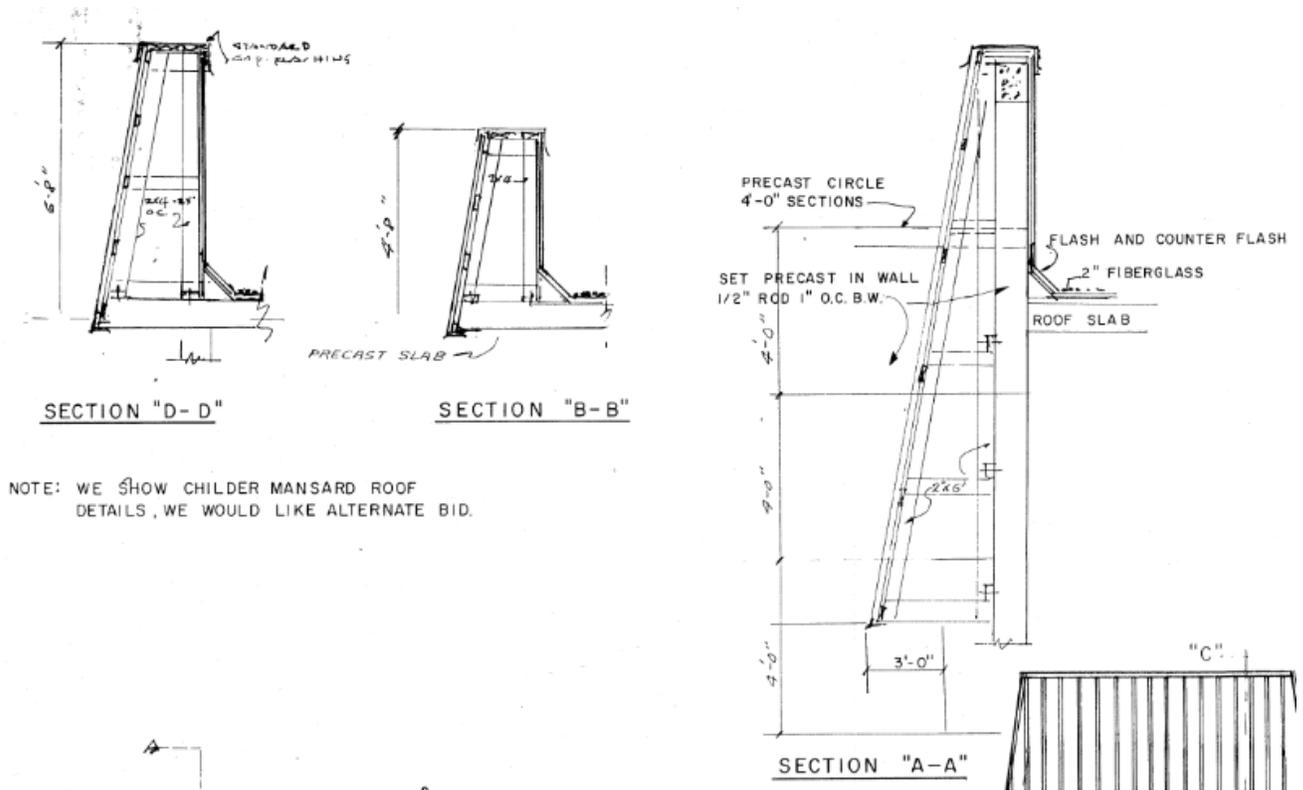
Roof Parapet Section Detail from Design Drawings

The structure is 2" x 6" not 2" x 4" by reading the drawing detail Section A-A shown below. The plywood if damaged is not a primary structural member either in the author's opinion. It's repair would fall outside this Inspection program jurisdiction.

Whether a parapet is considered a major structural system is to be determined. The building would still stand if the entire parapet was blown off in a hurricane. Perhaps how it is connected by cantilever, etc., is relevant. Note the damage to the vertical surface caused by wind. Therefore, hip roofs comprising 90% or more of a residential roof see a reduced insurance premium rate. Vertical gable ends are more susceptible to wind damage than horizontal or mildly sloped roof surfaces. Understanding wind forces on structures is a critical skill inspecting PEs must have.

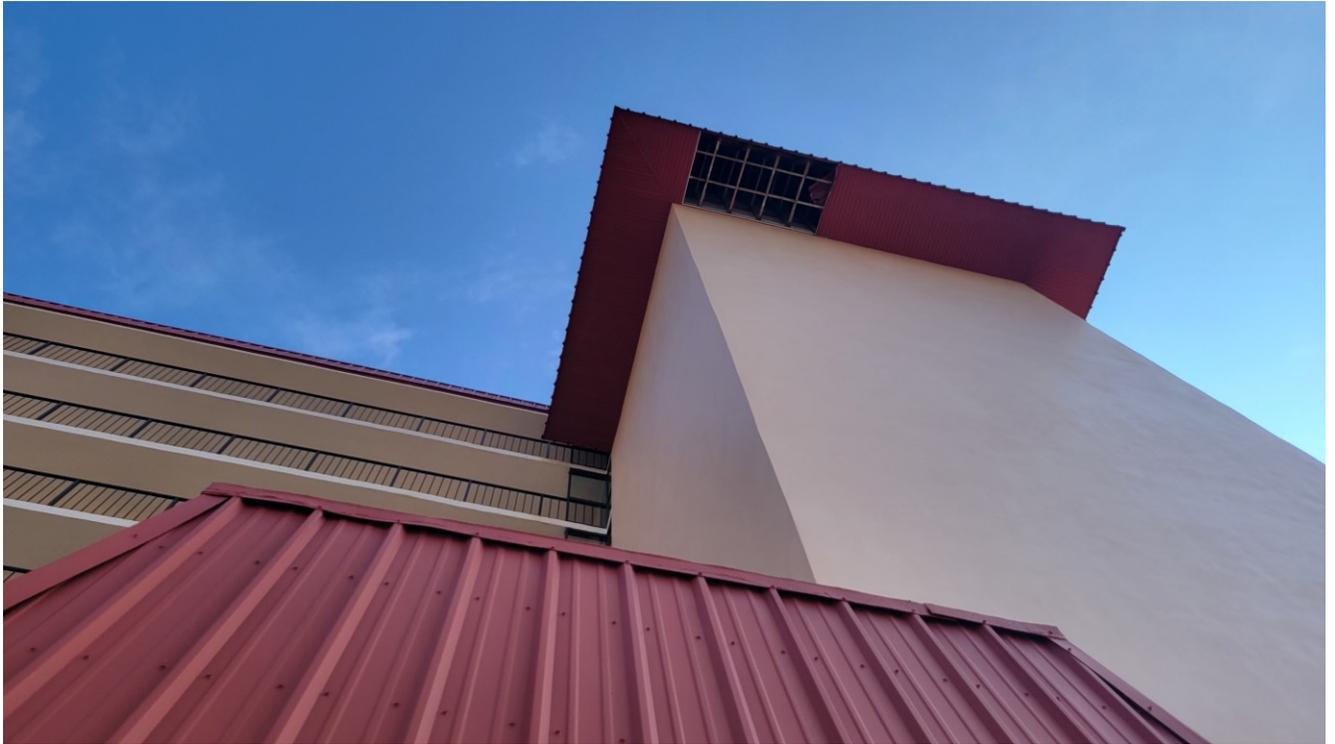
Camera image looking almost straight up at a condo soffit

This picture shows that Hurricane Ian blew about 35 square feet of red metal soffit panels off the property from their 75-foot height. With binoculars, the PE can ascertain that the 2" x 6" or 2" x 4" framing (unlabeled in detail Section A-A) was not substantially distressed. The façade integrity that poses a danger to pedestrians below might be considered significant, but it is not a primary structural member. This Florida program is not similar to New York City's Façade Inspection & Safety Program (FISP), once known as Local Law 11/98 with scaffold issues repairing six story and higher sidings.

Again, this extensive damage would not warrant phase one attention. In general, hurricane wind damage is a separate issue. High rise condos built to stricter building codes with steel and concrete instead of wood frame will resist wind forces better, although fenestration and gable style roofs remain vulnerable. The legislation was written before the Ian Hurricane, and its implementation would probably not have affected property damage totals in the author's opinion.

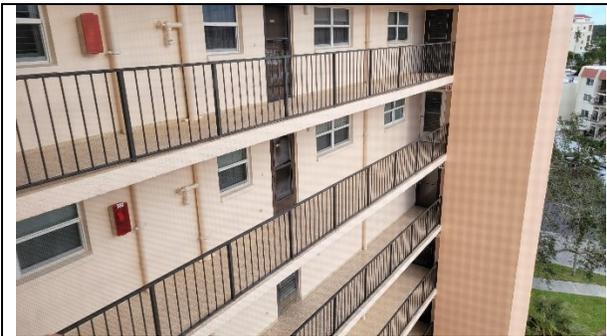
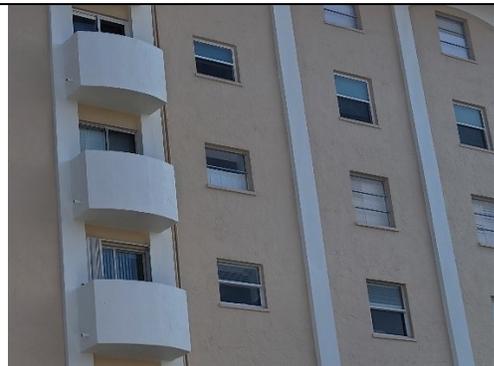
Walkways and balconies may or may not be integrated with the building structure as to be considered a primary structural member. See photo angle below. This example is primary.

Small balconies independent of the primary building structure. These balconies were constructed after the building was erected. They are not part of phase one.

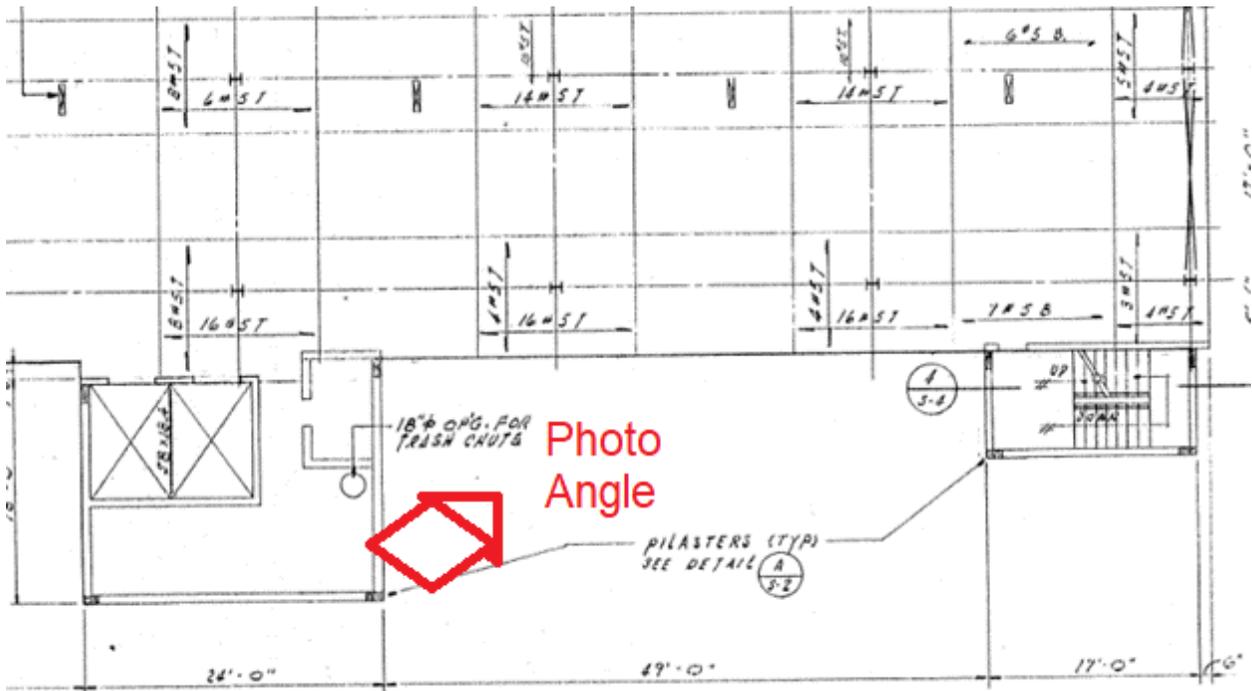
From the plans above, the exterior reinforced concrete slab walkway passages are in a continuous cantilever pour with 16 number 5 rebars top running from the condo unit across the walkway. Certain failure here could affect the system, so these should be part of phase one. But with this strong design, failure risk is minimal.

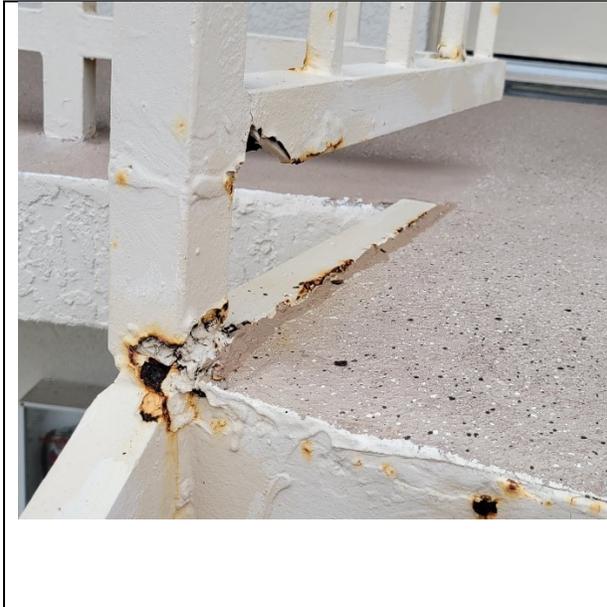
The handrail to the left may need attention, especially if nearby supports are just as deteriorated.

But handrails are not “primary structural members” for “support and stability for the vertical or lateral loads of the overall structure”.

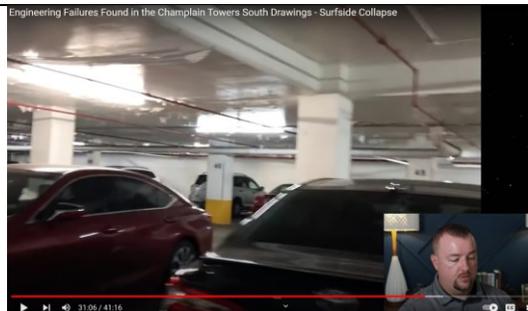
<p><i>The owner asked to remove the 12" step between the two levels. The step depths had reinforced concrete beams colored orange on the plan above. But the 1980 design omitted all beam rebar.</i></p>
--	--

Josh Porter notes no beams existed in the garage level below, so the 1980 beam and rebar elimination occurred.

Additional planter weight was added to the slab without beam support. The small column cross sections probably caused shear failure of the overloaded slab above, possibly when a car hit the planter at 1:20 am?

In the author's opinion, agreeing with Josh Porter, the cause of collapse was not inadequate repair money but a time bomb waiting for a car to hit the under designed structure at 1:20 am. This delivered dynamic load to the two-way slab that lost its 1979 design support beams in a 1980 redesign to eliminate a 12" step. The shear load to the narrow columns was exceeded and started the domino effect. Snap shots from the publicly available video are shown. YouTube offers many more related videos for those interested.

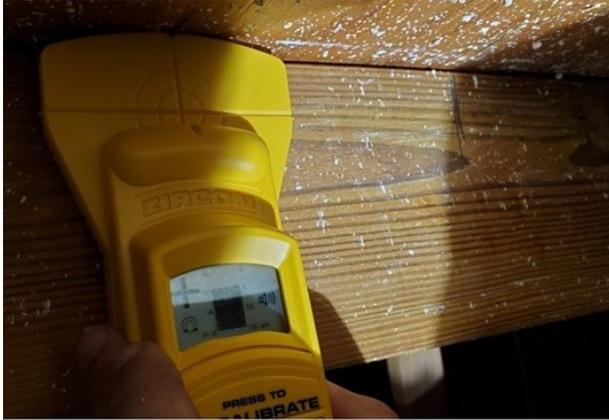
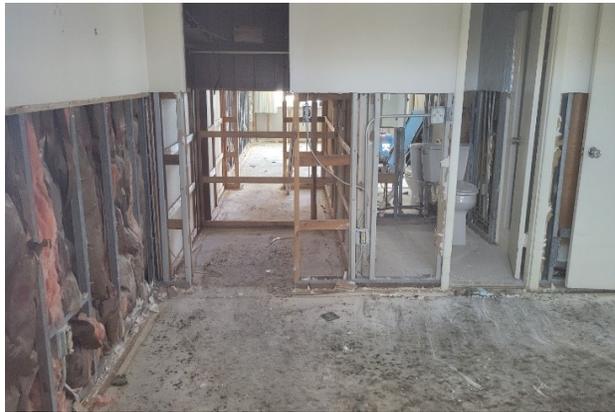
Phase Two - substantial structural deterioration with possible testing Most buildings should not require phase two. If a more physical and in-depth inspection of a phase one defect is required, the PE may use traditional probing tools such as this MetalliScanner. This battery powered instrument locates nails that are not visible shiners. It can also be used to locate rebar and tendons if necessary for a non-destructive test.

Tavino's ZirconMetalliScanner MT6 finds ring shank nails. Exposed concrete floor.

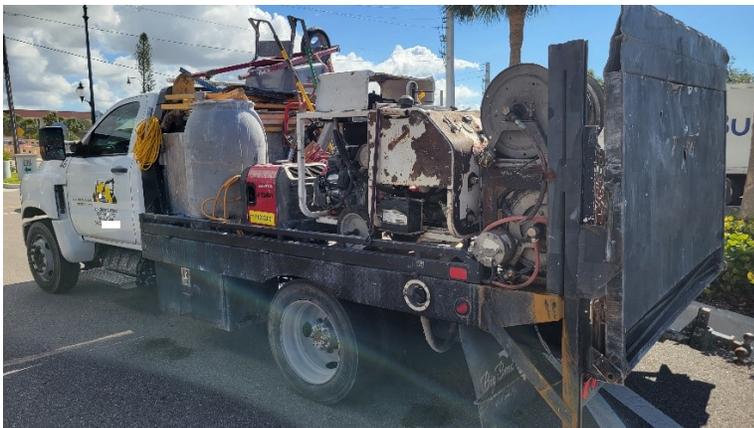
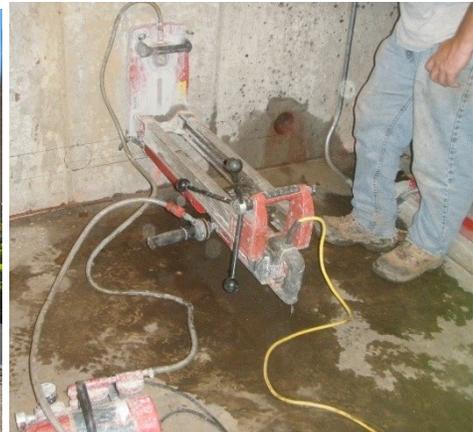
If the PE requires concrete core cylinders be drilled and crush tested for compressive strength, a core drill from a concrete core drill services truck like below can be used especially in a unit whose floor is under construction if the unit owner allows. Such destructive methods need to be required by the PE only after special consideration.

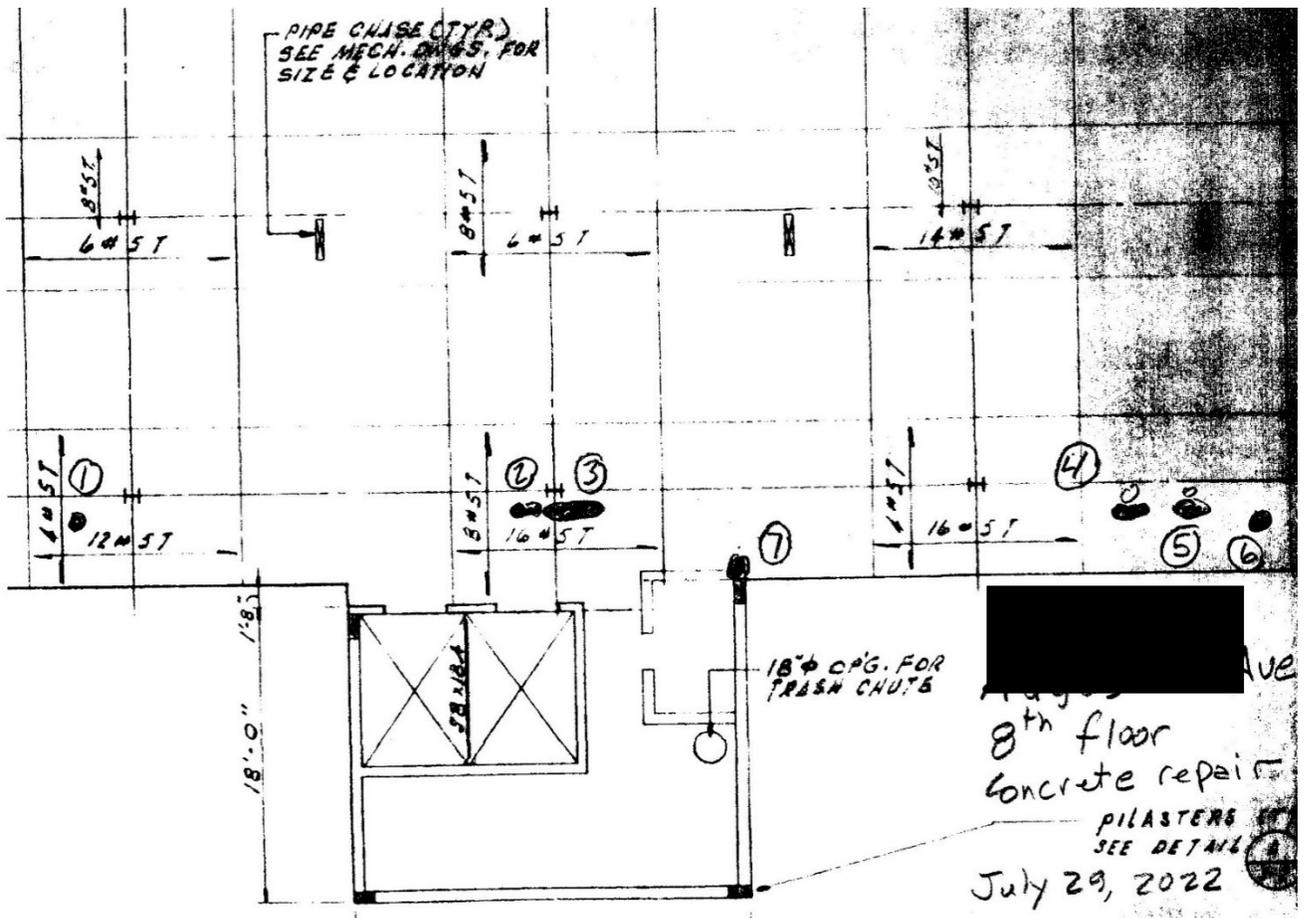
Item#1 - The numbered locations of the repairs are as shown below for the Xx Building.

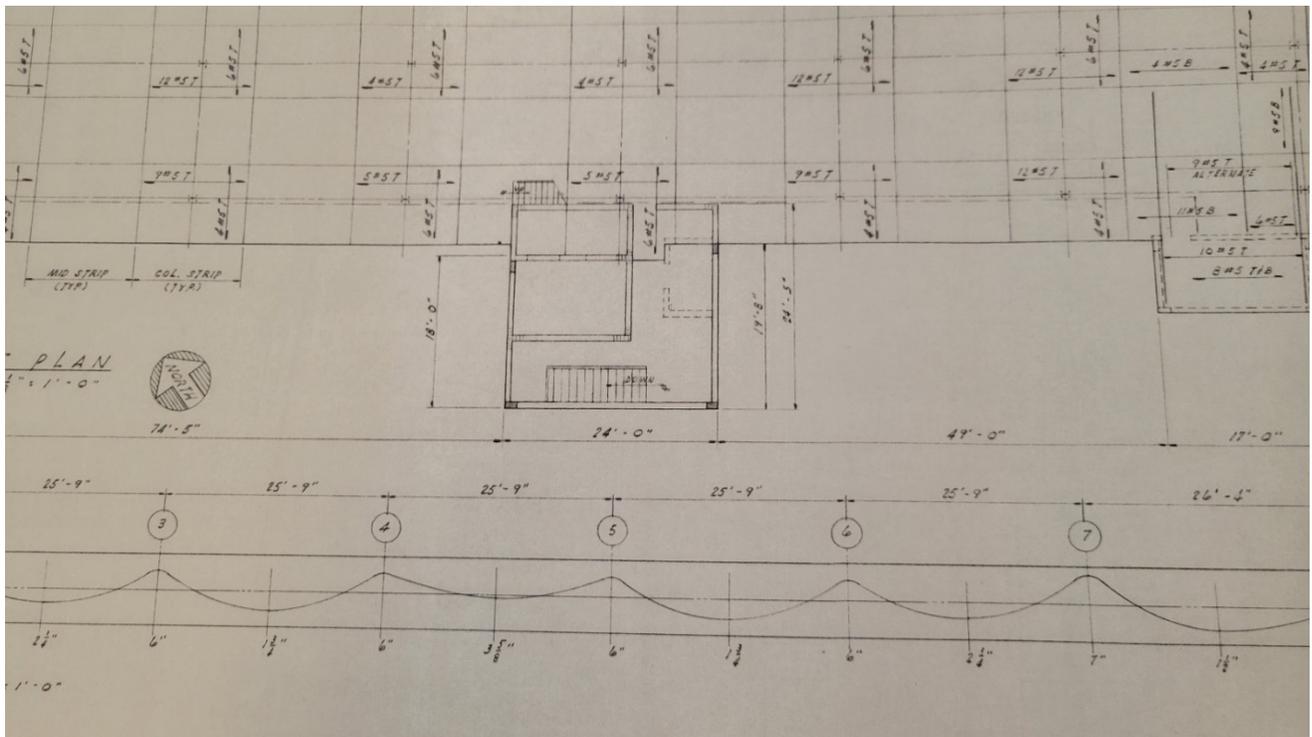
Item #4 – Prestressed Tension Cable profile from construction drawings.

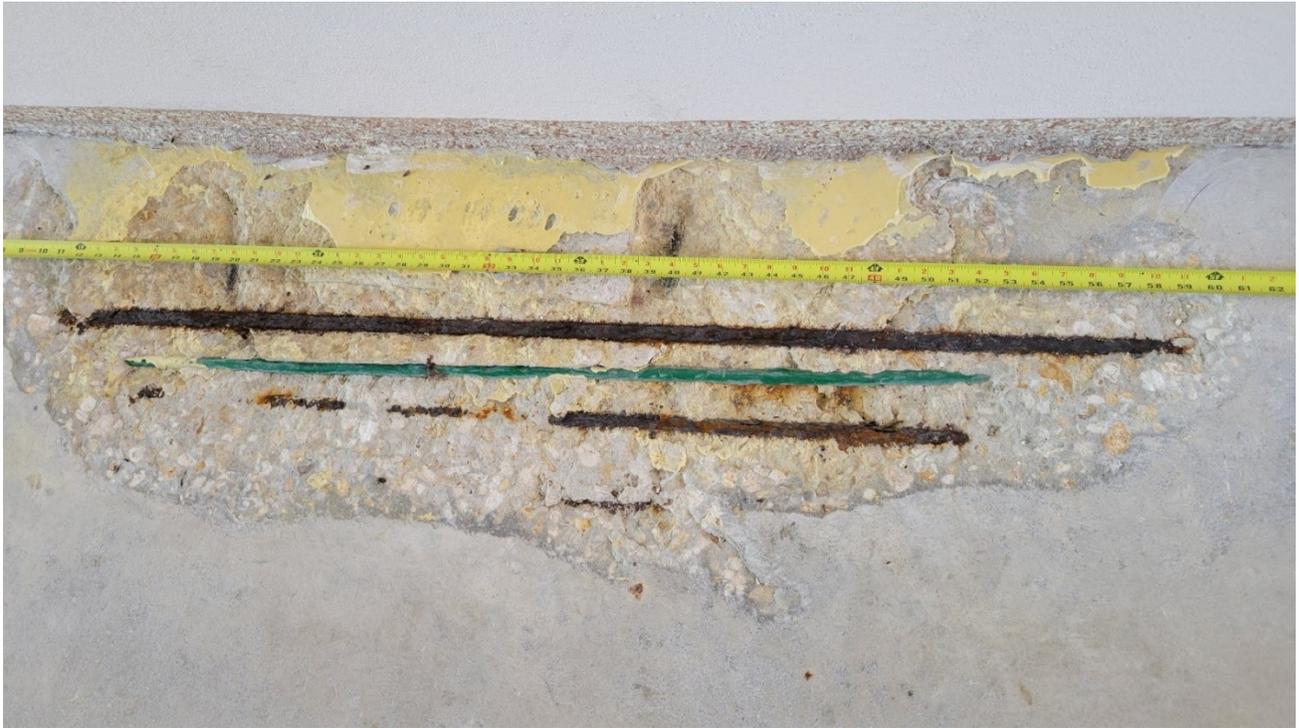
Item #5 – Detail of largest repair area in Xxx Building (referenced as location 3).

- a. This picture is before any remediation work began.
- b. These are 4-foot and 3-foot lengths of #5 top rebar with green Prestress Tension Cable sheathing between.
- c. The yellow is old epoxy from a previous repair.

During the preparation (grinding) project phase, there were a few small areas where corroded rebar and prestressed tension cables were visible. Two minor nicks, less than 1” each, were observed in the tension cable sheathing. The structural cable was carefully examined at the areas where the nicks occurred and determined to be intact and in its original installed condition. The contractor was instructed by the Board to cease any further work until these areas could be properly repaired.

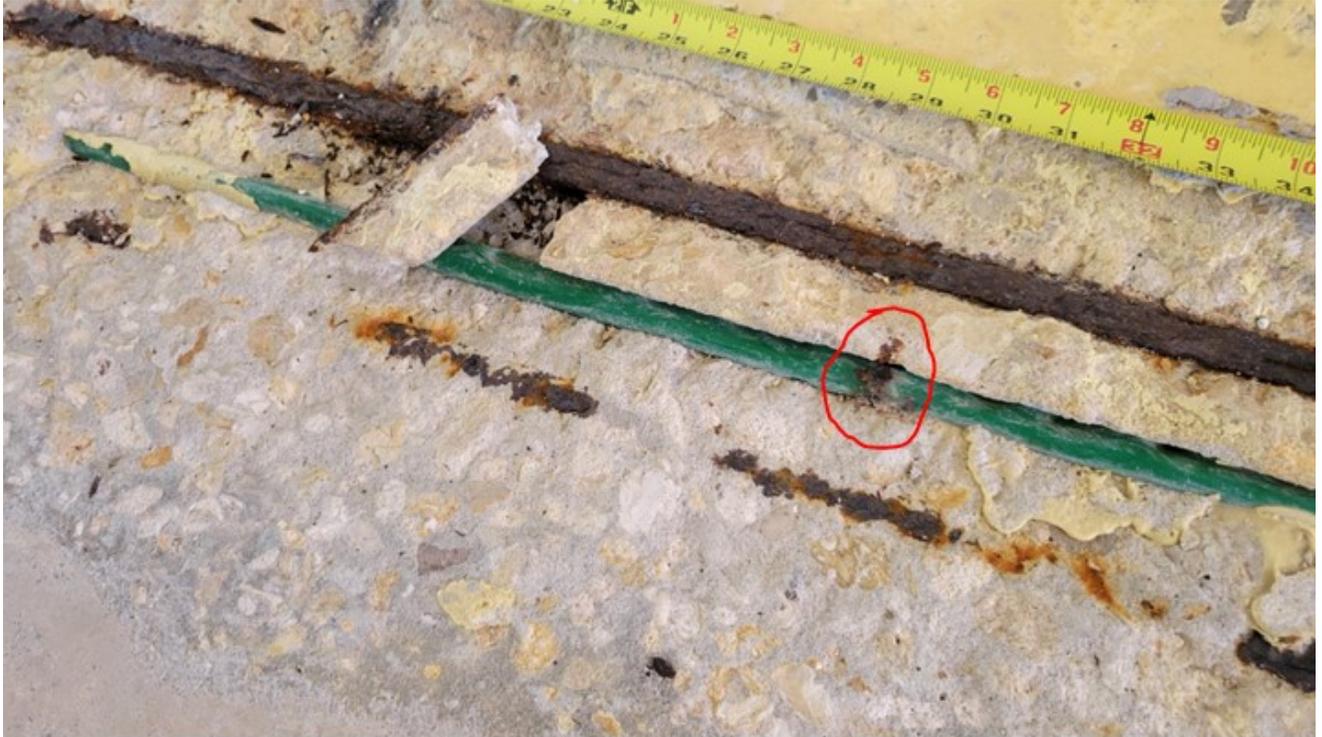
Item#6– Close up of largest repair area in Xxx Building.

- a. nick in the green sheathing as shown close up and circled in Red.

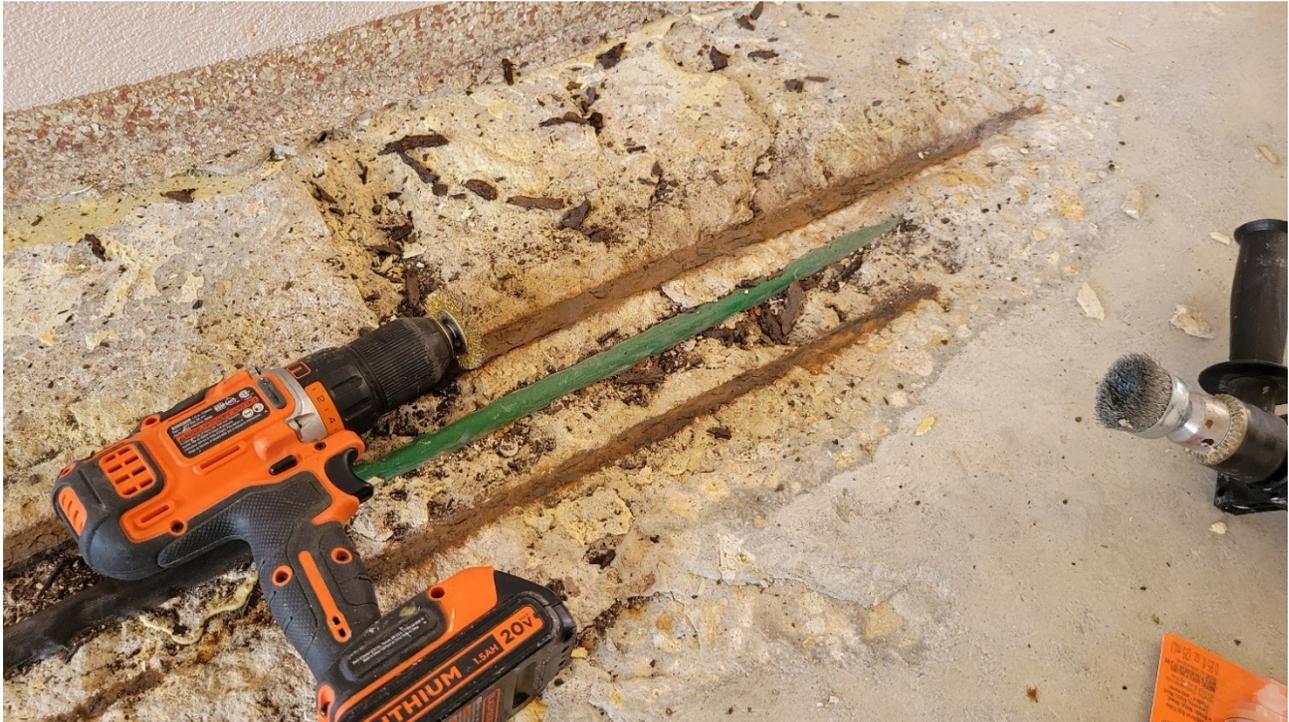
Item#7 – Preparing work on large repair area in 244 Building.

- a. Conduct hammer tapping testing to identify any non-bonded concrete pieces. Use extreme caution in area located next to the Tension Cable.
- b. NOTE: there were no peripheral cracks emanating from this repair area and no spalling or cracking in the ceiling directly underneath.
- c. Hard cold small chisel used to carefully remove any unbounded/loose concrete and old epoxy located in the repair area.
- d. Wire wheel and soft wire and plastic brushes used to remove flaking rust from rebar. (Note: No flakes exceeding 1/16" inch were observed.)
- e. Verify that vast majority of #5 bar is intact. Note ribs where possible.
- f. Remove all dust caused by rebar rust remediation to prepare for epoxy.
- g. Mix two-part epoxy and apply over entire rebar area.

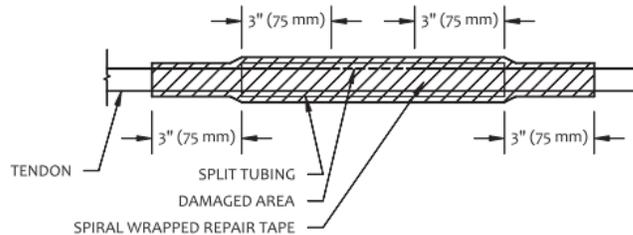
Item#8 – Diagram from Post Tension Cable Institute showing recommended procedure

(b) Spirally wrap the entire length of the damaged sheathing area with repair tape and extend past tubing by 3 in. (75 mm). Tape repair should be smooth without folds.

Note: Material used should be of suitable quality to allow for seal of aforementioned tubing method to be watertight

If no significant portion of the original sheathing is missing (that is, nicks or cuts of 1/4 x 2 in. [6 x 51 mm] size), then taping can be used in place of the aforementioned method by spirally wrapping a minimum of two layers of repair tape extending a minimum of 3 in. (75 mm) past the damaged area in both directions.

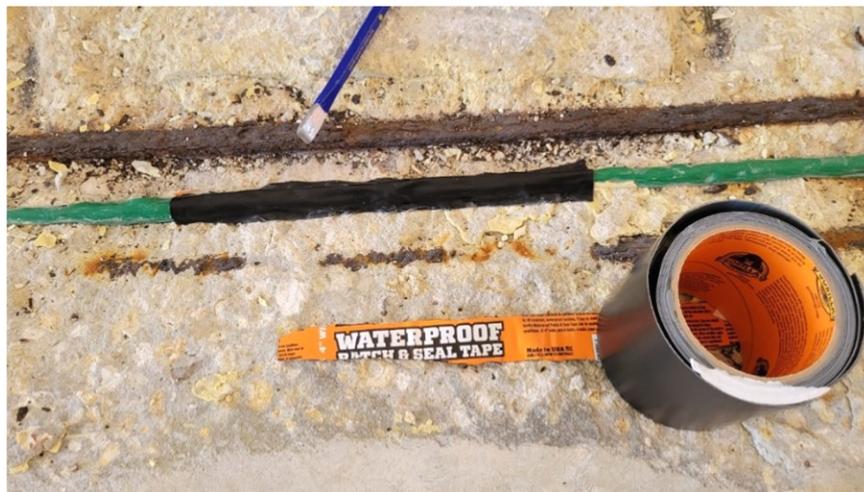
- a. Waterproof tape must extend at least 3 inches past the nick.
- b. Sheathing must be cleaned of any residue before tape applied.

Item#9 - Repaired Tension Cable sheathing with waterproof tape.

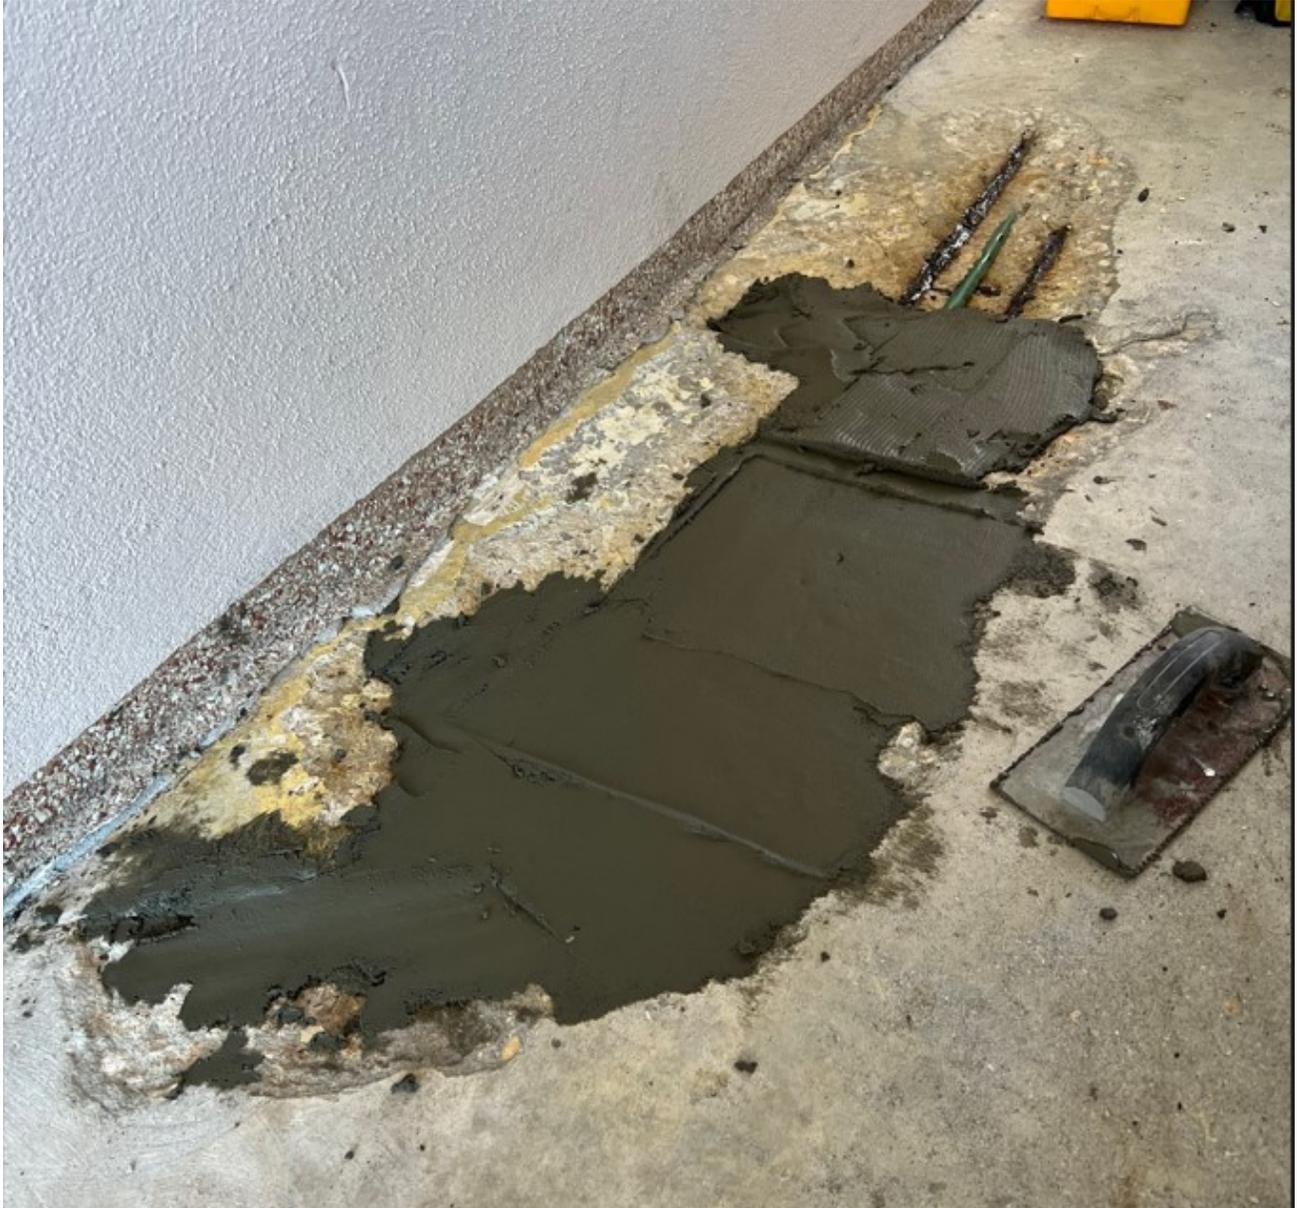
Item #10 – Applying concrete patch in largest repair area in Xxxx Building. Shiny epoxy on rebar is shown.
