A SunCam online continuing education course

Florida's Mandatory Structural Inspections

Peter J. Tavino, Jr. PE

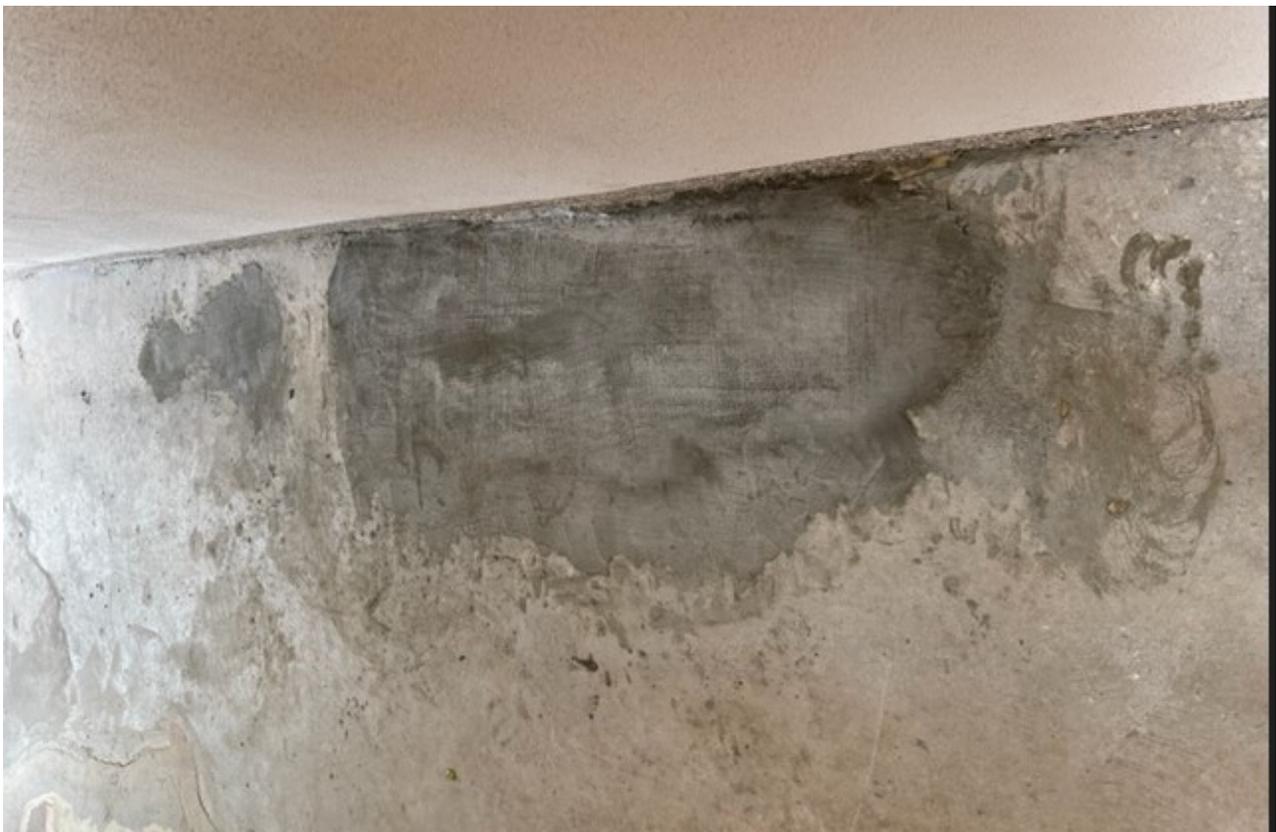
- a. Wet surface area with potable water.
- b. Mix enough low aggregate concrete to fill the hole and entirely cover the rebar and tendon cables. Mix to conventional mortar smoothest in water content (to peanut butter consistency).
- c. Hand glove pack at rebar and then trowel to level top with rough surface to receive future base coat.
- d. Prevent foot traffic for 3-hour set time and 24-hour dried strength.

Item#11 - concrete patch in largest repair area in Xxxx Building curing process.

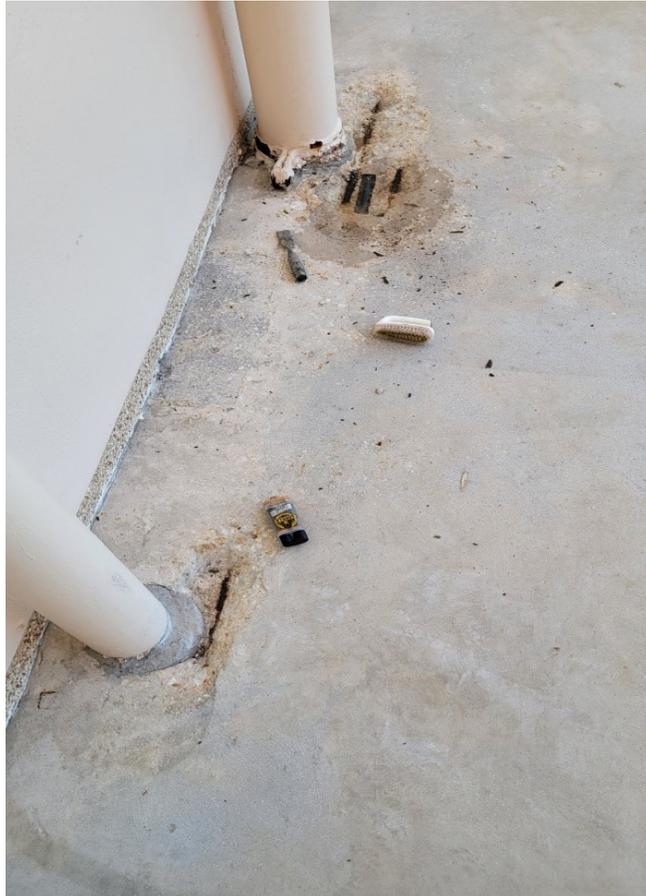
Item#12 – other repair areas 4 and 5 utilizing same remediation process.
